Known for excellence.
Built on trust.

**2023 COVER INSPECTION REPORT
MASSACHUSETTS PORT AUTHORITY
Anderson Regional Transportation Center
100 Atlantic Avenue
Woburn, Massachusetts**

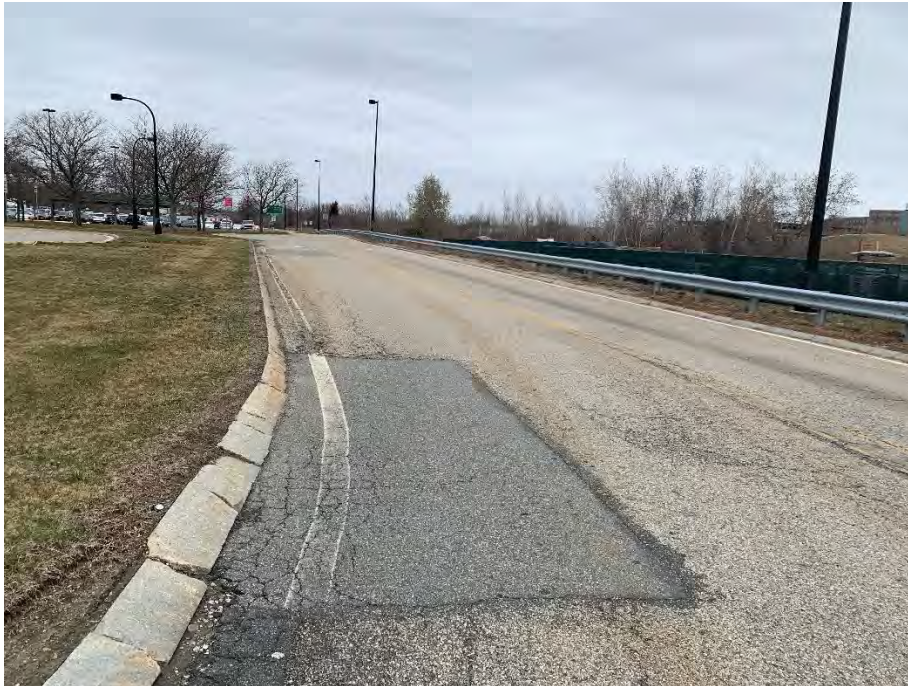
Photo 1: Observed, moderate fatigue cracking approximately 0 to 1/2" and subsidence at site entrance, looking north.

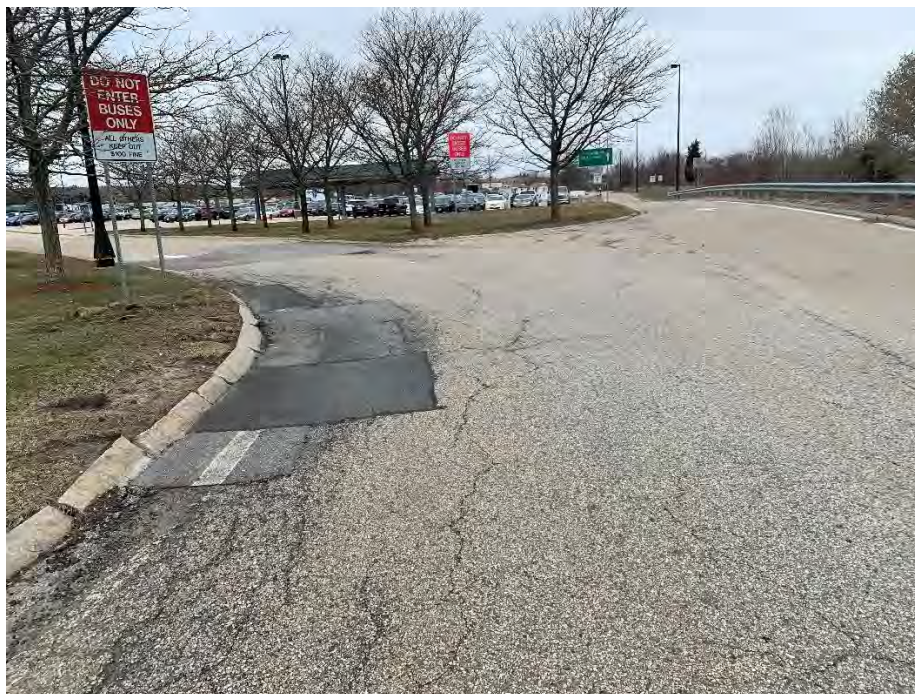
Photo 2: Observed, moderate fatigue cracking approximately 0 to 1/2" deep at the site entrance, looking north.

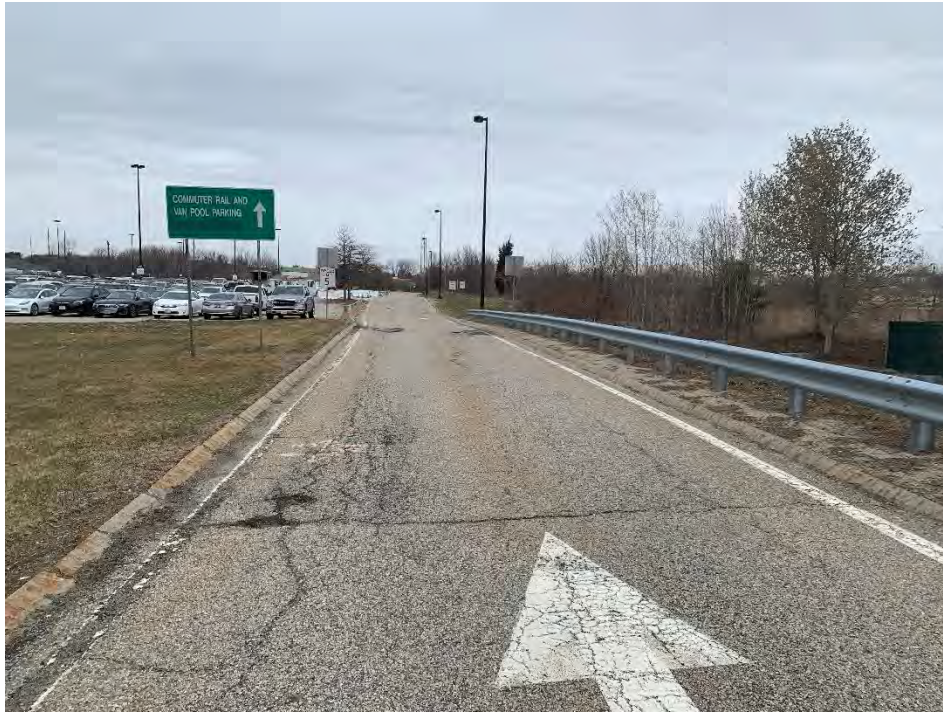
Photo 3: Observed moderate/ severe fatigue cracking approximately 200' long and traverse cracking, general conditions (north of Photo 2), looking northwest.

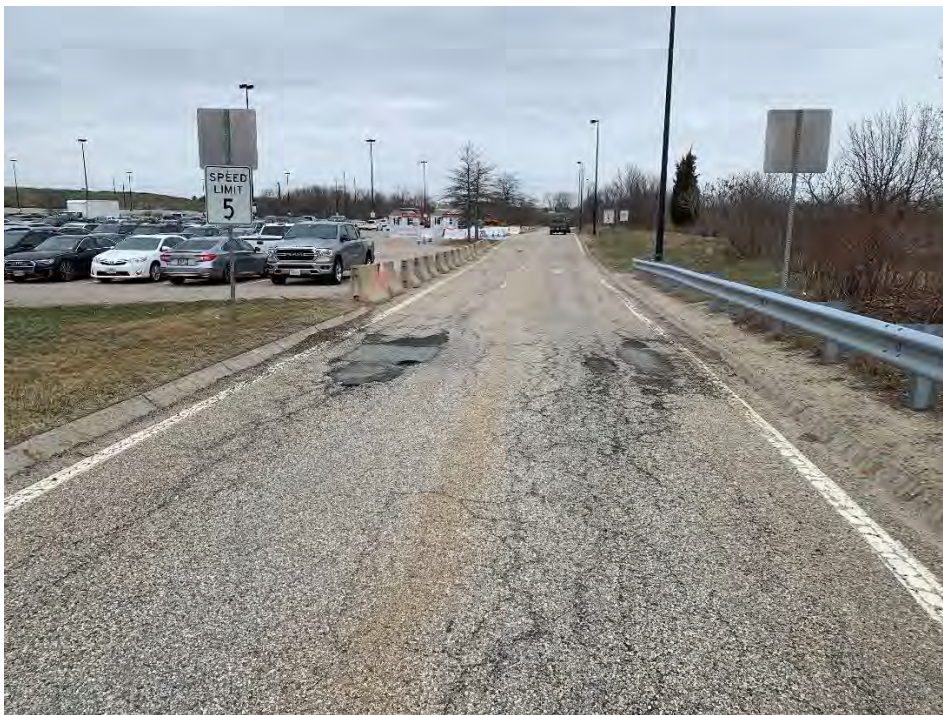
Photo 4: Observed approximately 200' of moderate/ severe fatigue cracking approximately 0 to 1" feet deep, and rutting (north of Photo 2), looking north.

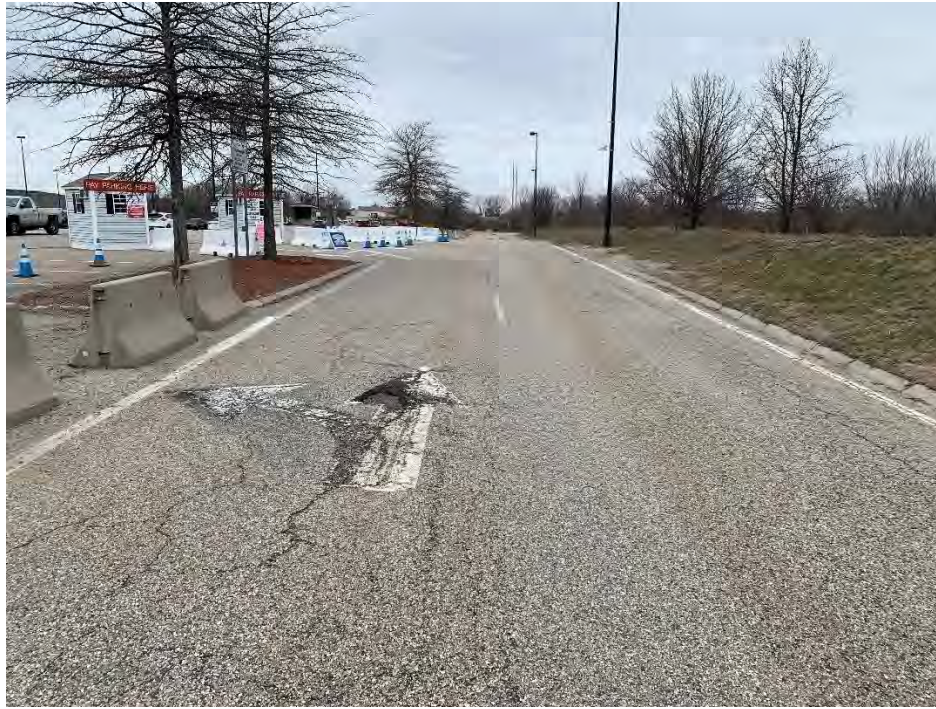
Photo 5: Observed approximately (2"x13') longitudinal cracking in pavement and a hole in the pavement on the eastern edge of the pavement, looking northwest.

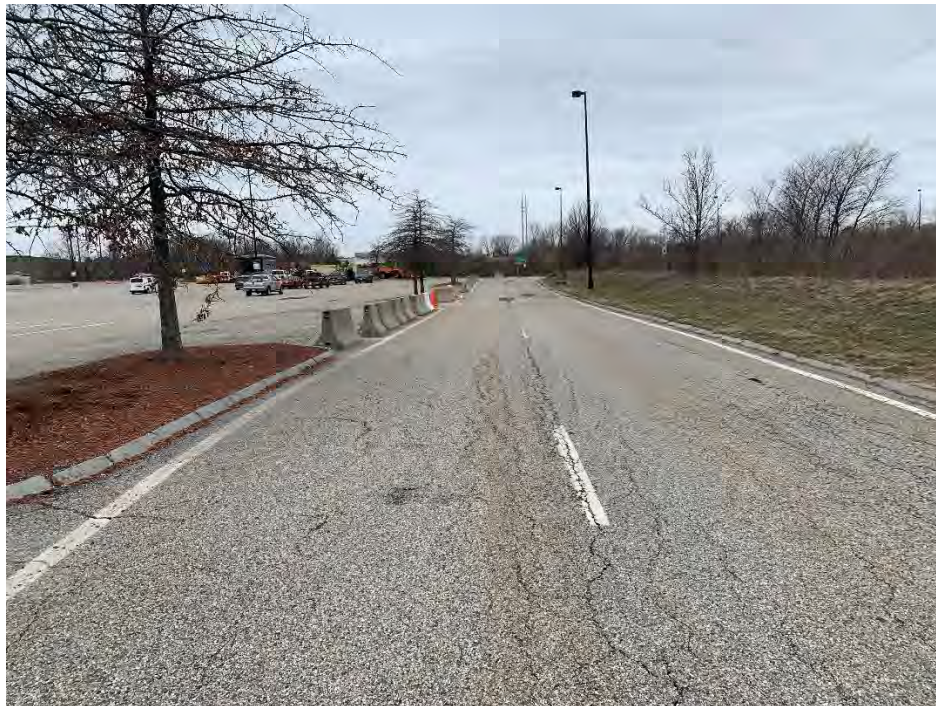
Photo 6: Observed approximately 150' of moderate fatigue cracking on the centerline and edge of the pavement, on the eastern edge of the paved area, looking northwest.

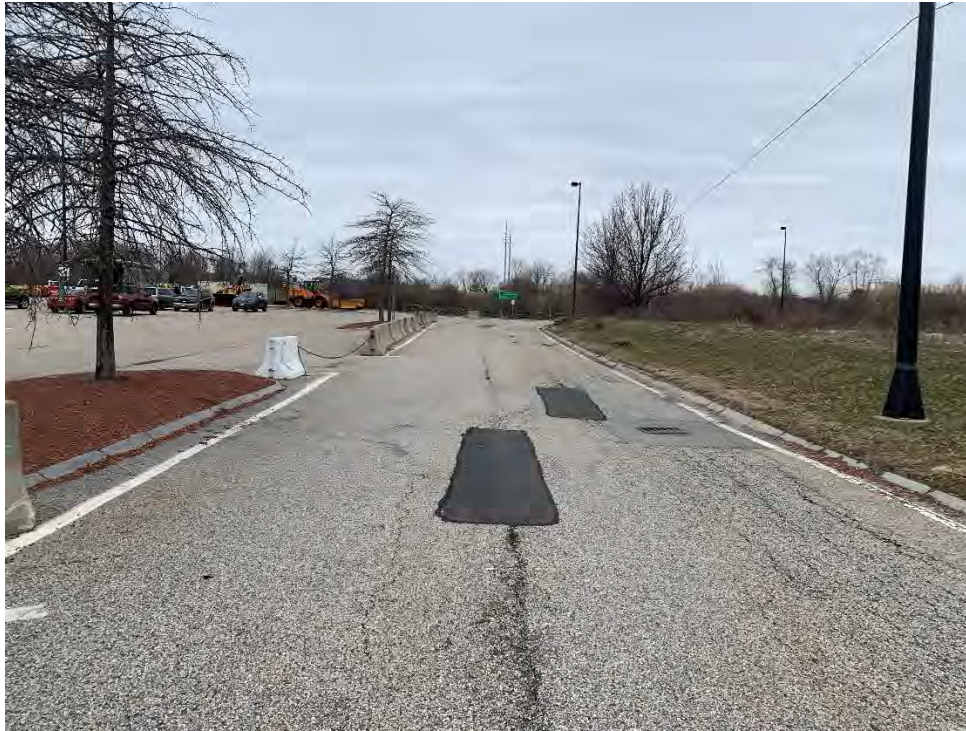
Photo 7: Observed approximately (1"x150') longitudinal crack, approximately (200') of fatigue cracking on edge of the pavement, and multiple holes in pavement approximately, on the eastern edge of the paved area, looking northwest.

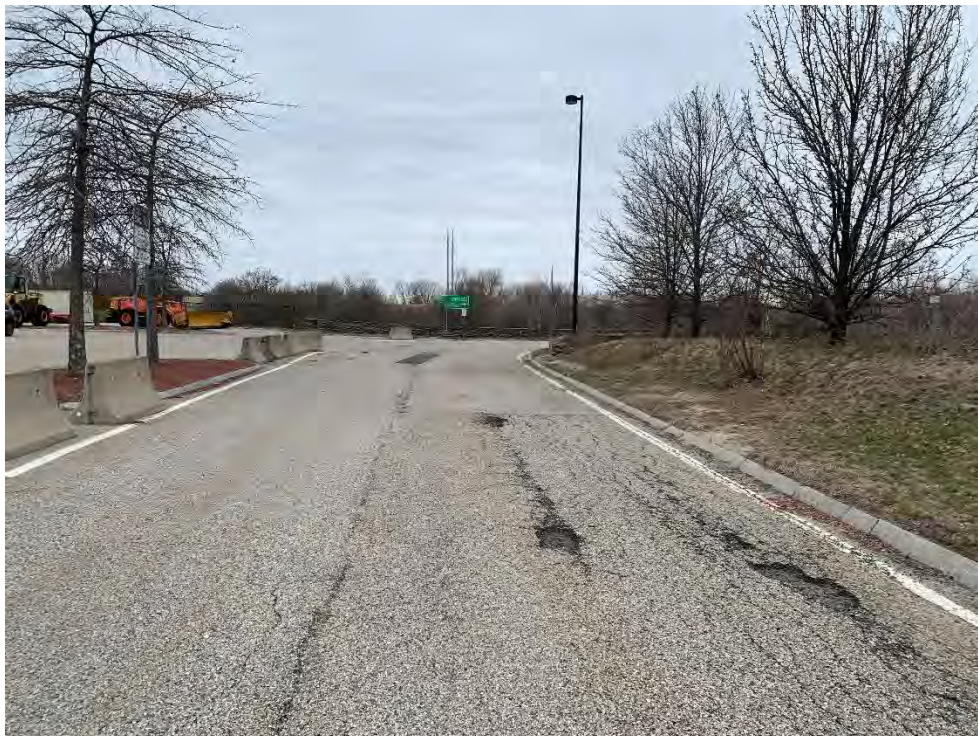
Photo 8: Observed fatigue cracking and holes in the pavement.

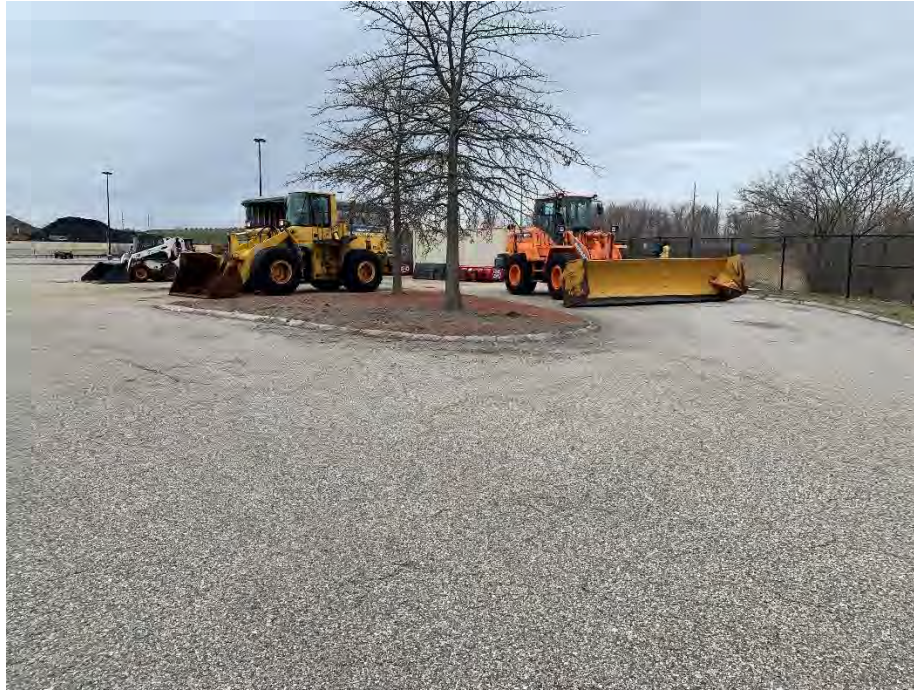
Photo 9: Observed minor cracking (near northeast entrance), looking west.

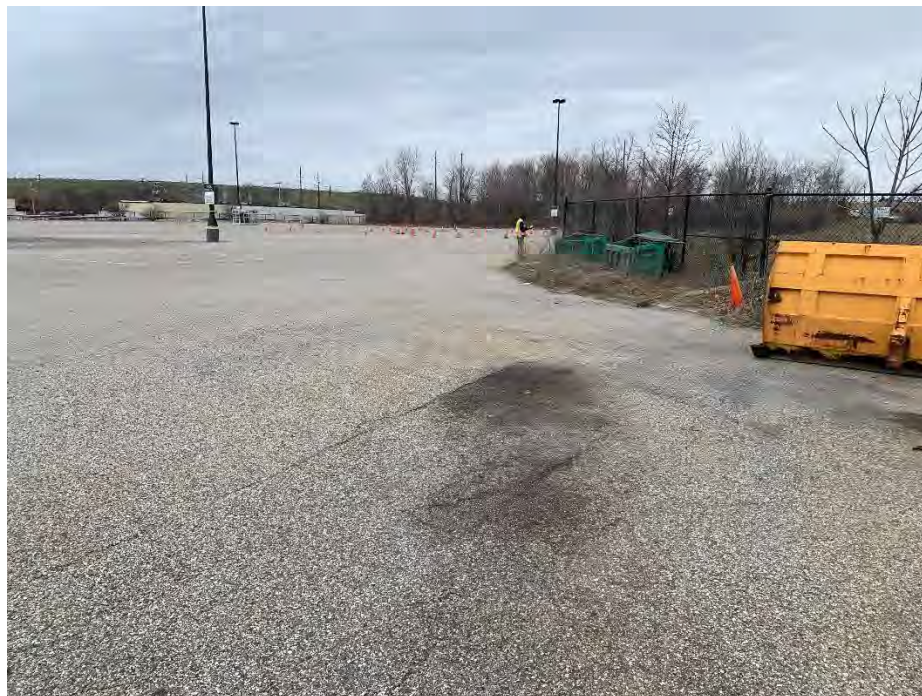
Photo 10: Observed moderate longitudinal cracking and approximately (375') of longitudinal cracking, (northern parking area), looking northwest.

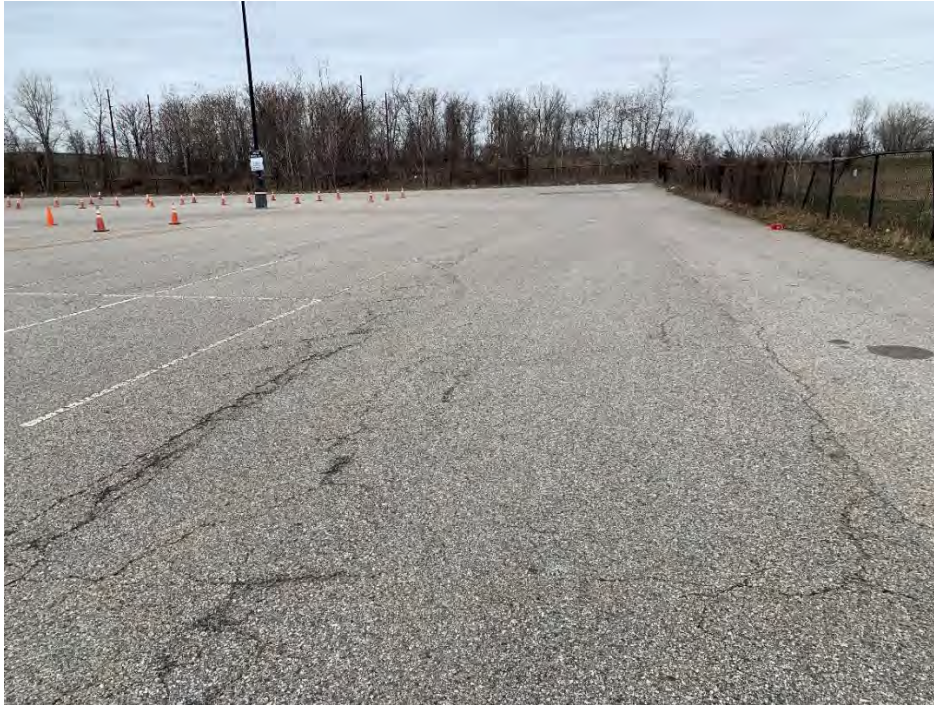
Photo 11: Observed moderate longitudinal cracking (northern parking area), looking north.

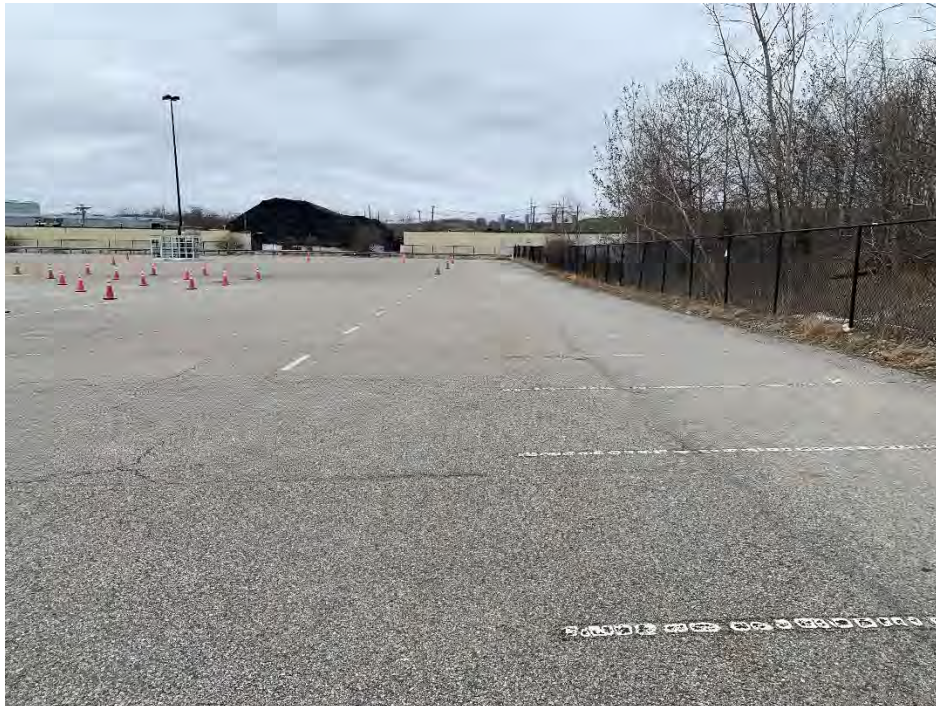
Photo 12: Observed moderate cracking, general conditions (north corner of parking lot), looking west.

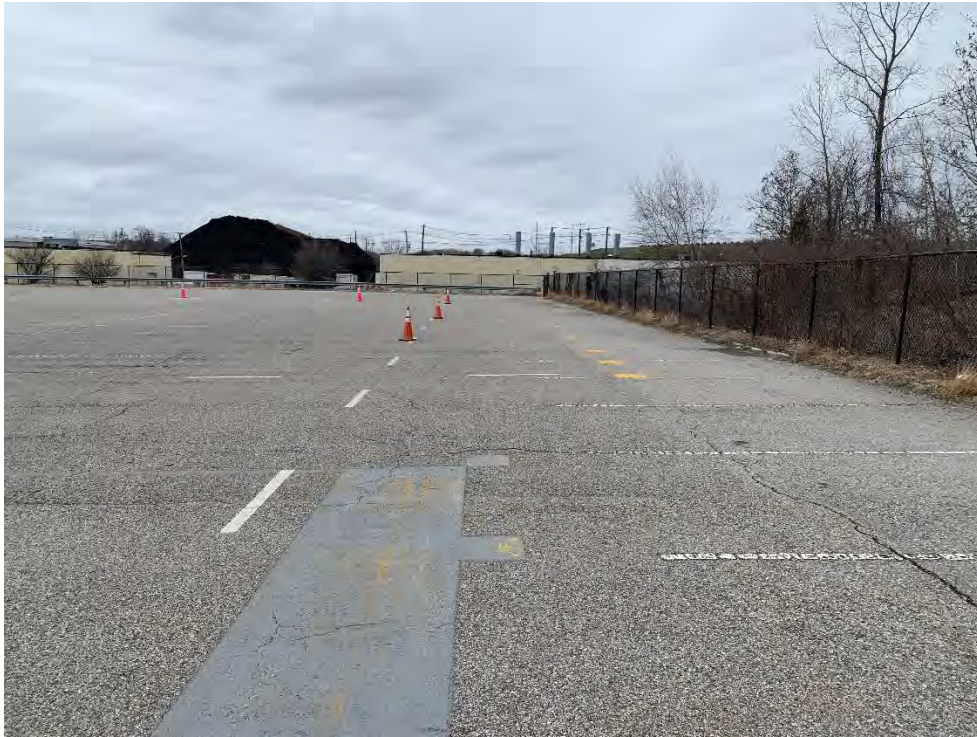
Photo 13: Observed moderate cracking, general conditions (northern parking area), looking west.

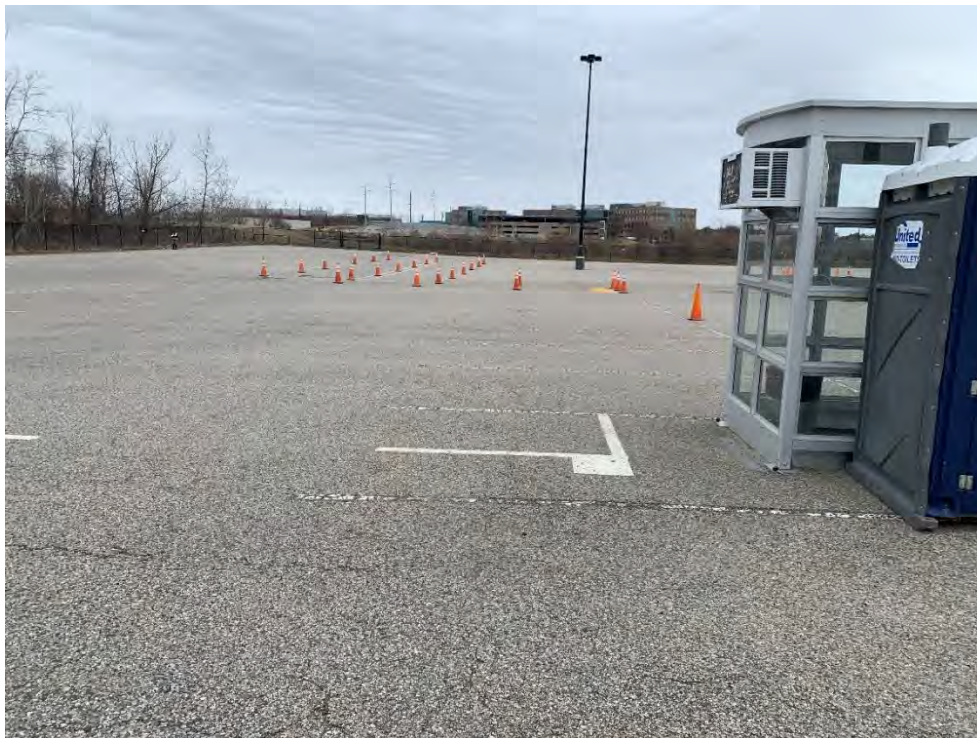
Photo 14: Observed minor fatigue cracking, general conditions (northern parking area), looking northeast.

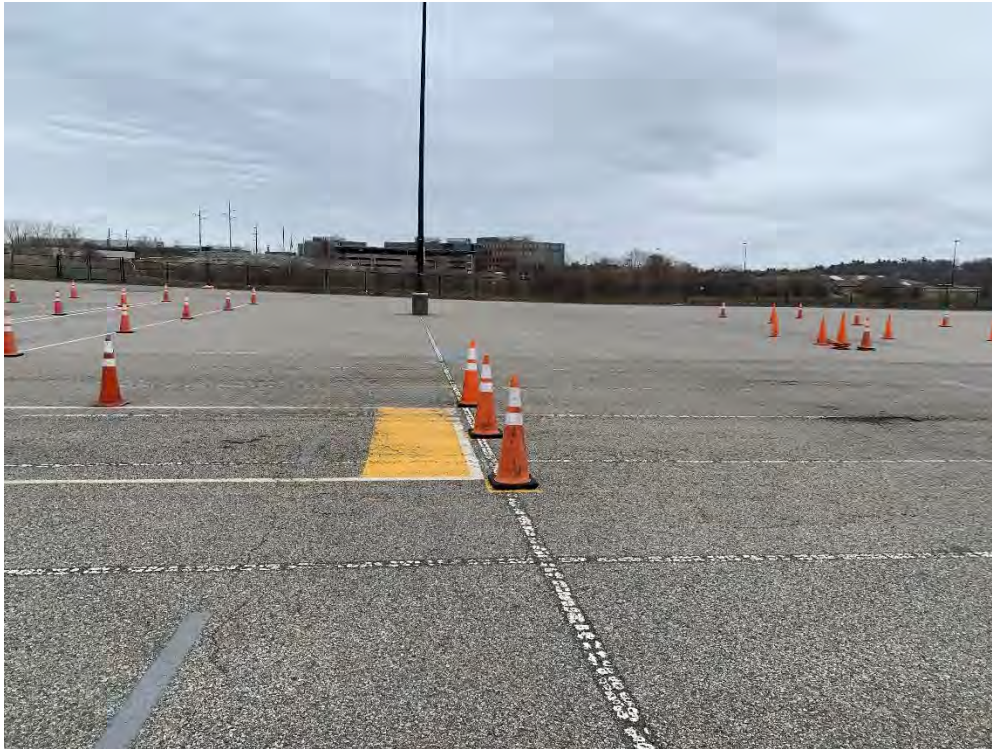
Photo 15: Observed moderate fatigue cracking, holes in pavement general conditions (near CB27), looking northeast.

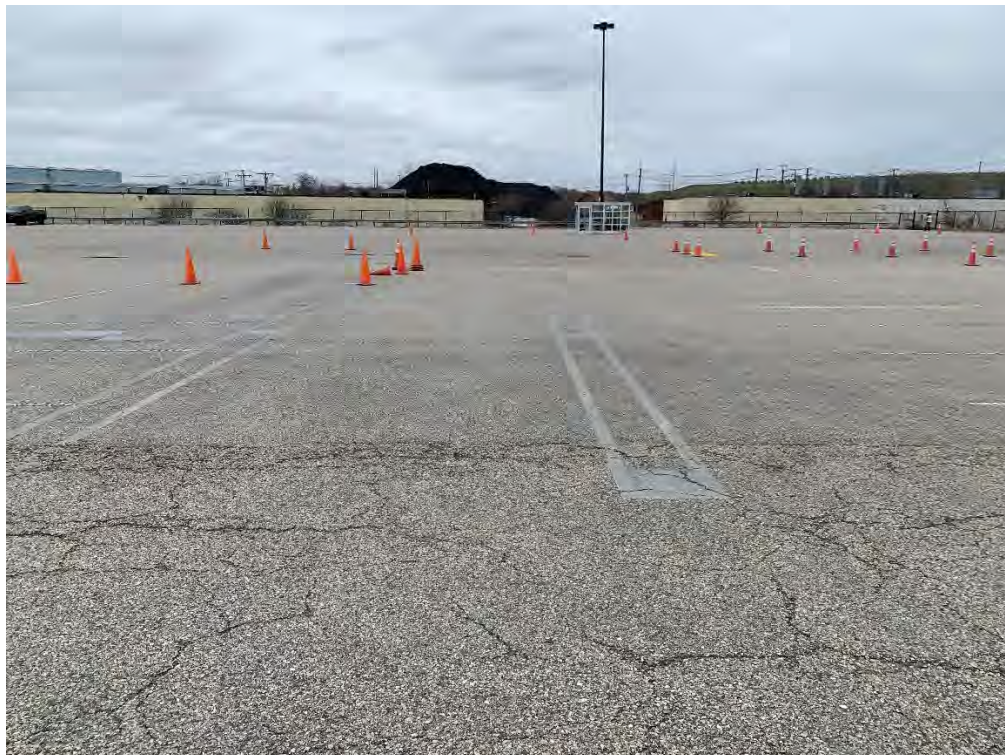
Photo 16: Observed moderate/severe cracking, general conditions (northern parking area), looking west.

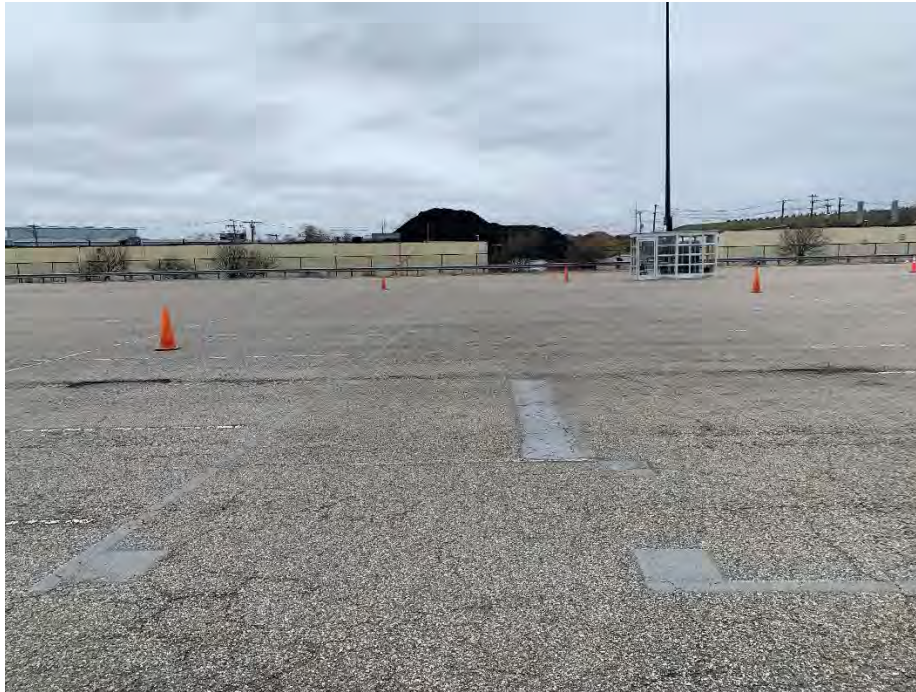
Photo 17: Observed moderate fatigue cracking and two holes approximately (northern parking area), looking west.

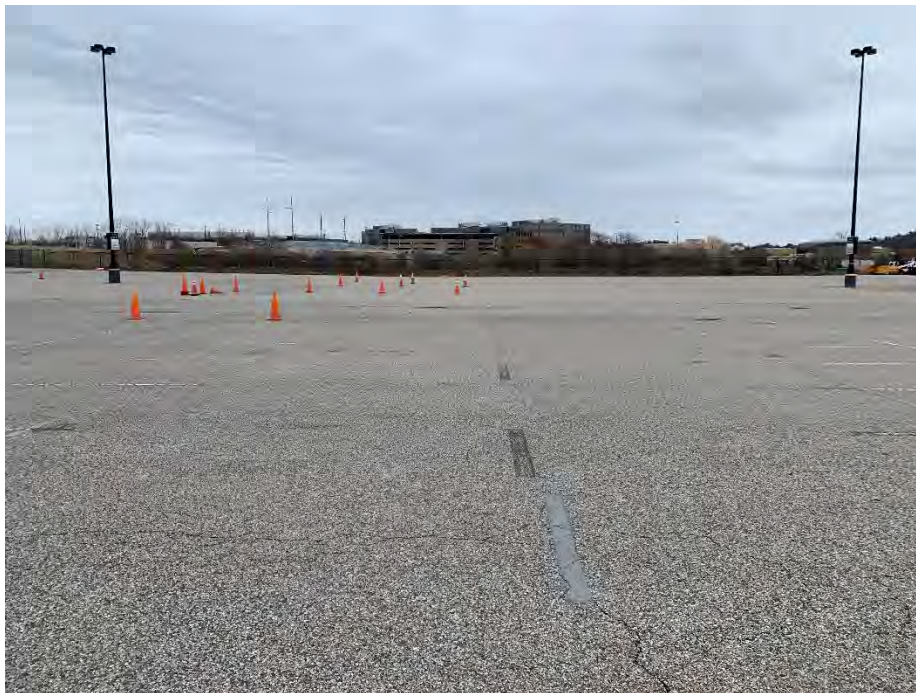
Photo 18: Observed minor fatigue cracking, general conditions near SF-2, looking east.

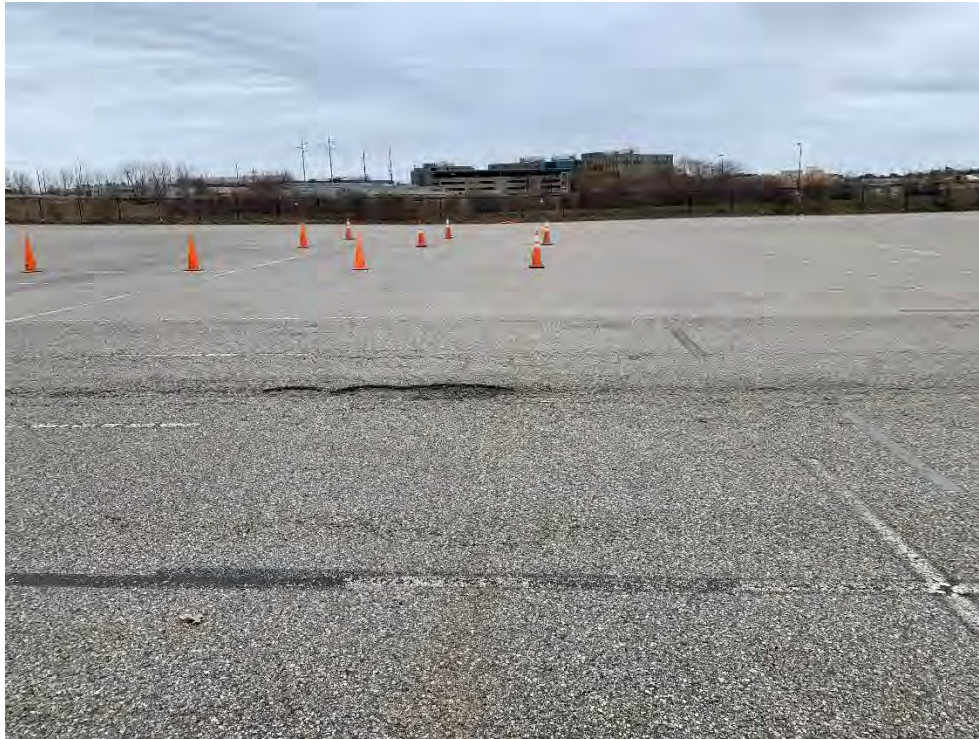
Photo 19: Observed moderate/severe fatigue cracking, hole in pavement general conditions near SF-2, looking east.

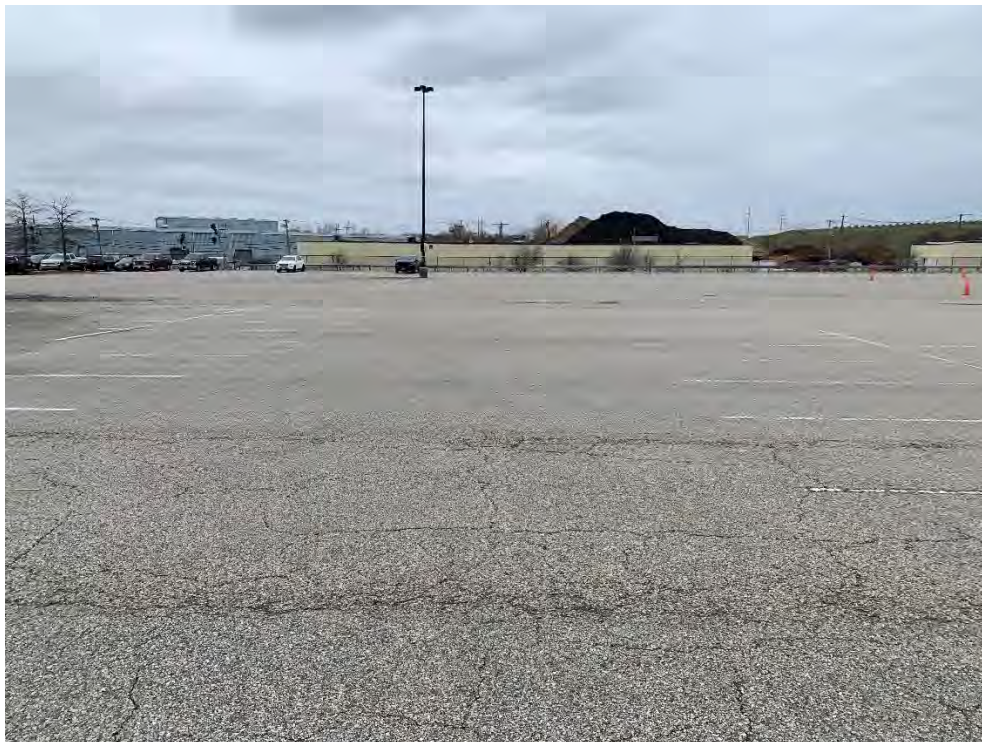
Photo 20: Observed moderate fatigue cracking, general conditions near SF-2, looking west.

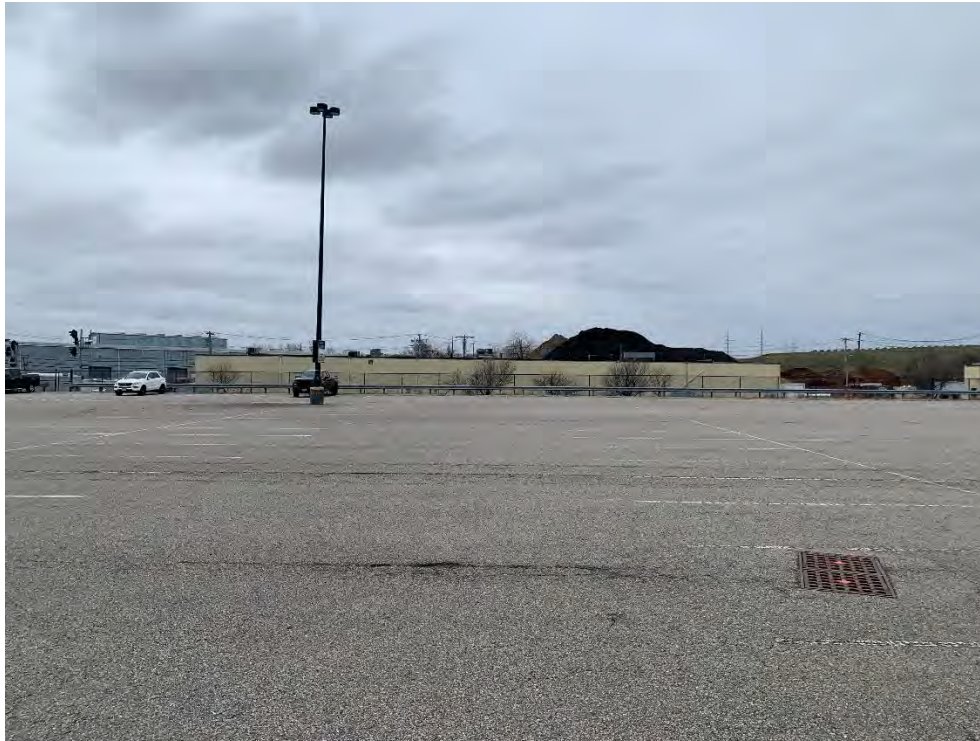
Photo 21: Observed moderate fatigue cracking, holes in pavement, west of photo 16, looking west.

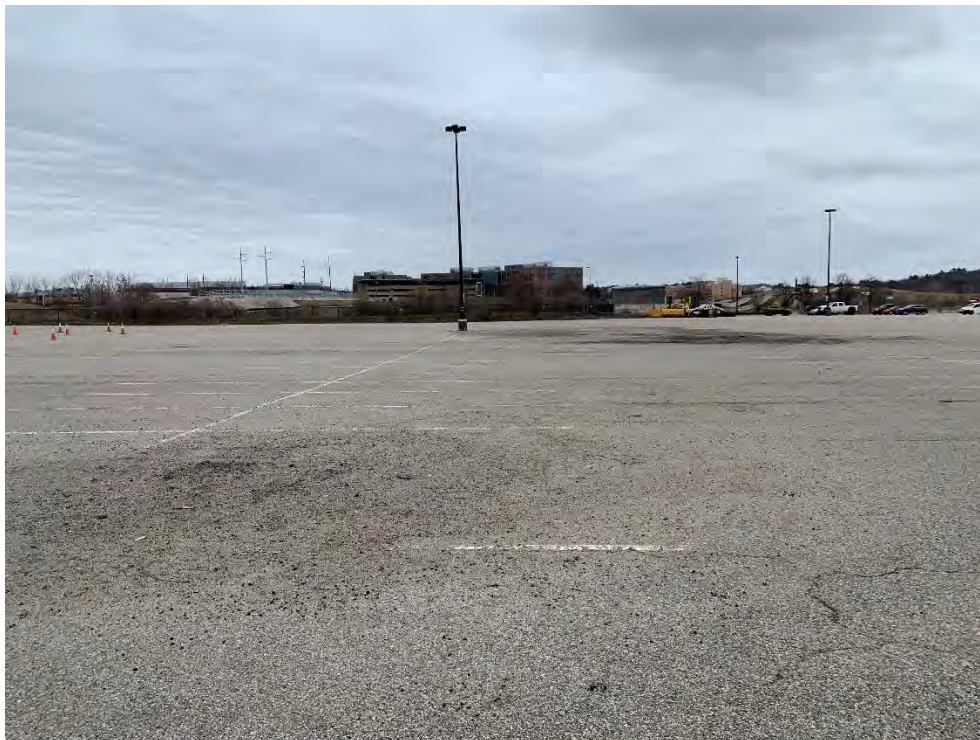
Photo 22: Observed moderate fatigue cracking in the pavement, general rock and pavement debris, at the northwest of CB15, looking northeast.

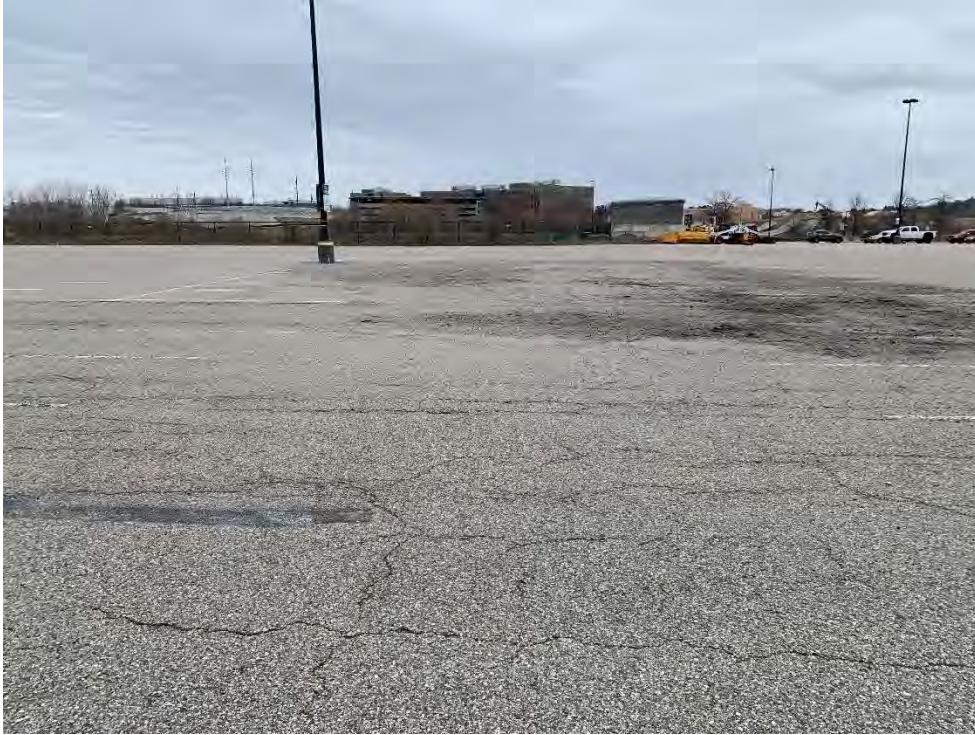
Photo 23: Observed moderate cracking in pavement and general rock and pavement debris southeast of CB26 looking northeast.

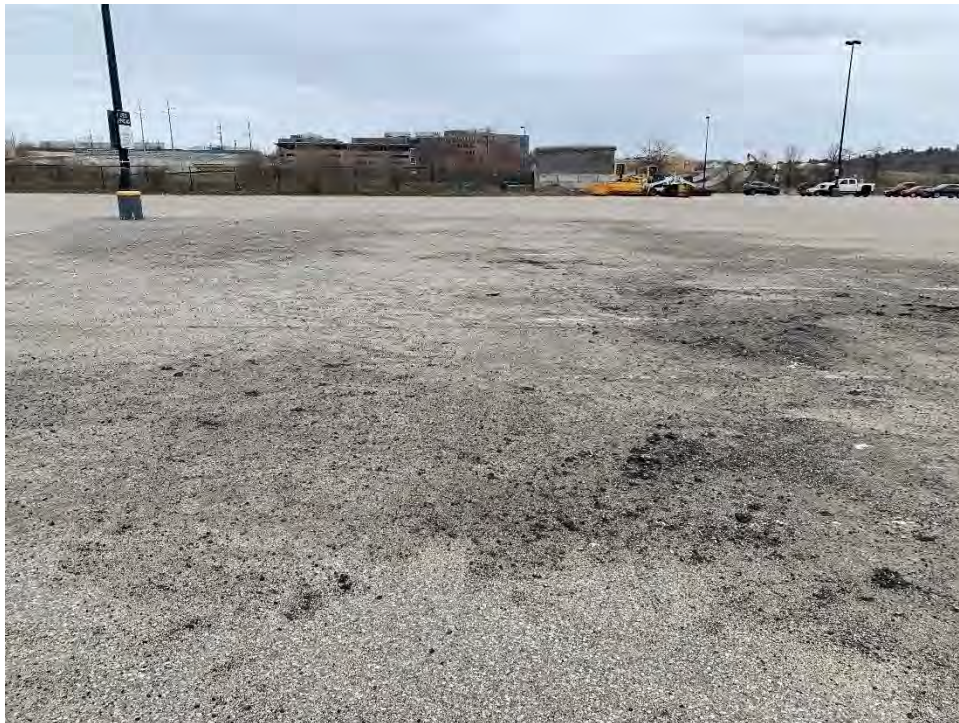
Photo 24: Observed minor cracking and general rock and pavement debris southeast of CB26 looking northeast.

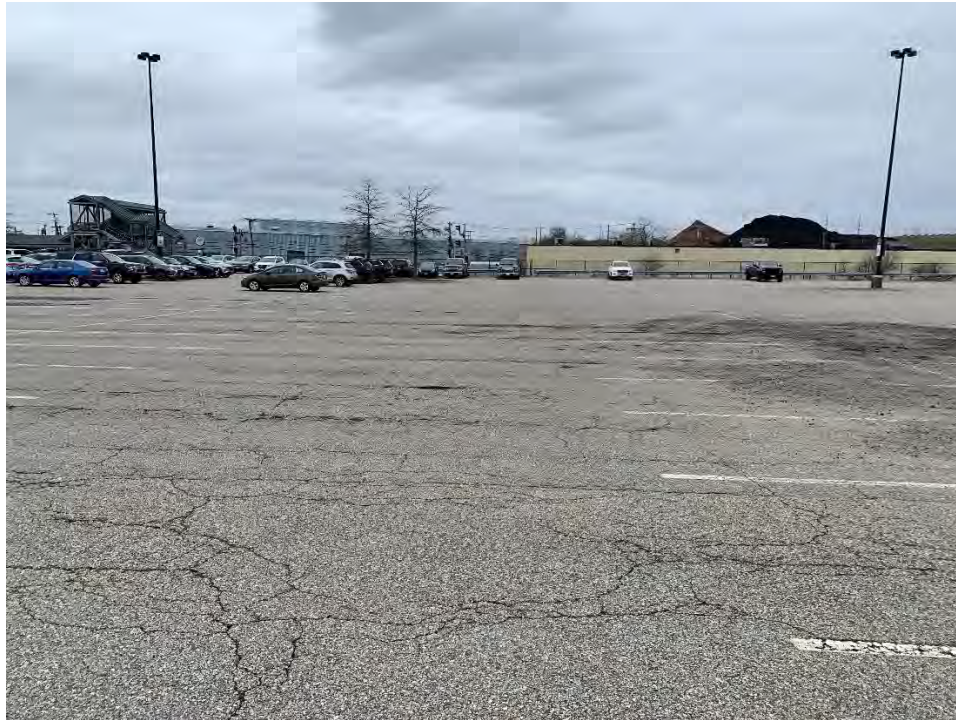
Photo 25: Observed moderate/ severe cracking in pavement, general rock and pavement debris, holes in pavement south of SF-1, looking west.

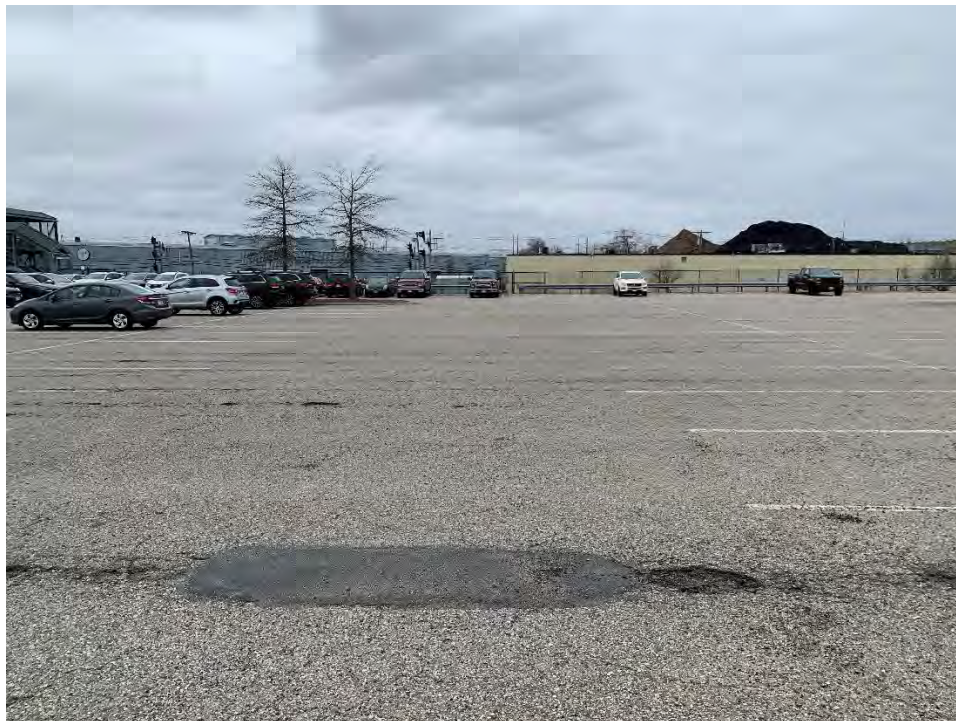
Photo 26: Observed multiple holes in the pavement, and moderate fatigue cracking north northeast of CB25.

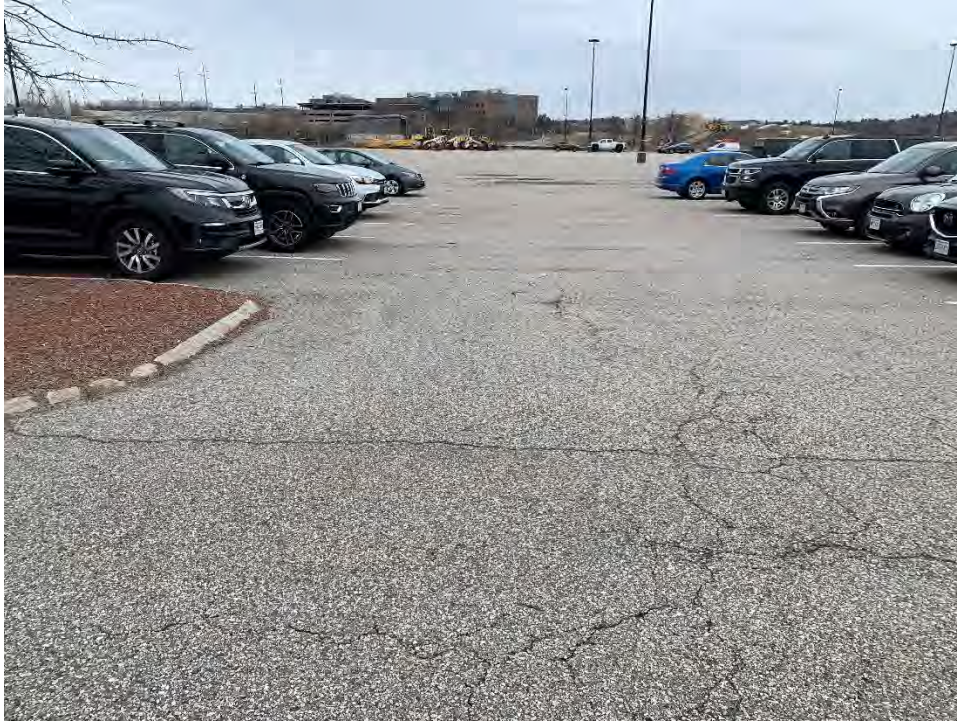
Photo 27: Observed moderate fatigue cracking in pavement west of CB25, looking northeast.

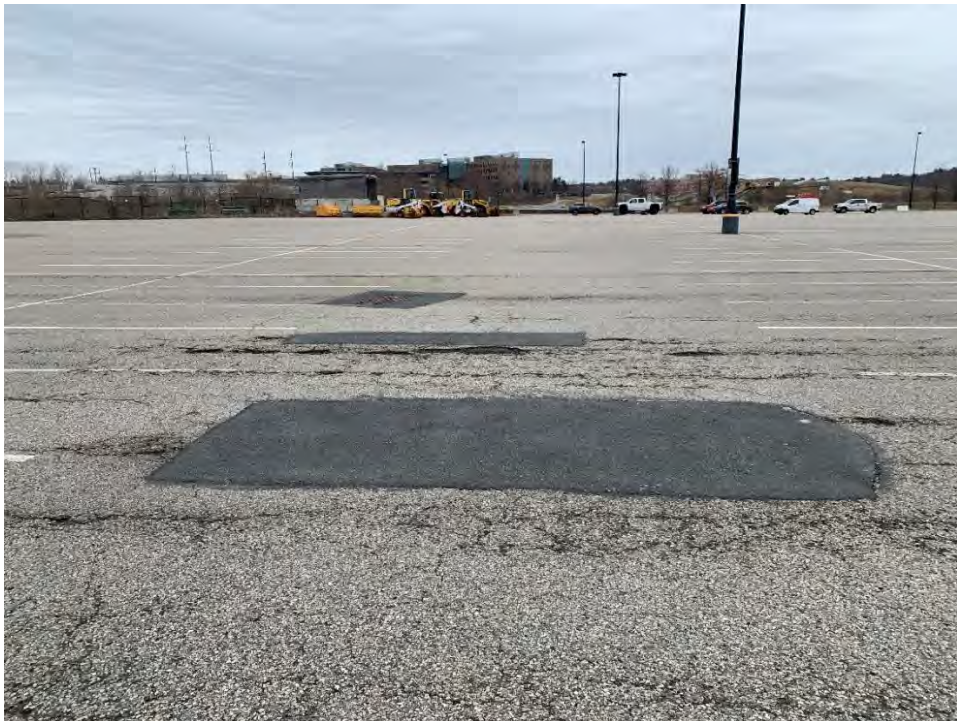
Photo 28: Observed multiple holes in the pavement and moderate to severe fatigue cracking, near CB25, looking northeast.

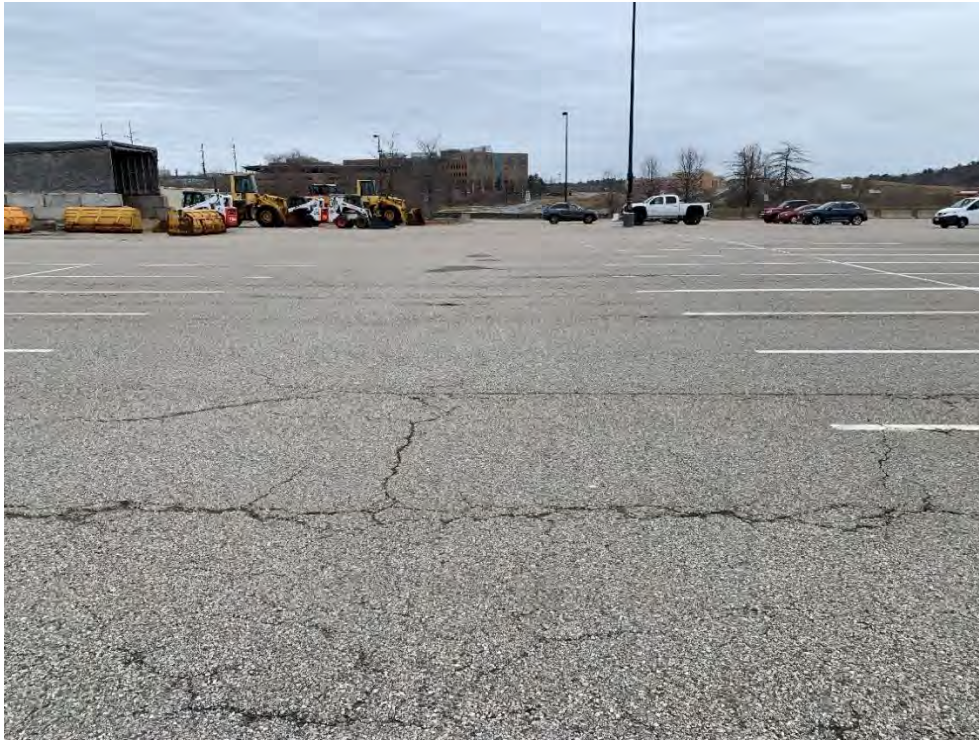
Photo 29: Observed moderate cracking in pavement east of CB25, looking northeast.

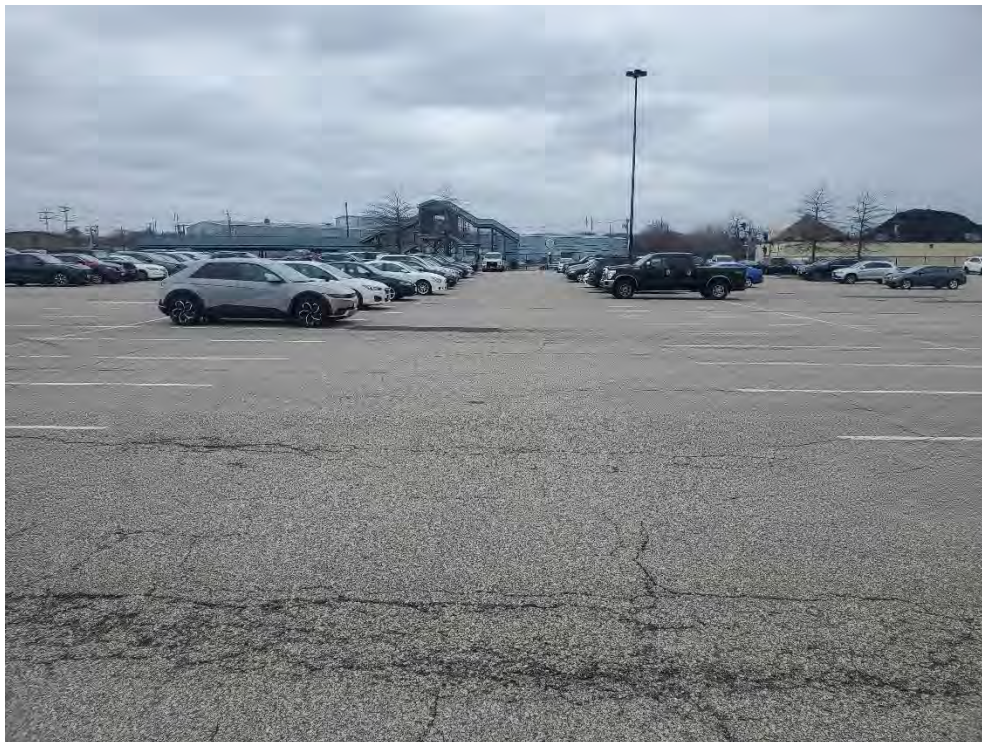
Photo 30: Observed moderate/severe cracking in the pavement in the north section of commuter rail parking area northwest of GB964, looking west.

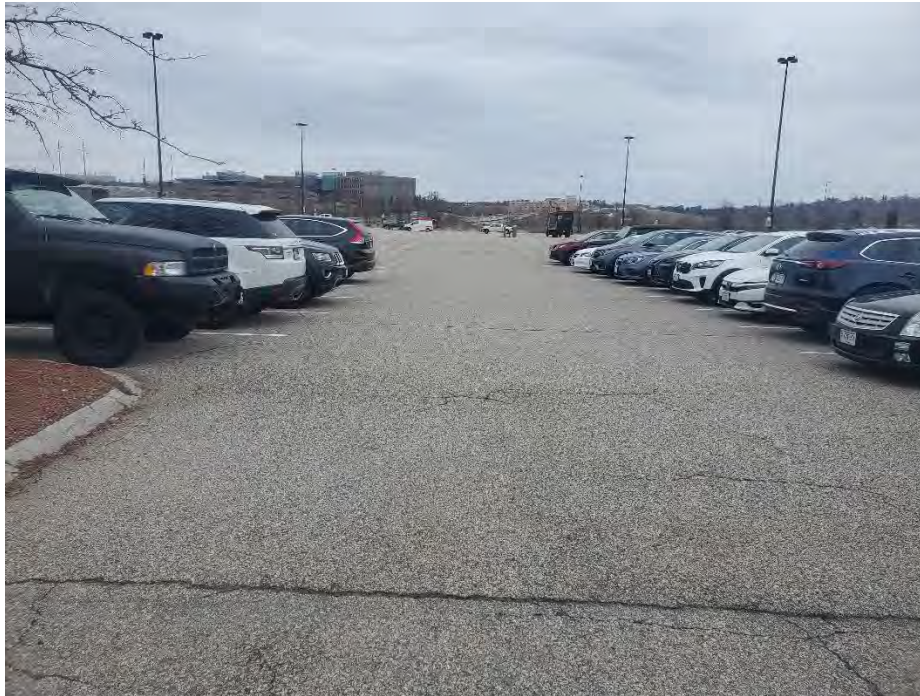
Photo 31: Observed moderate transverse fatigue cracking in pavement in north section of commuter rail parking area (southeast of DSK-963), looking northeast.

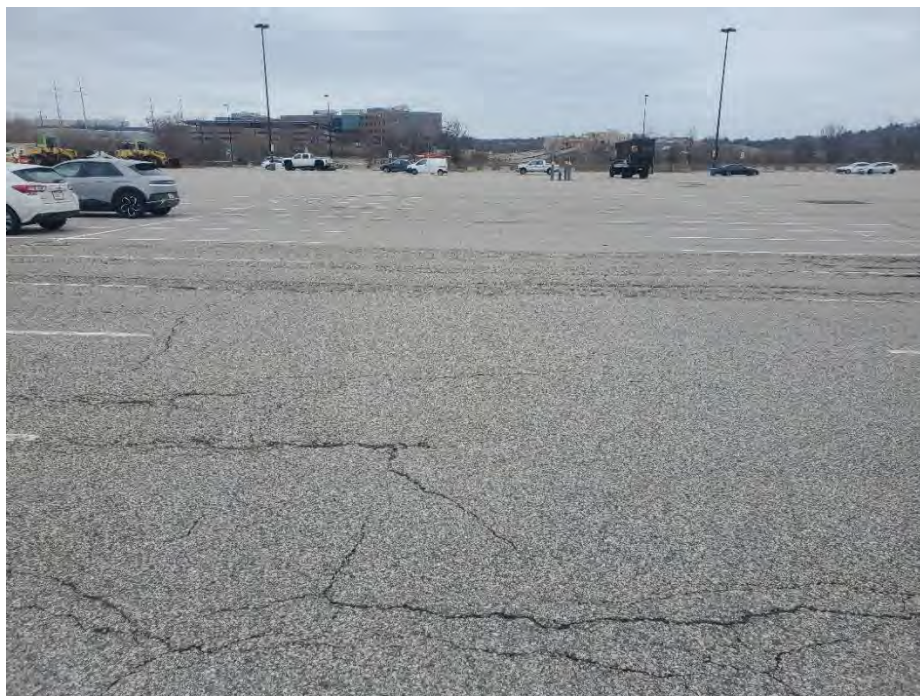
Photo 32: Observed moderate/severe fatigue cracking, in north section of commuter rail parking area (northeast of Photo 26), looking northeast.
