Known for excellence.
Built on trust.

**2023 COVER INSPECTION REPORT
MASSACHUSETTS PORT AUTHORITY
Anderson Regional Transportation Center
100 Atlantic Avenue
Woburn, Massachusetts**

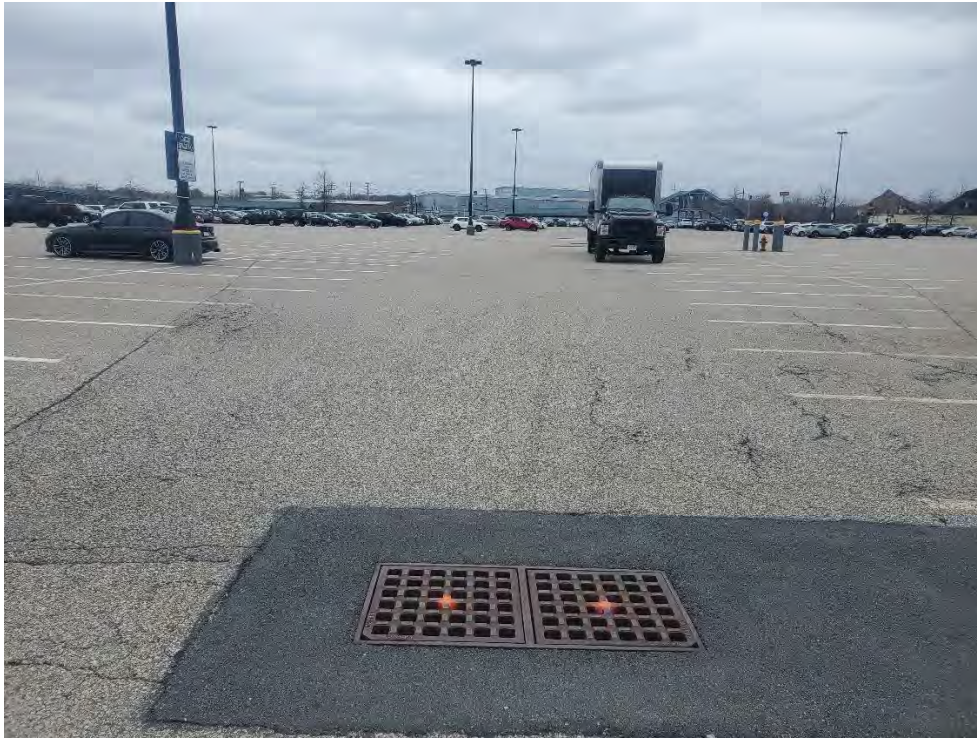
Photo 33: Observed moderate fatigue cracking in pavement in north section of commuter rail parking area, looking west.

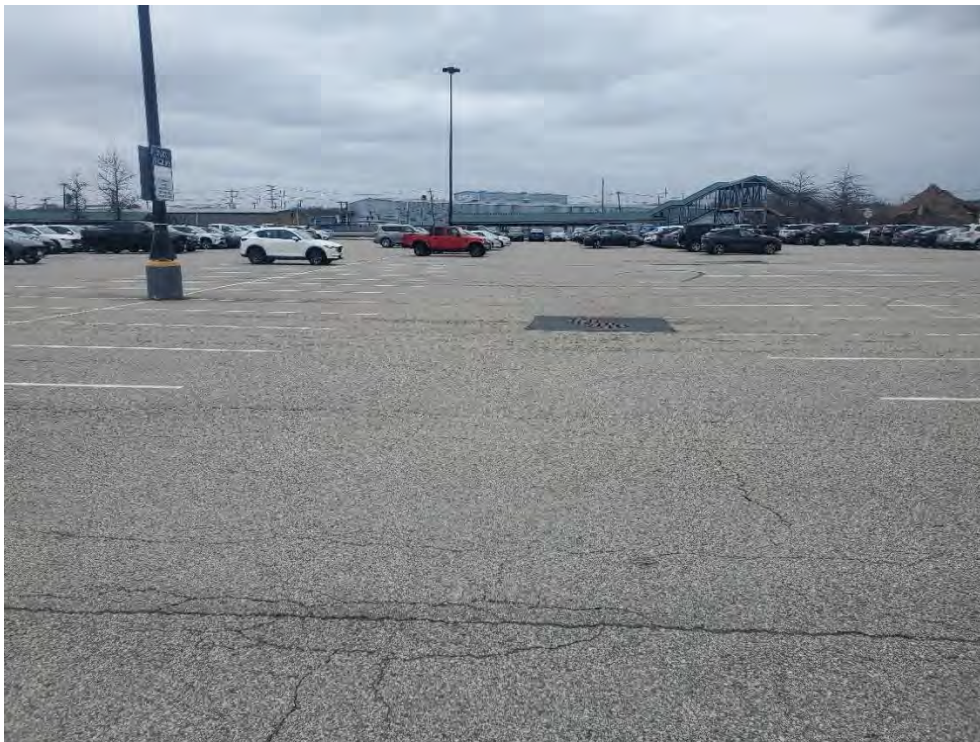
Photo 34: Observed moderate to severe fatigue cracking in pavement in north section of commuter rail parking area (west of CB21), looking west.

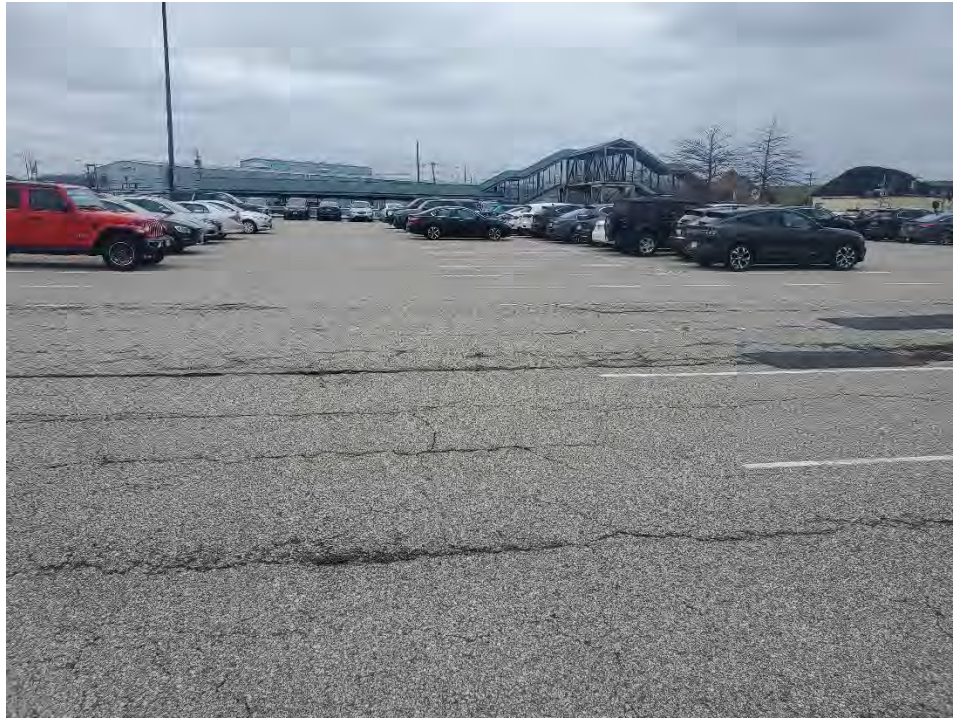
Photo 35: Observed moderate/ severe fatigue cracking, holes in the pavement in the north section of the commuter rail parking area (west of CB21), looking west.

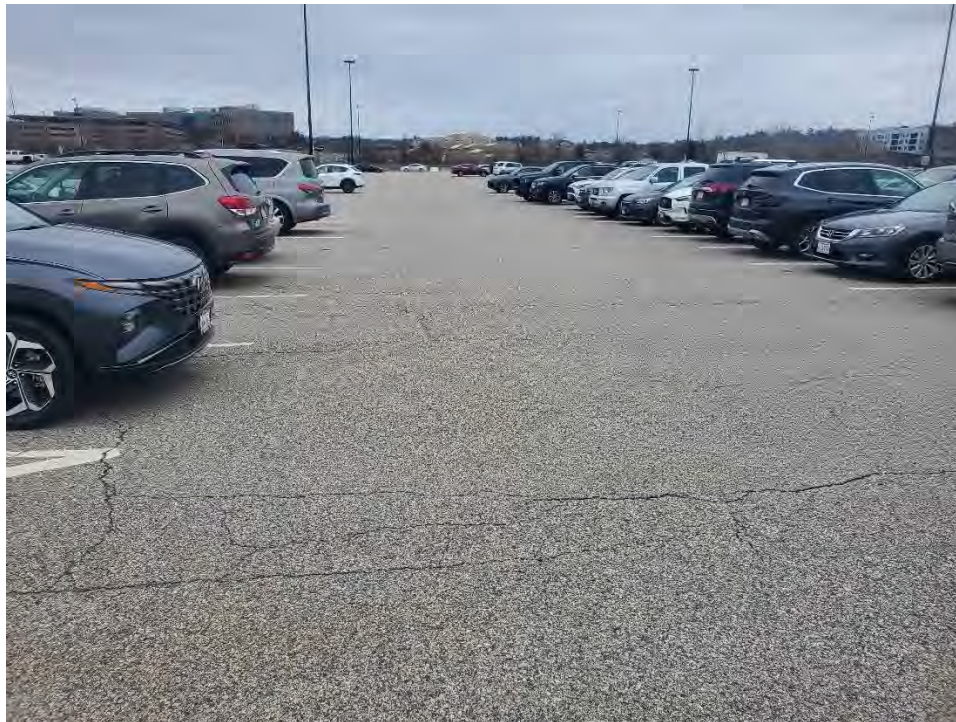
Photo 36: Observed minor cracking in the pavement in the north section of the commuter rail parking area (near CI-4), looking northeast.

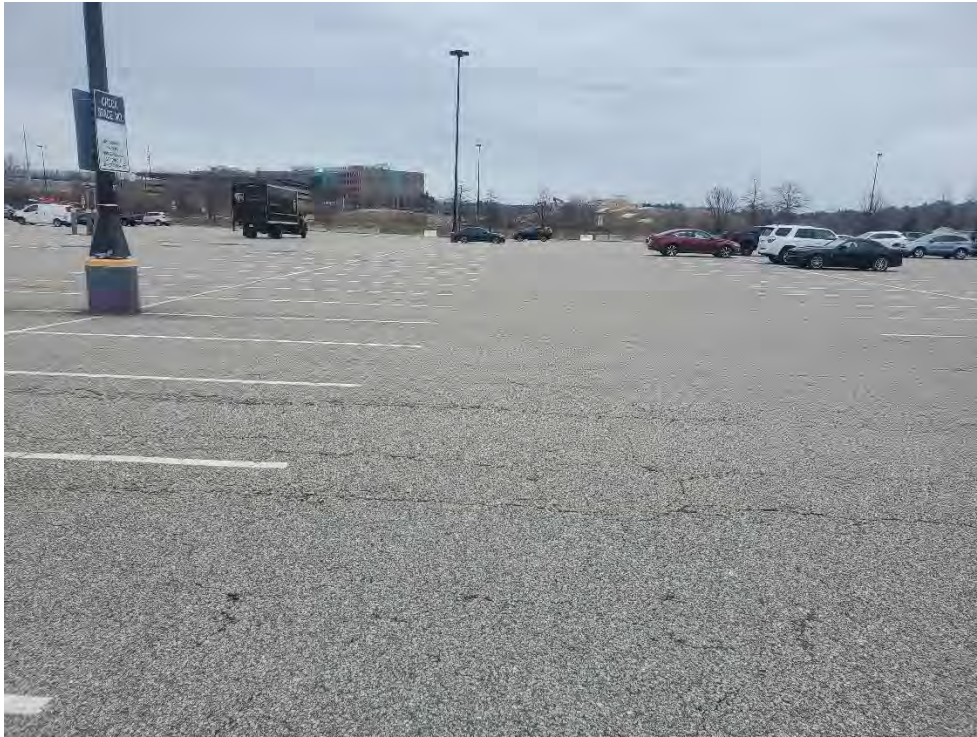
Photo 37: Observed minor to moderate fatigue cracking in the pavement in the north section of the commuter rail parking area (northeast of Photo 32), looking northeast.

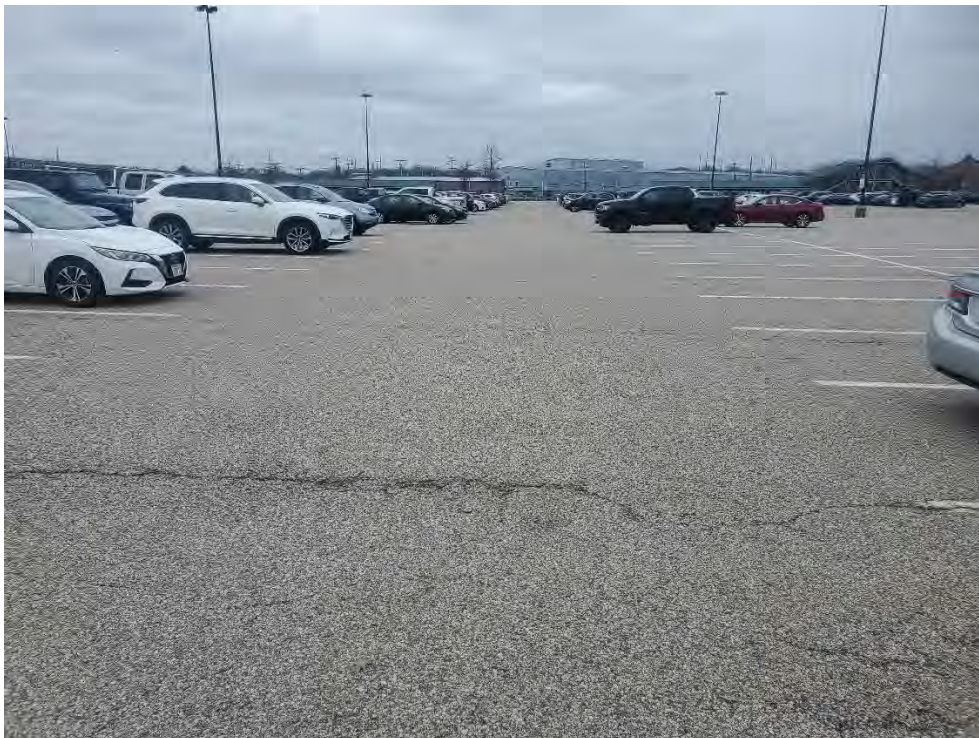
Photo 38: Observed minor/moderate cracking in the pavement in the north section of the commuter rail parking area, looking west.

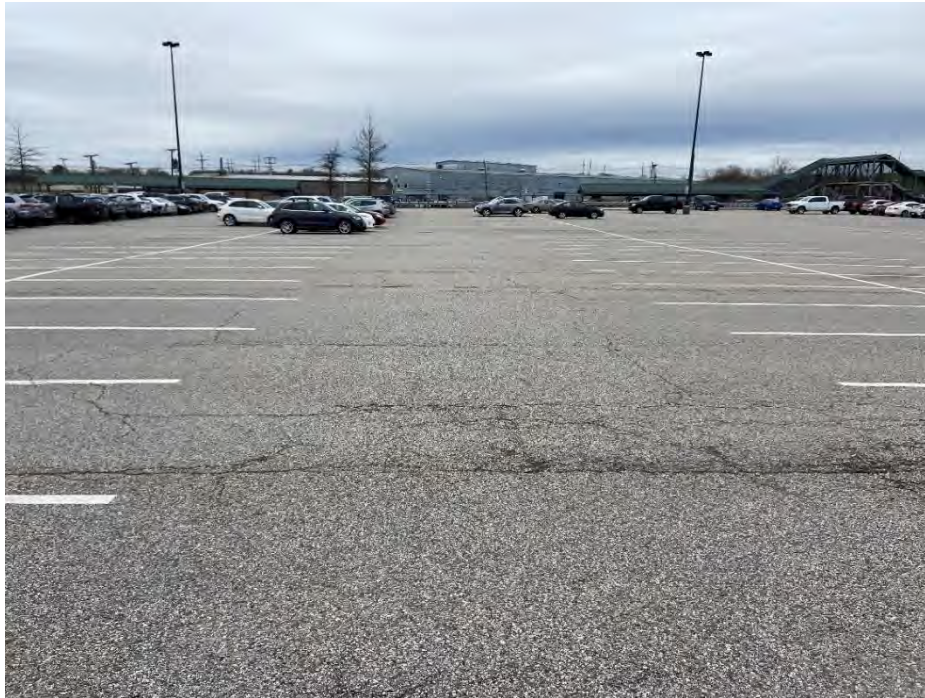
Photo 39: Observed moderate/ severe fatigue cracking in the pavement, multiple cracks wider than 2” and small holes, in the north section of the commuter rail parking area, looking west.

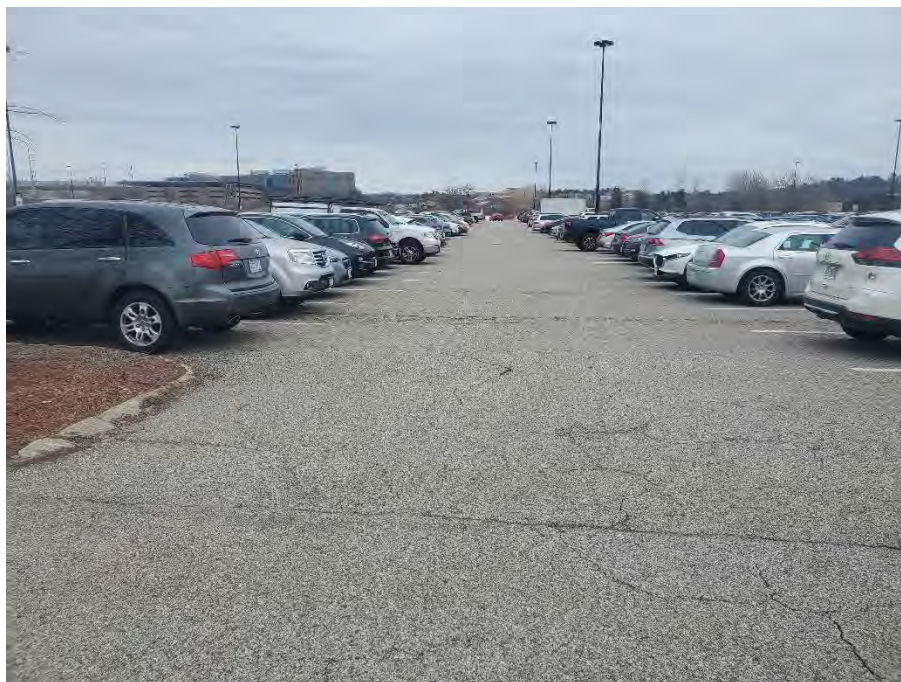
Photo 40: Observed minor to moderate fatigue cracking in the pavement in the north section of the commuter rail parking area (near SM-1), looking northeast.

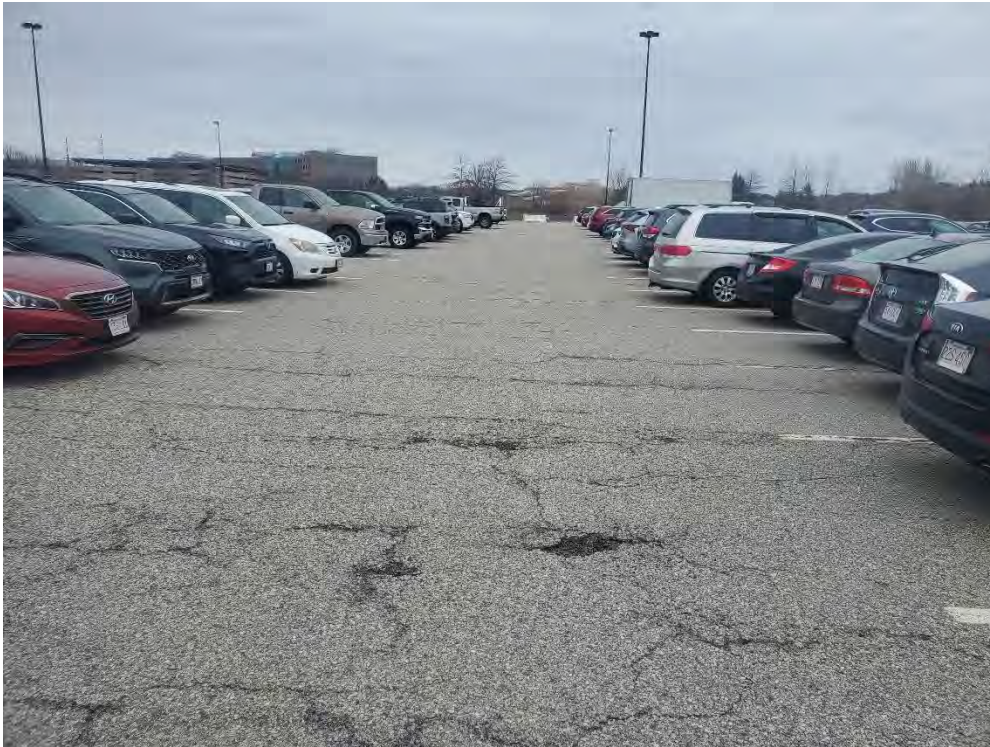
Photo 41: Observed moderate/ severe fatigue cracking, multiple holes in pavement (2"x2"x1"), in the north section of the commuter rail parking area (northeast of Photo 35), looking northeast

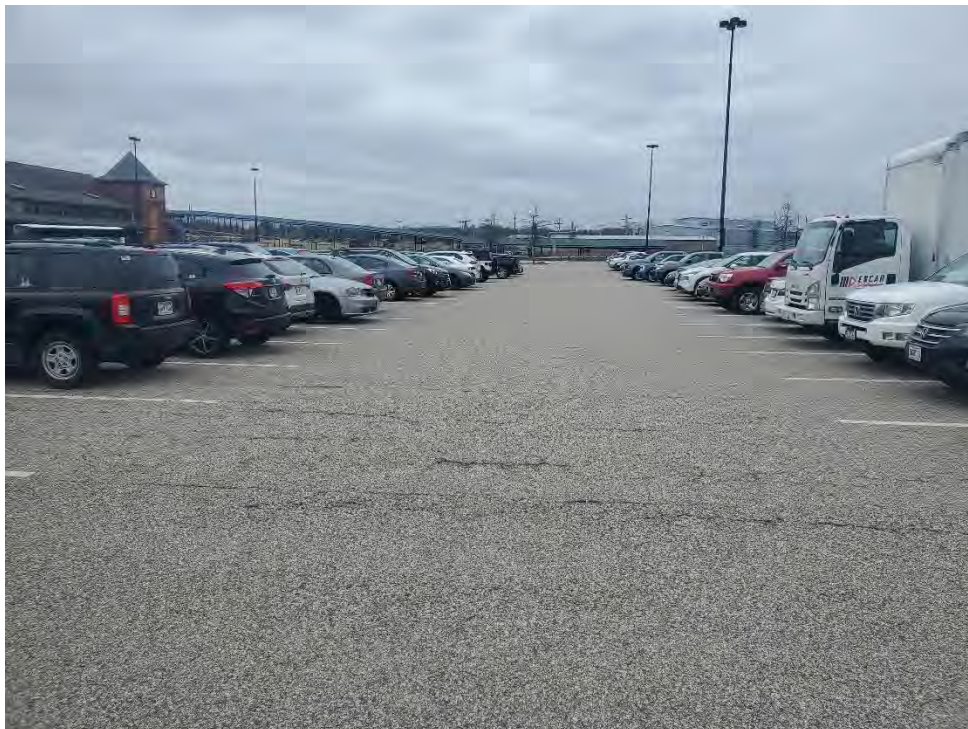
Photo 42: Observed minor cracking in the pavement in the north section of the commuter rail parking area, looking west.

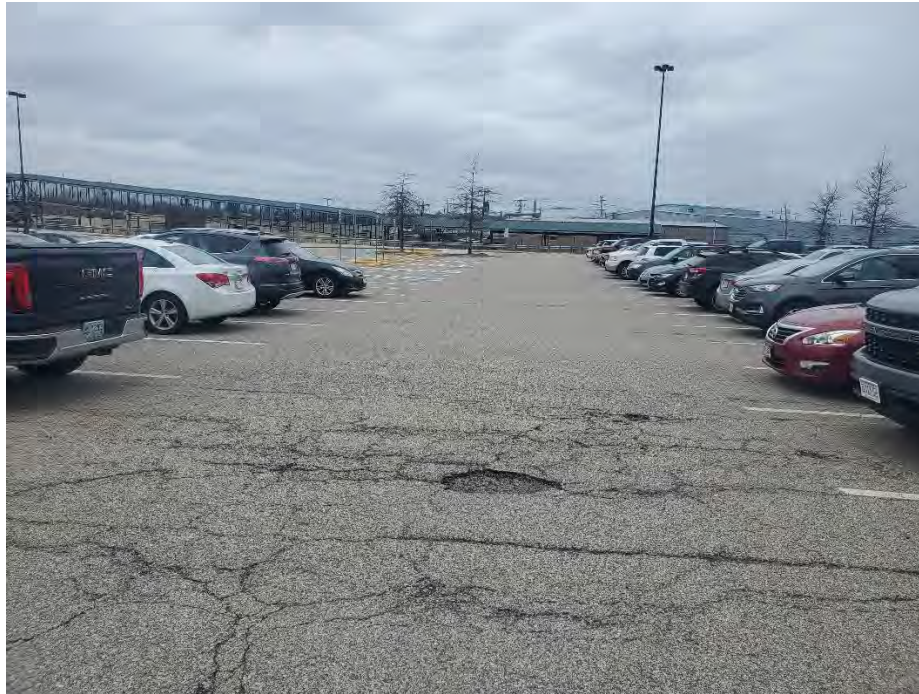
Photo 43: Observed moderate/severe fatigue cracking, multiple holes in the pavement in the north section of commuter rail parking area (south of MH10), looking west.

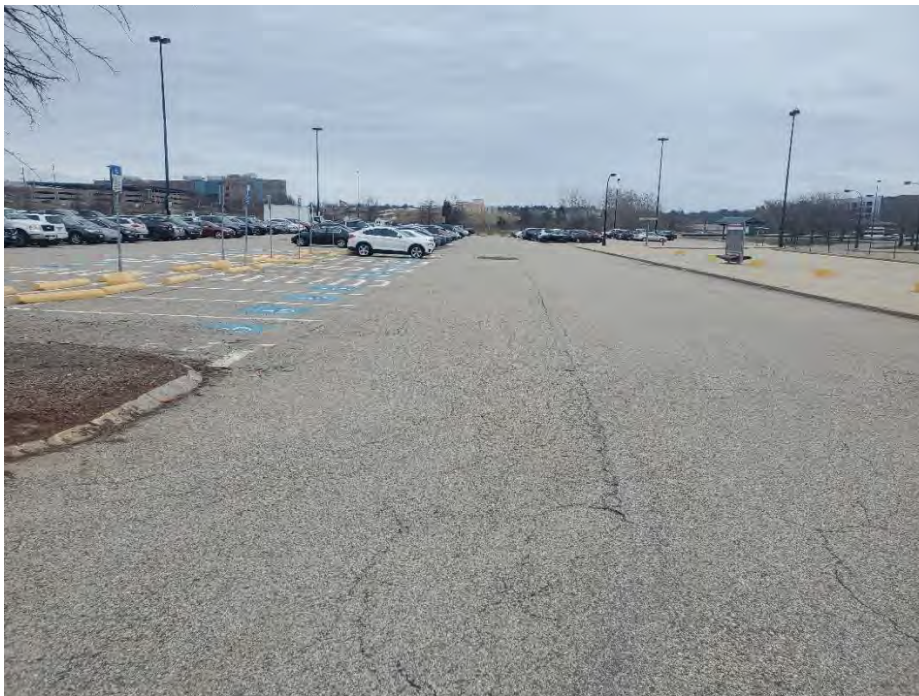
Photo 44: Observed minor transverse cracking approximately (100') in the pavement in the north section of the commuter rail parking area (north of DSK-966), looking northeast.

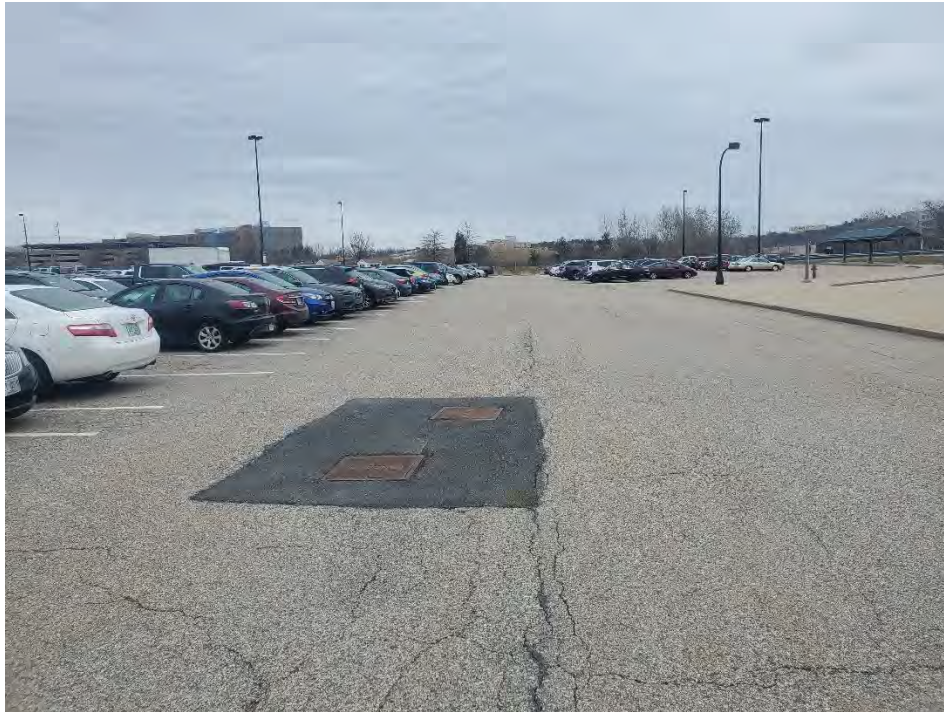
Photo 45: Observed moderate fatigue cracking and small holes in the pavement, (north of CB13), looking northeast.

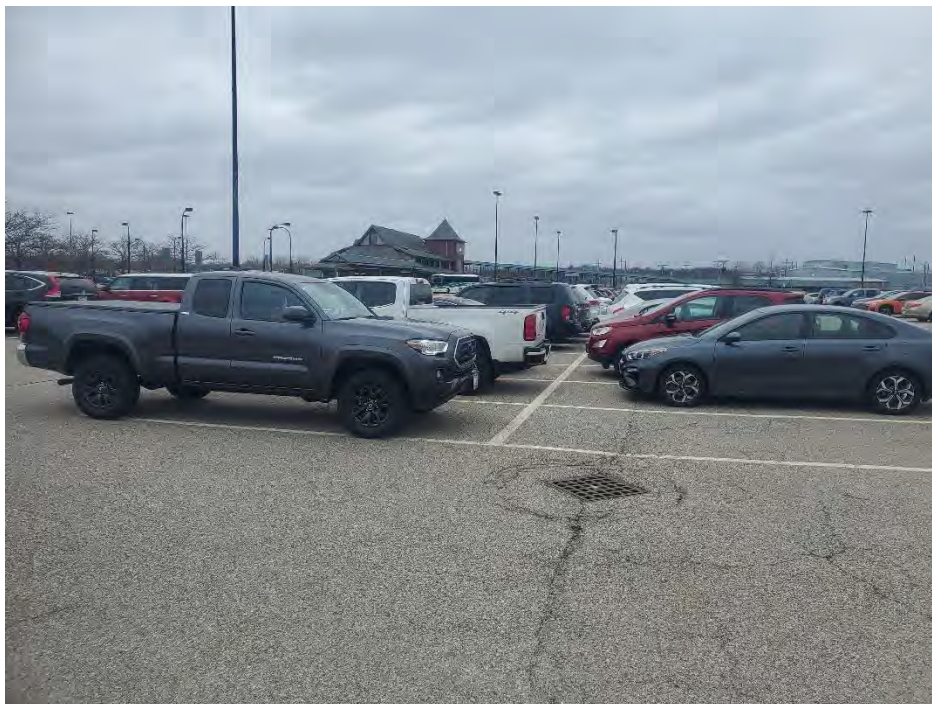
Photo 46: Observed longitudinal cracking in pavement and subsidence around CB18

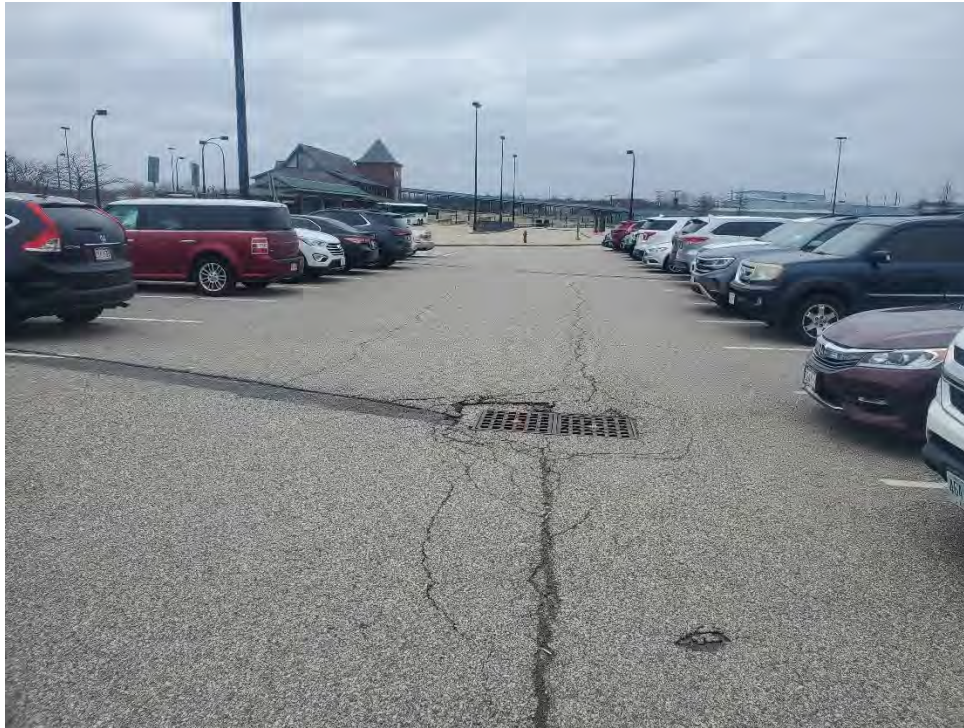
Photo 47: Observed (2'x3'x3") hole, moderate longitudinal cracking, possible subsidence in the utility patch, and moderate fatigue cracking at CB17.

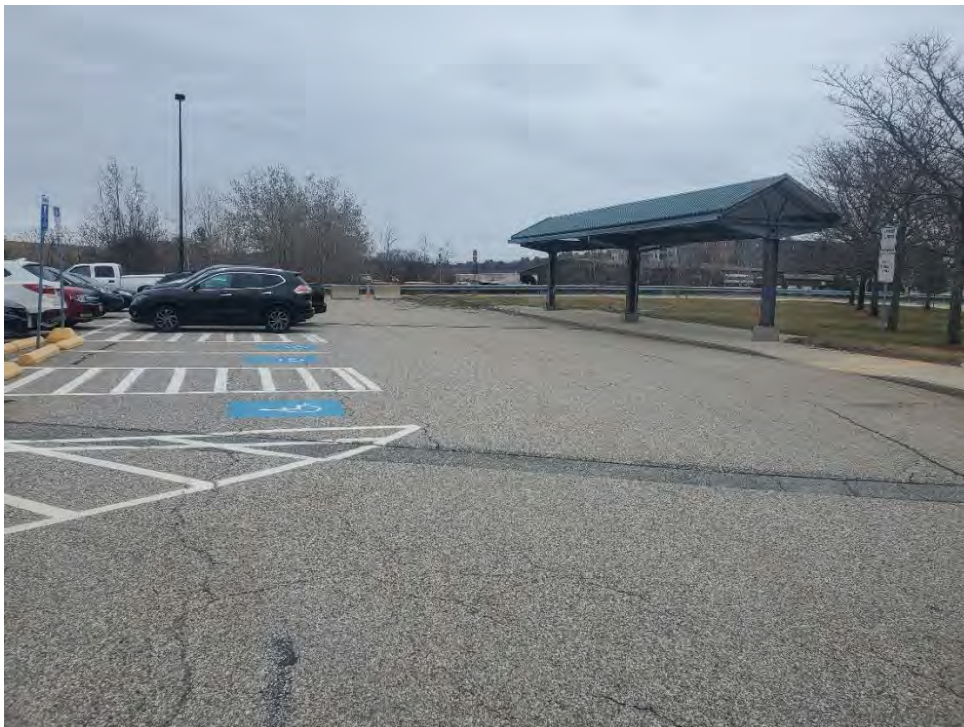
Photo 48: Observed minor cracking in pavement and subsidence in the trenched area, northeast of CB-A, looking east.

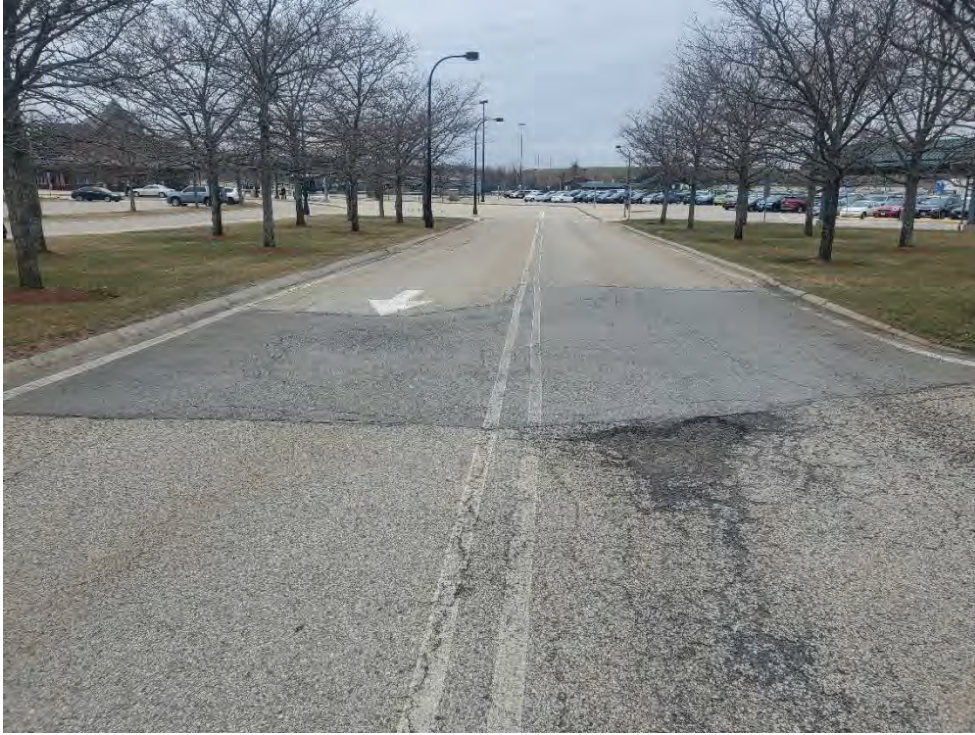
Photo 49: Observed subsidence in pavement, moderate/severe cracking, larger hole in pavement on the eastern edge of the middle section of the commuter rail parking area, looking west.

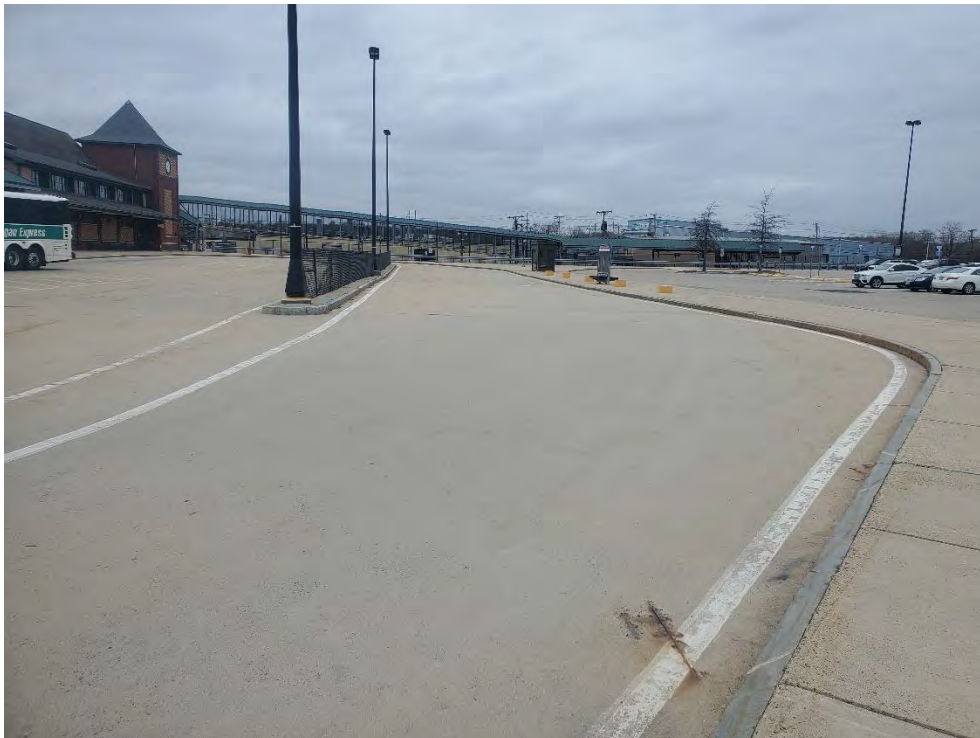
Photo 50: Observed general conditions of concrete pavement in the middle section of the commuter rail parking area, looking west.

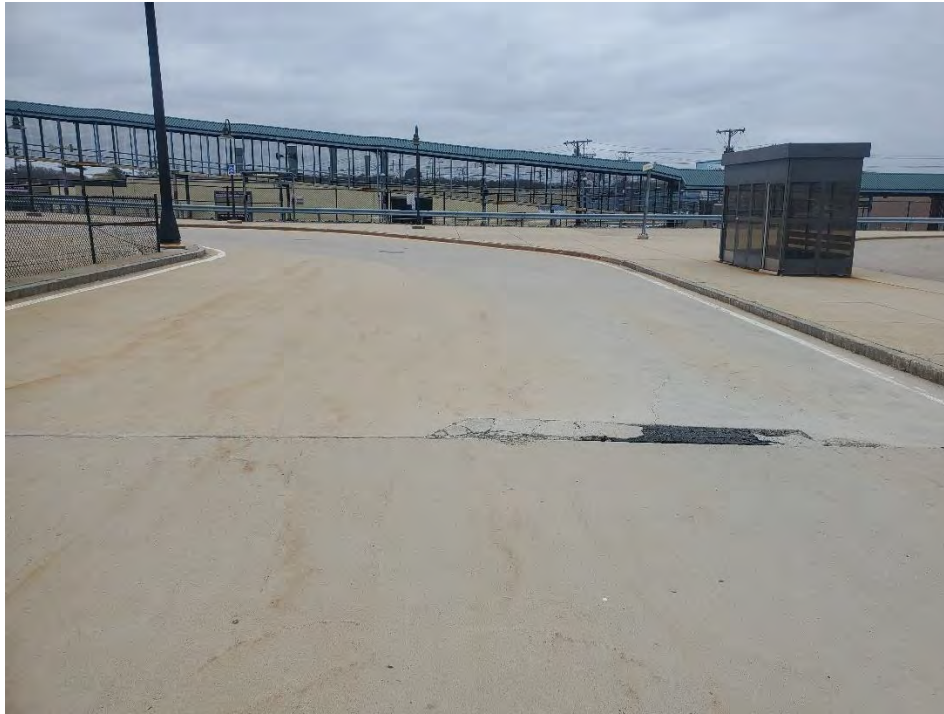
Photo 51: Observed moderate cracking in the concrete pavement in the middle section of the commuter rail parking area, looking west.

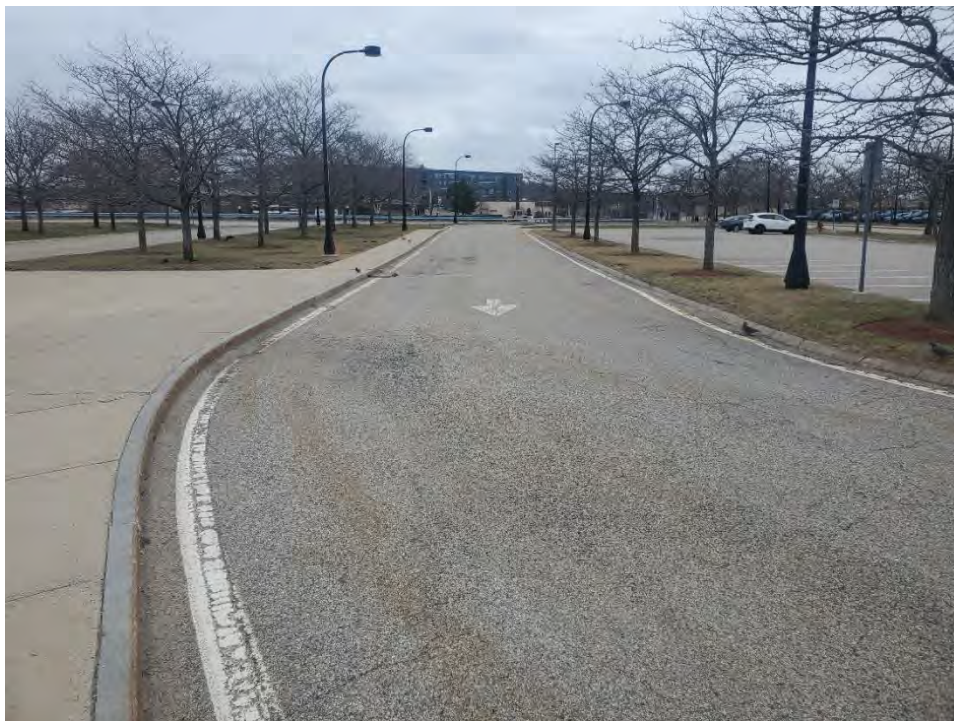
Photo 52: Observed minor cracking in pavement near the center of the middle of the commuter rail parking area, looking east.

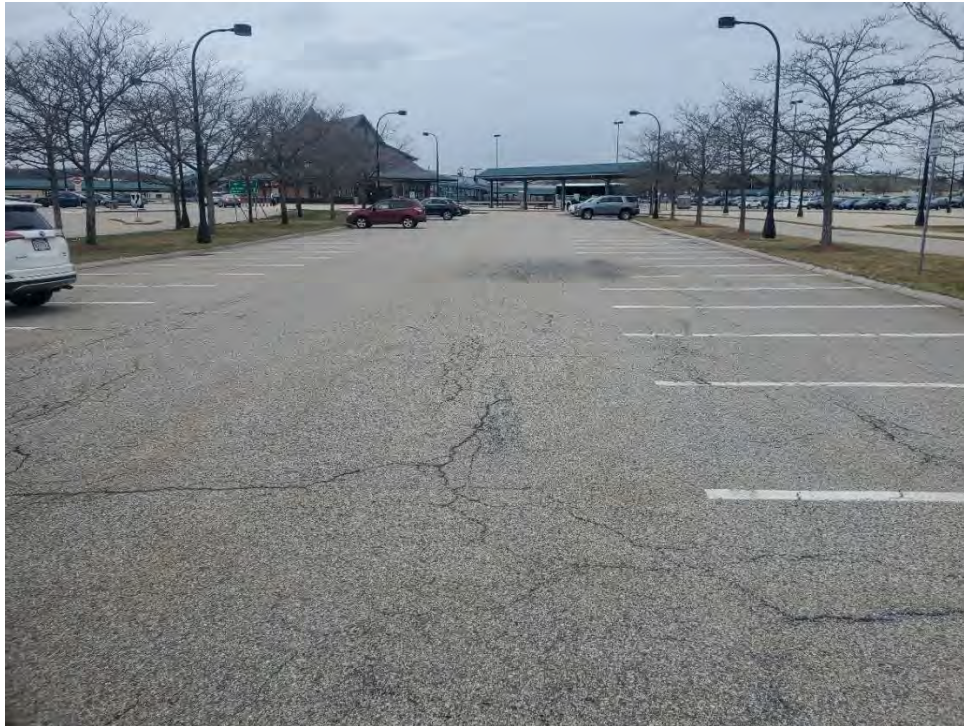
Photo 53: Observed minor/moderate cracking in pavement southeast of CB8, looking northwest.

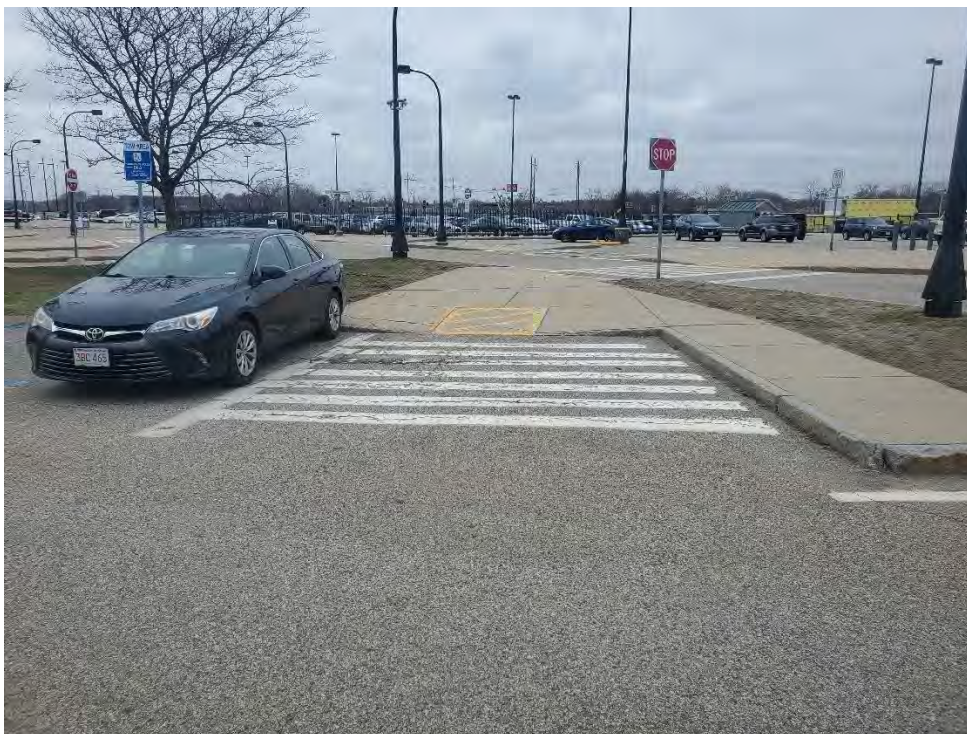
Photo 54: Observed moderate cracking in crosswalk pavement northwest of MBTA Station Building, looking south.

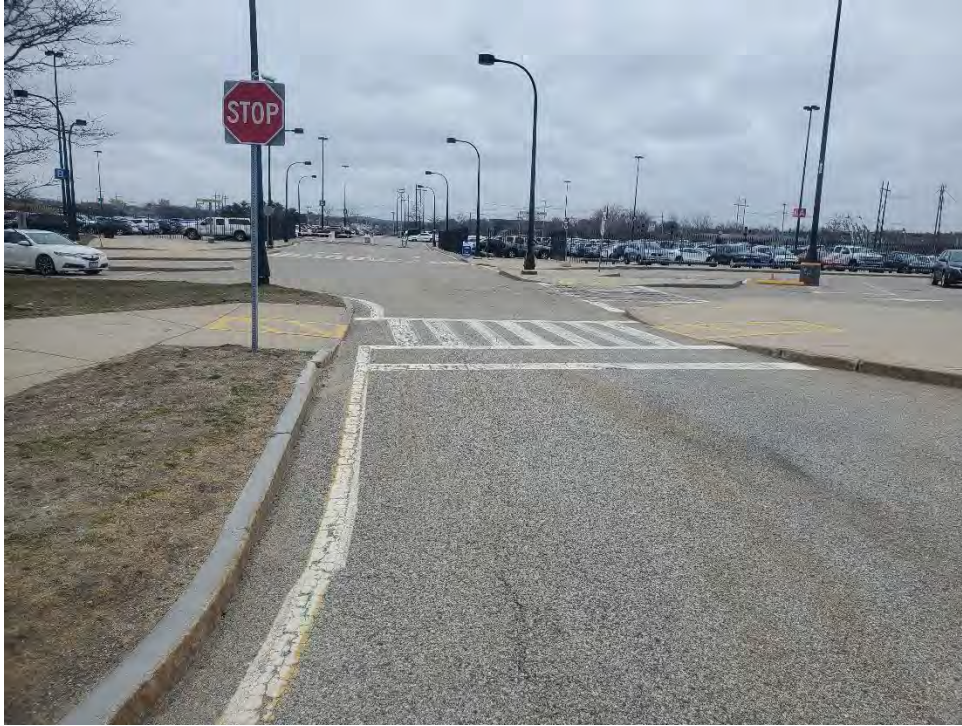
Photo 55: Observed minor cracking in pavement northeast of MBTA Station Building, looking south.

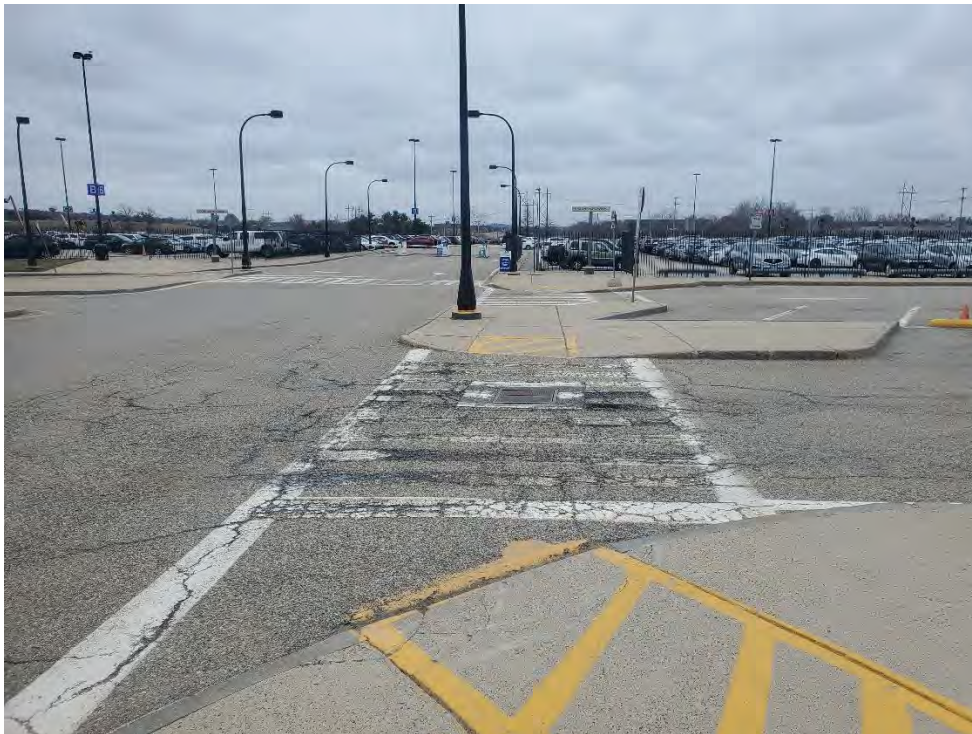
Photo 56: Observed severe cracking and holes in crosswalk pavement southeast of MBTA Station Building, looking southwest.

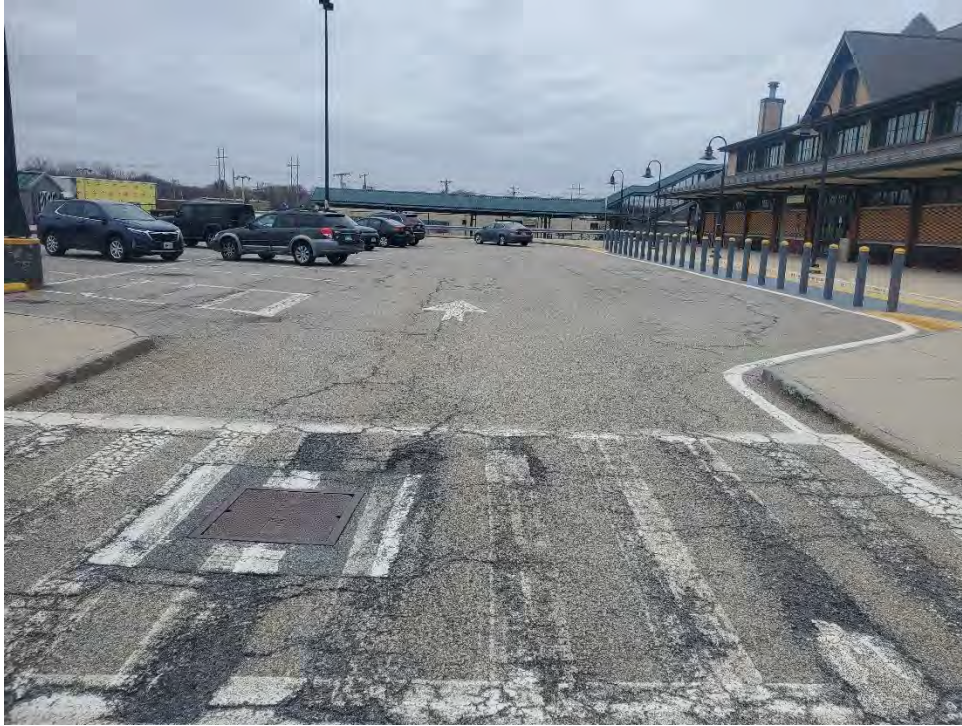
Photo 57: Observed moderate/ severe cracking in pavement south southeast of MBTA Station Building (northwest of CB7), looking southwest.

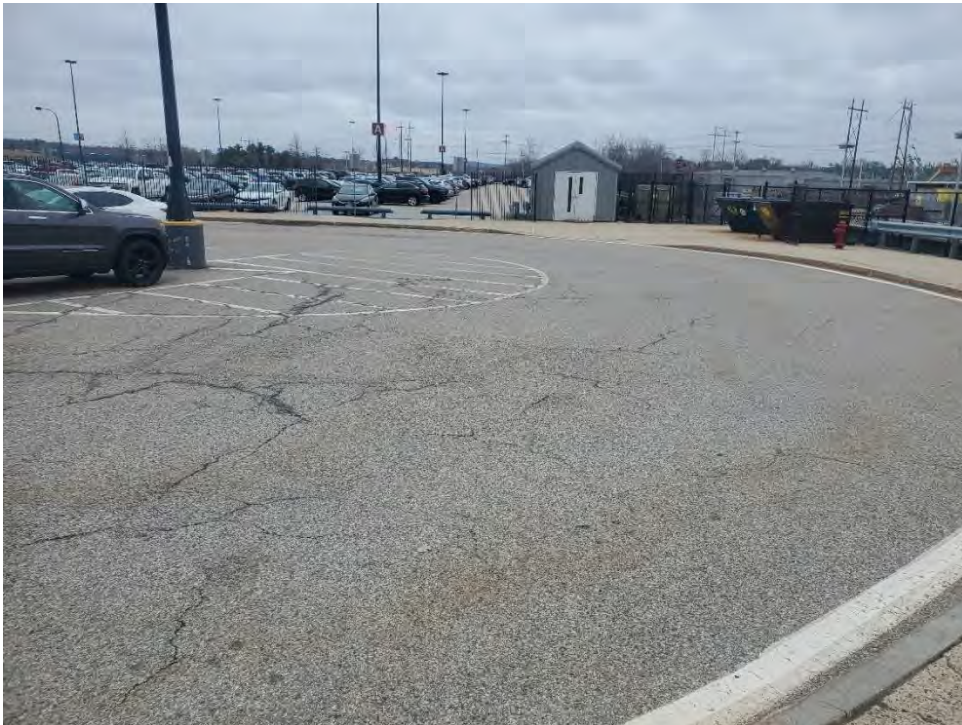
Photo 58: Observed moderate cracking in pavement south of MBTA Station Building (northwest of CB6), looking south.

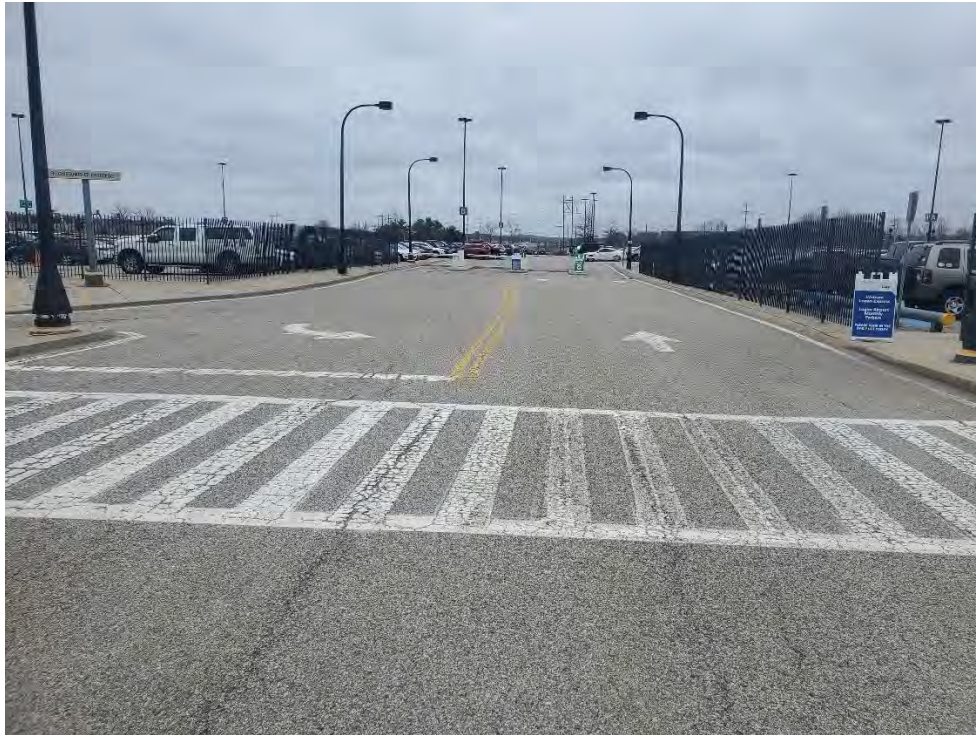
Photo 59: Observed moderate cracking in pavement near the center of the middle of the commuter parking area (north of MH1), looking south.

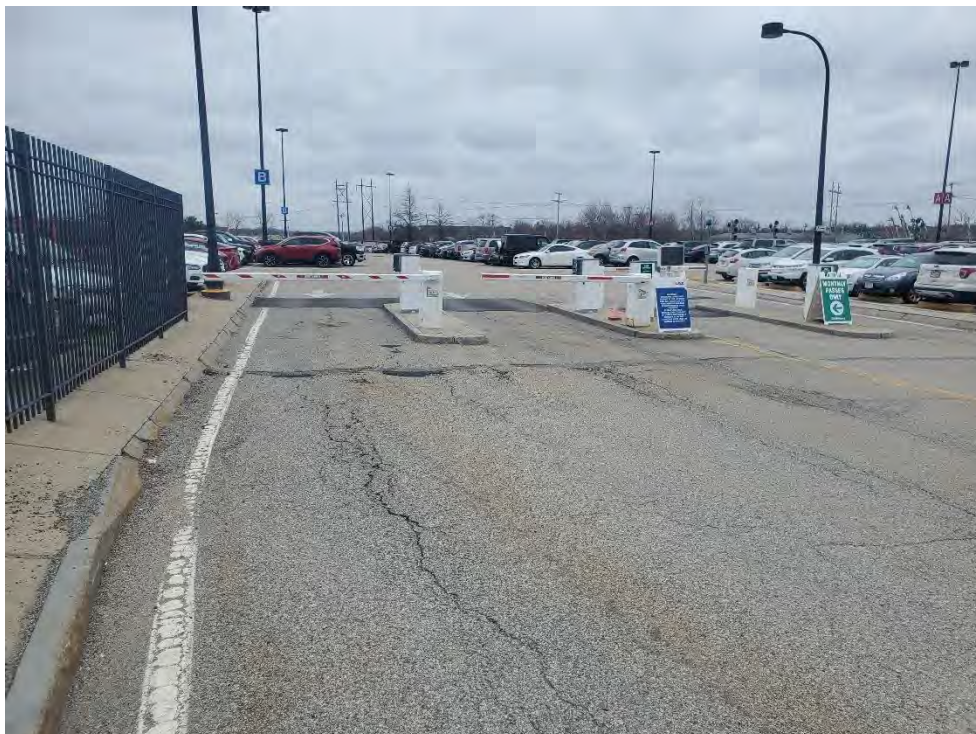
Photo 60: Observed subsidence, (30'x2"x1") moderate/ severe cracks in pavement (southeast of CB3), looking south.

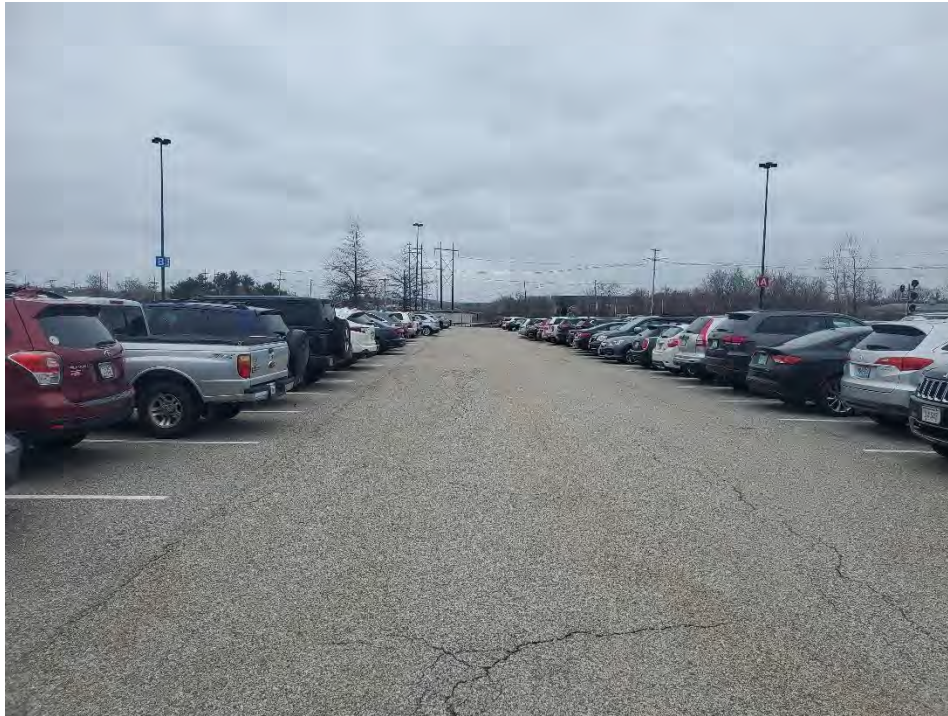
Photo 61: Observed minor/moderate cracking in the pavement in the southern parking area (southeast of CB3A), looking southeast.

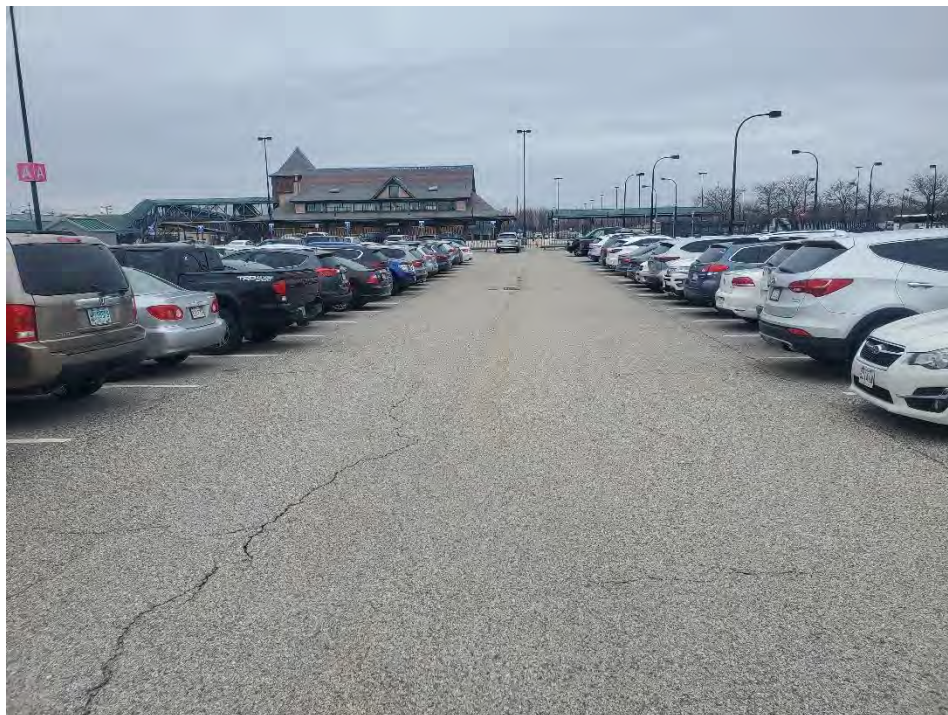
Photo 62: Observed minor/moderate cracking in the pavement in the southern parking area (southeast of CB3A), looking northwest.

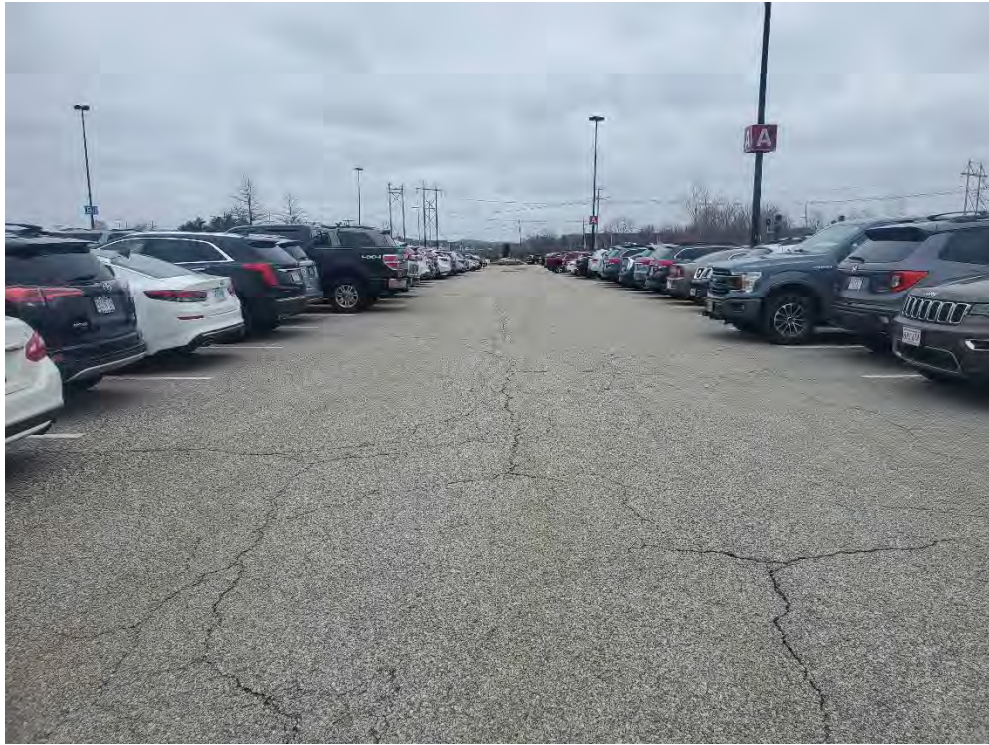
Photo 63: Observed moderate cracking in the pavement in the southern parking area (southeast of CB6), looking southeast.
