Known for excellence.
Built on trust.

**2023 COVER INSPECTION REPORT
MASSACHUSETTS PORT AUTHORITY
Anderson Regional Transportation Center
100 Atlantic Avenue
Woburn, Massachusetts**

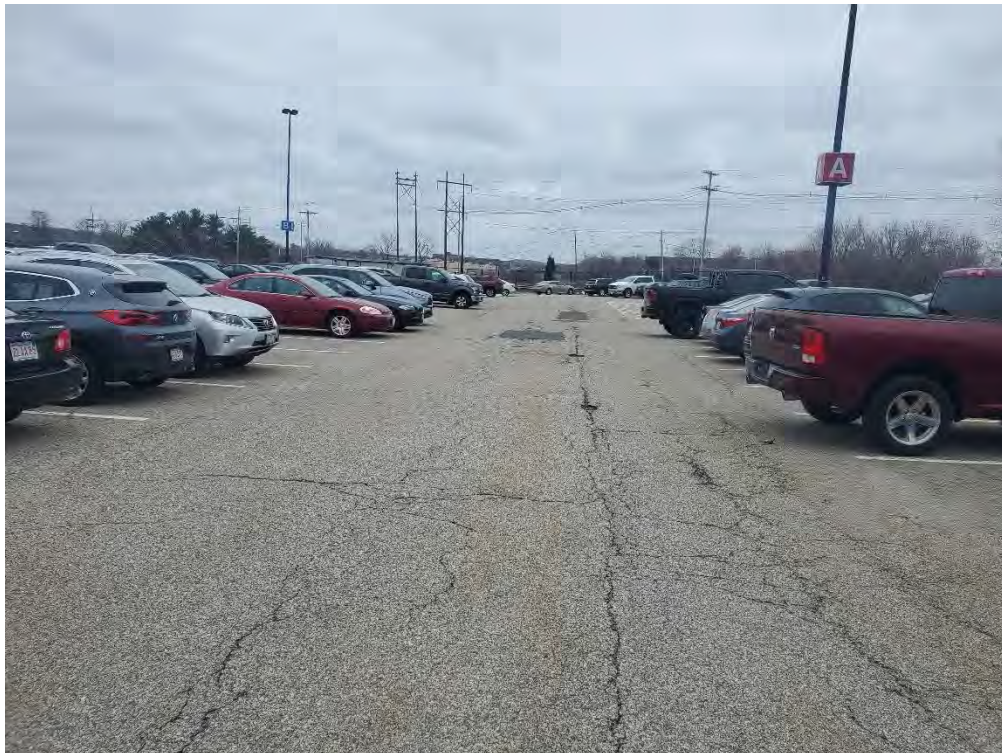
Photo 64: Observed moderate/severe fatigue cracking and holes in the pavement in the southern parking area, looking southeast.

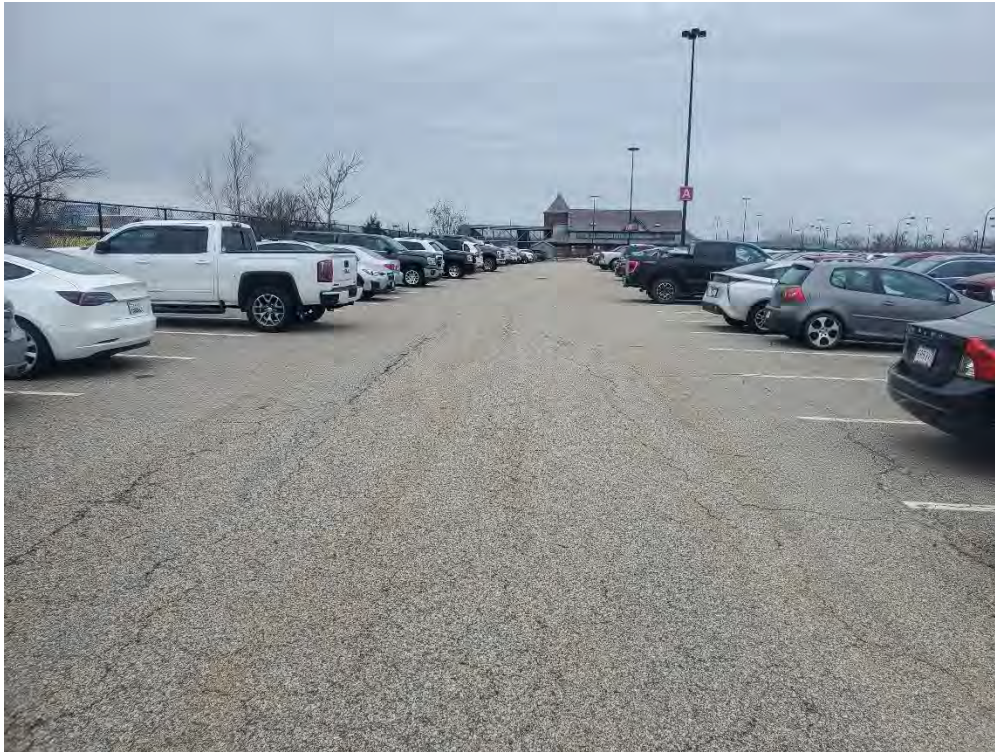
Photo 65: Observed moderate cracking in the pavement in the southern parking area, looking northwest.

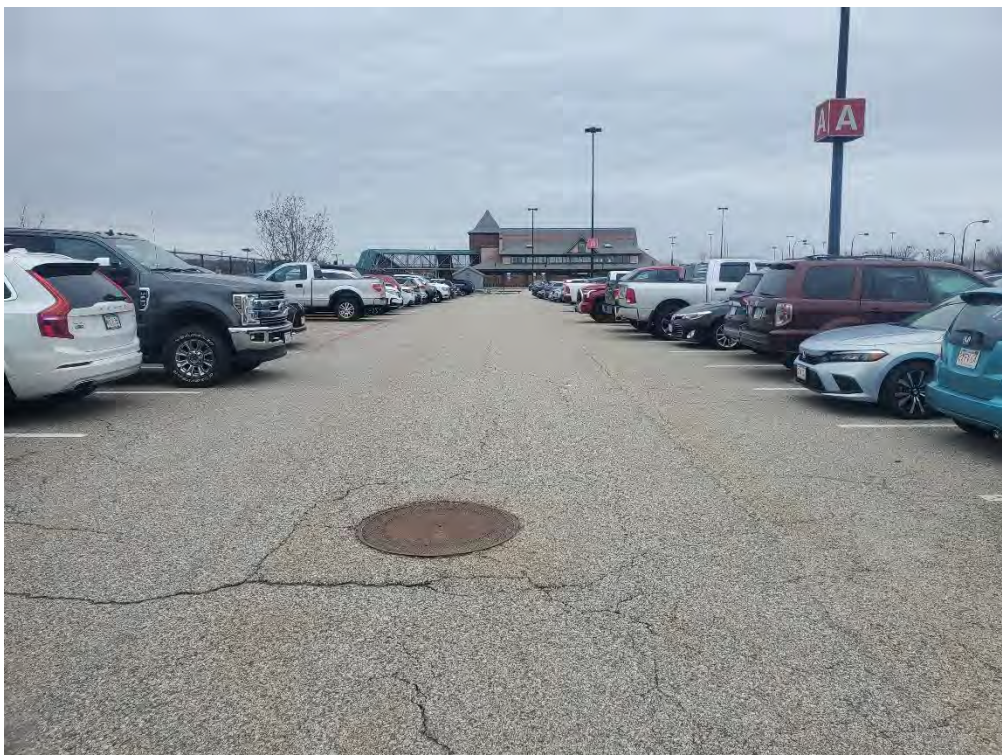
Photo 66: Observed minor/ moderate cracking in the pavement in the southern parking area, looking northwest.

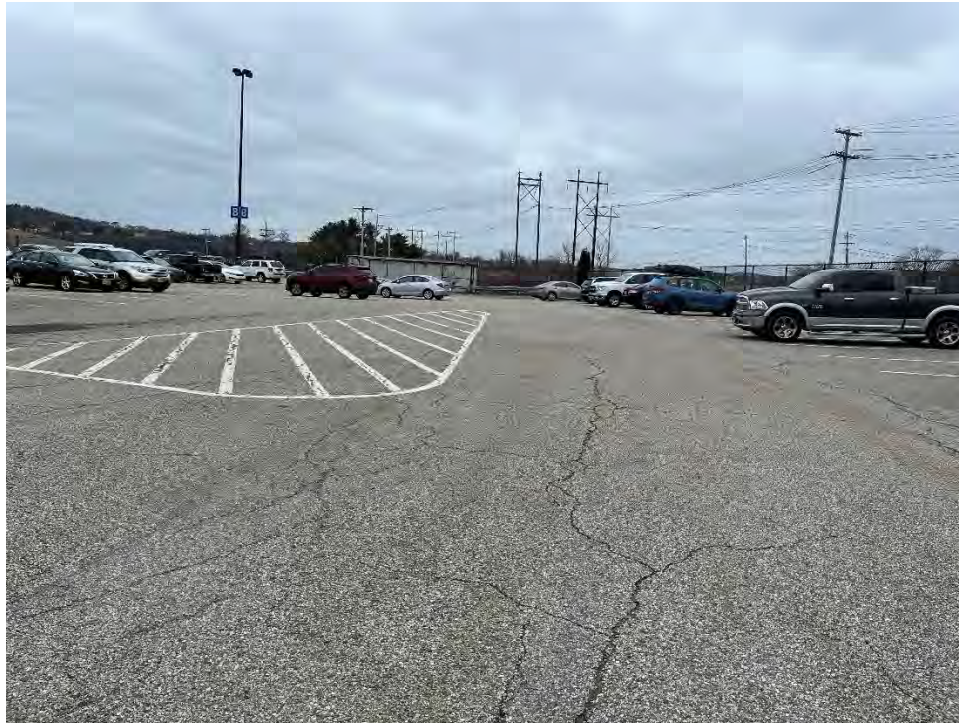
Photo 67: Observed moderate cracking in the pavement in the southern parking area, looking southeast.

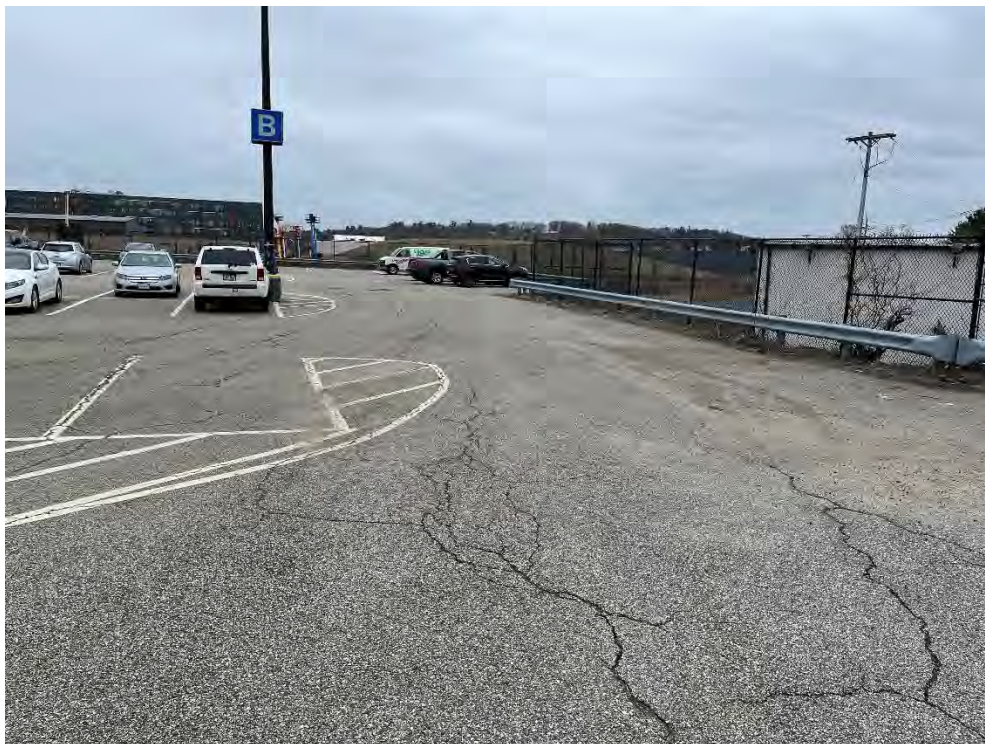
Photo 68: Observed moderate cracking in the pavement in the southern parking area (southwest of CB33), looking northeast.

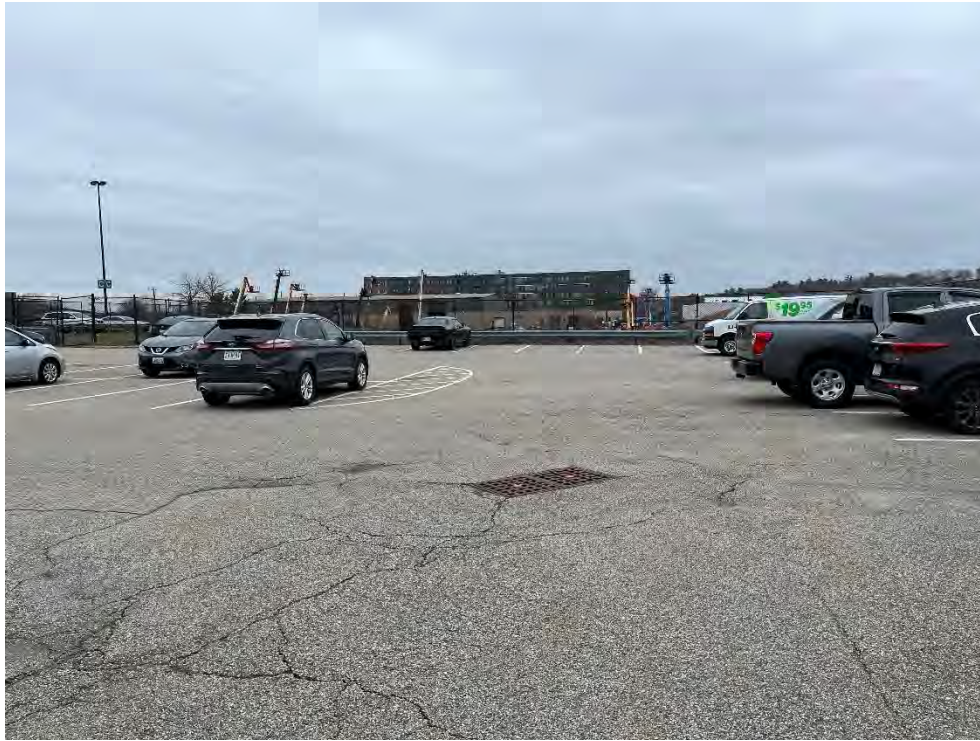
Photo 69: Observed subsidence and moderate cracking near CB33.

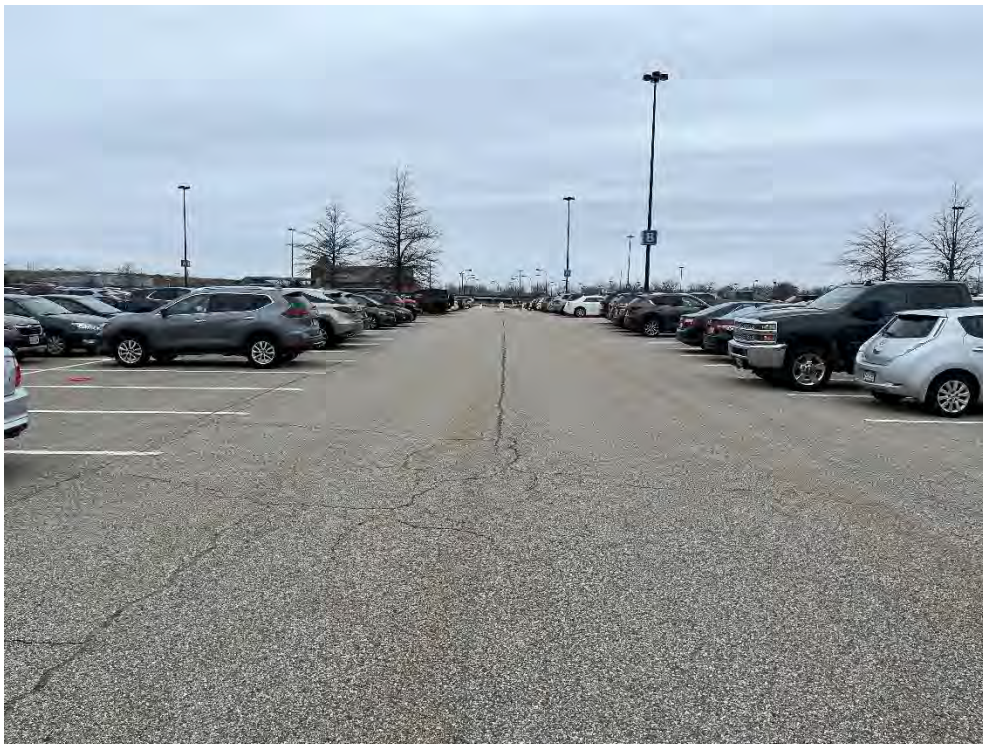
Photo 70: Observed (1" x 1" x 200') cracking in the pavement in the southern parking area (northwest of CB33), looking northwest.

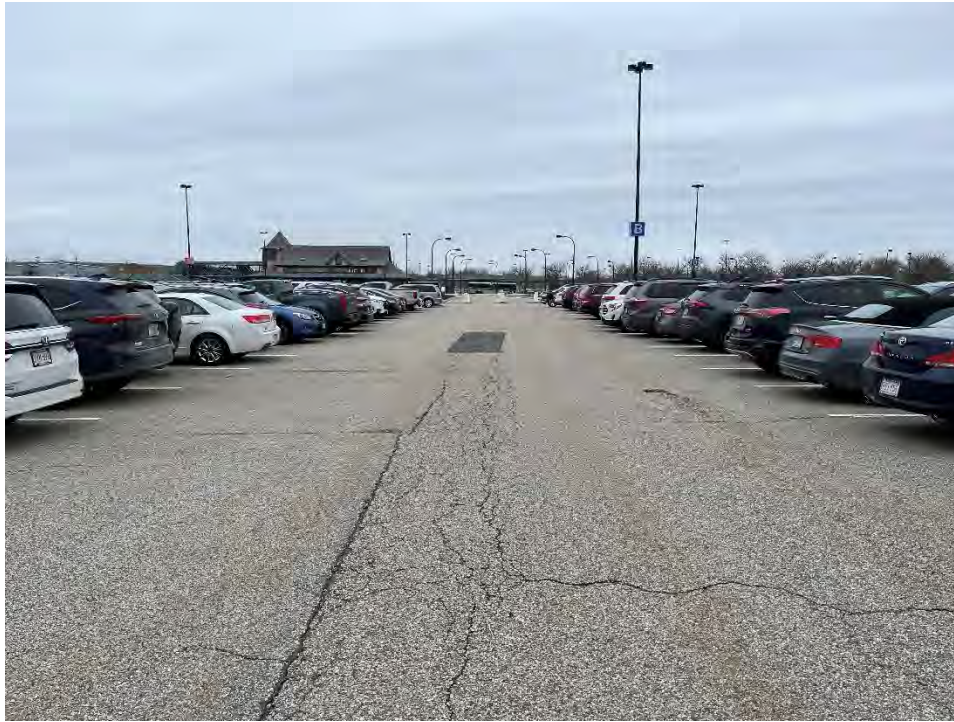
Photo 71: Observed moderate/severe cracking and hole in pavement in the southern parking area (northwest of MH28), looking northwest.

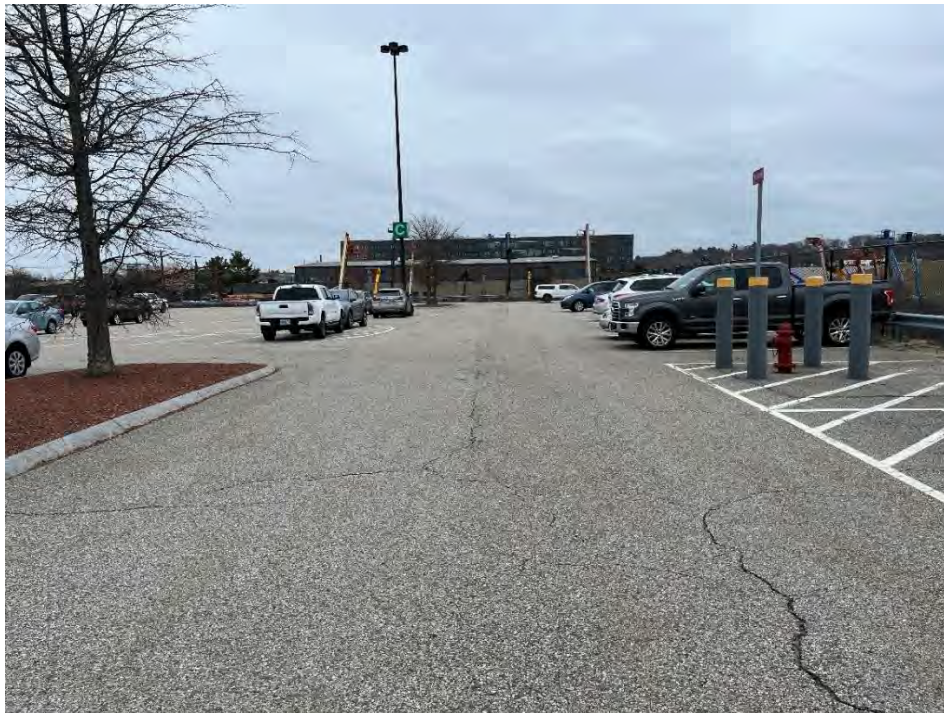
Photo 72: Observed minor/moderate cracking in the pavement in the southern parking area (northwest of SF-9), looking northeast.

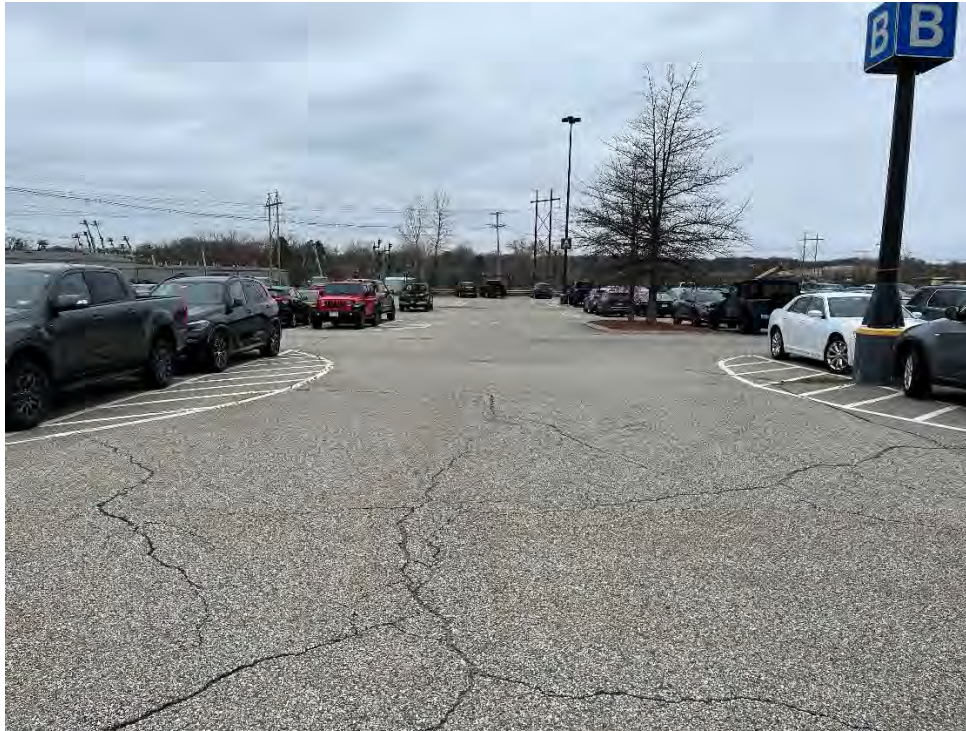
Photo 73: Observed minor/moderate cracking in the pavement in the southern parking area, looking south.

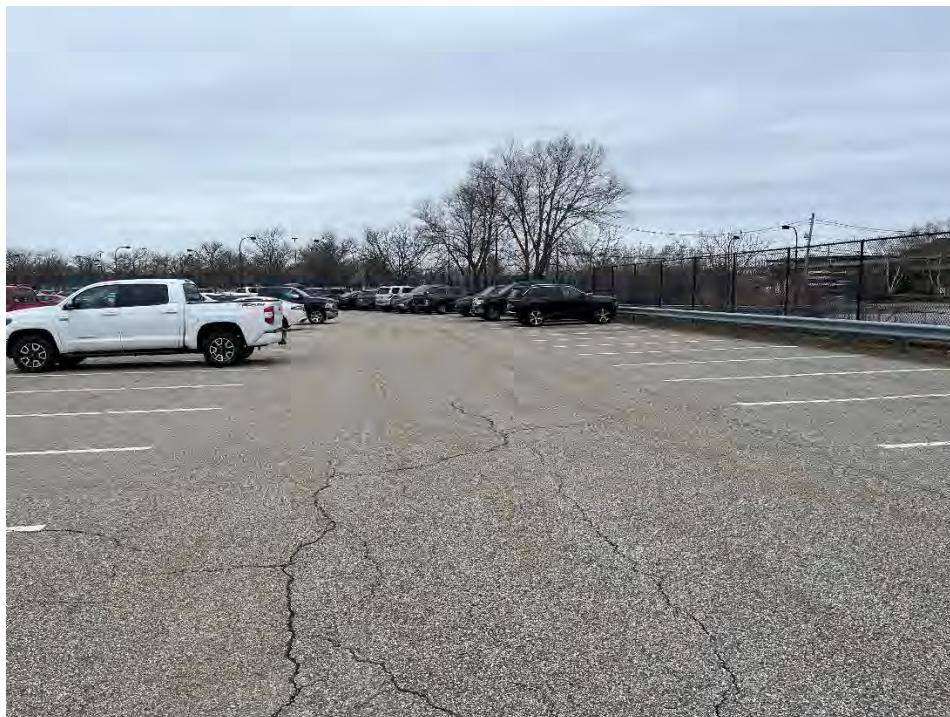
Photo 74: Observed minor/moderate cracking in pavement in southern parking area (northwest of SF-10), looking north.

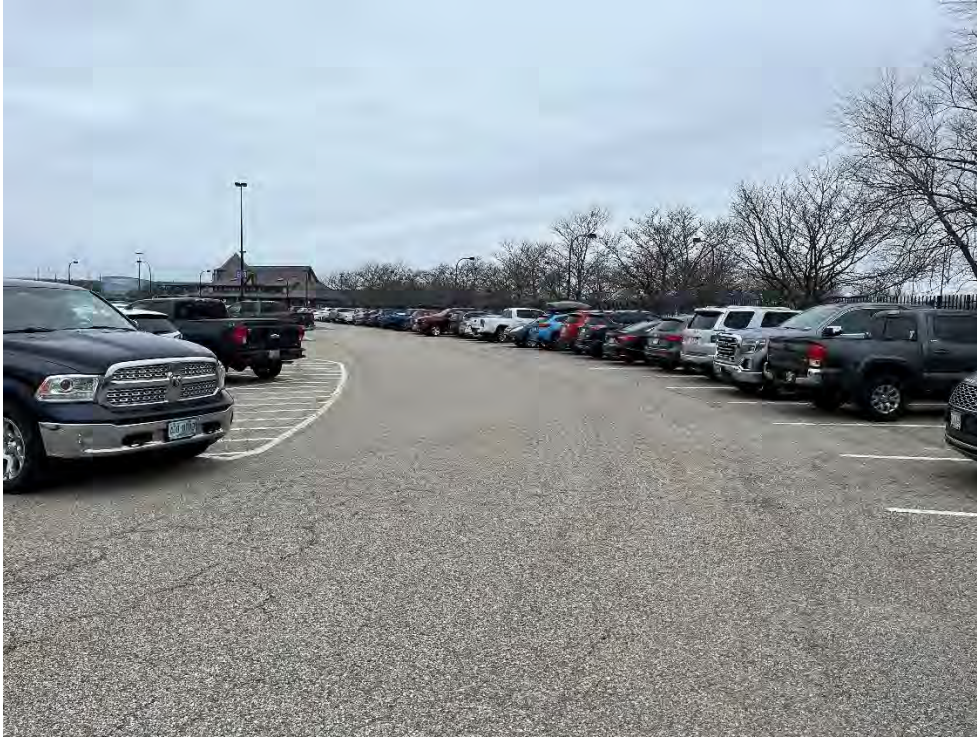
Photo 75: Observed minor cracking in pavement in southern parking area (southwest of MH-2), looking west.

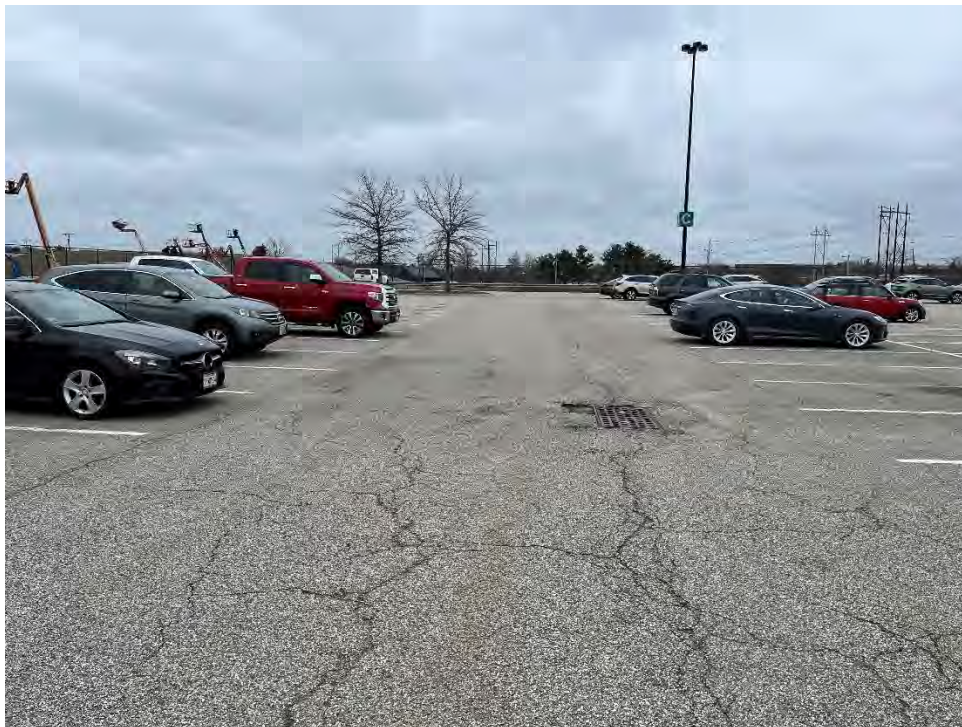
Photo 76: Observed moderate cracking and holes in the pavement in the southern parking area (northwest of CB29), looking southeast.

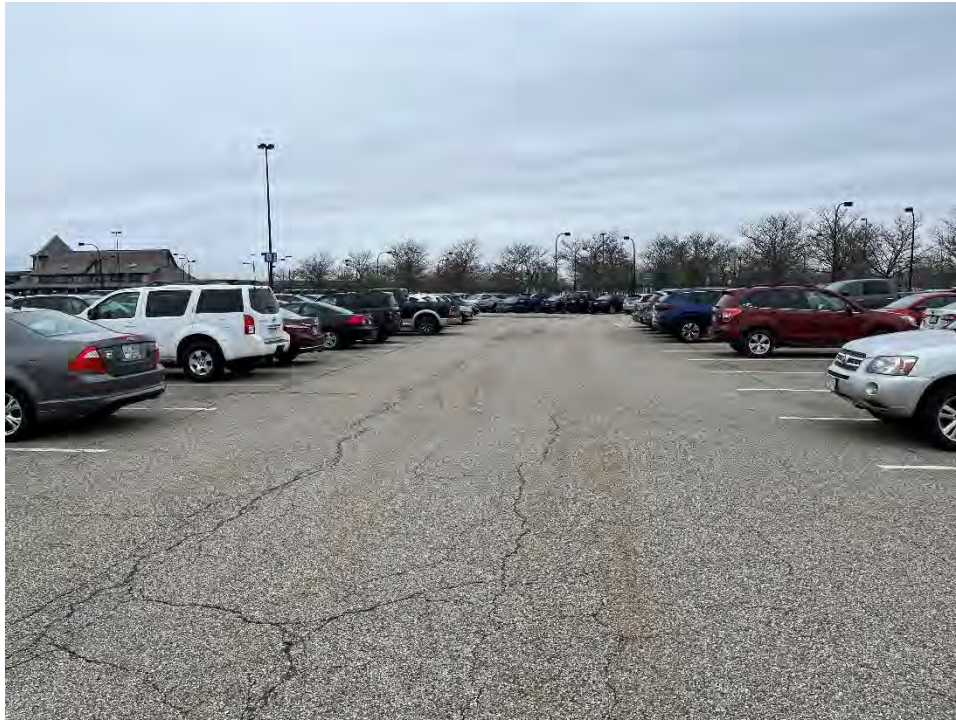
Photo 77: Observed minor/moderate cracking in the pavement in the southern parking area (north of SF-9), looking northwest.

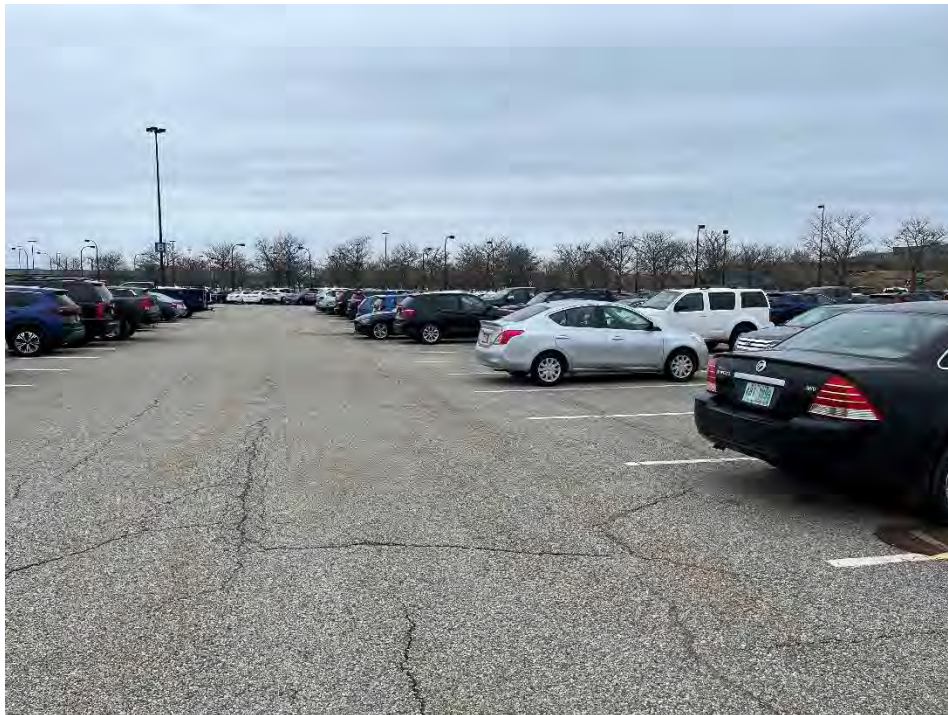
Photo 78: Observed minor/moderate cracking in the pavement in the southern parking area (northeast of MH30), looking northwest.

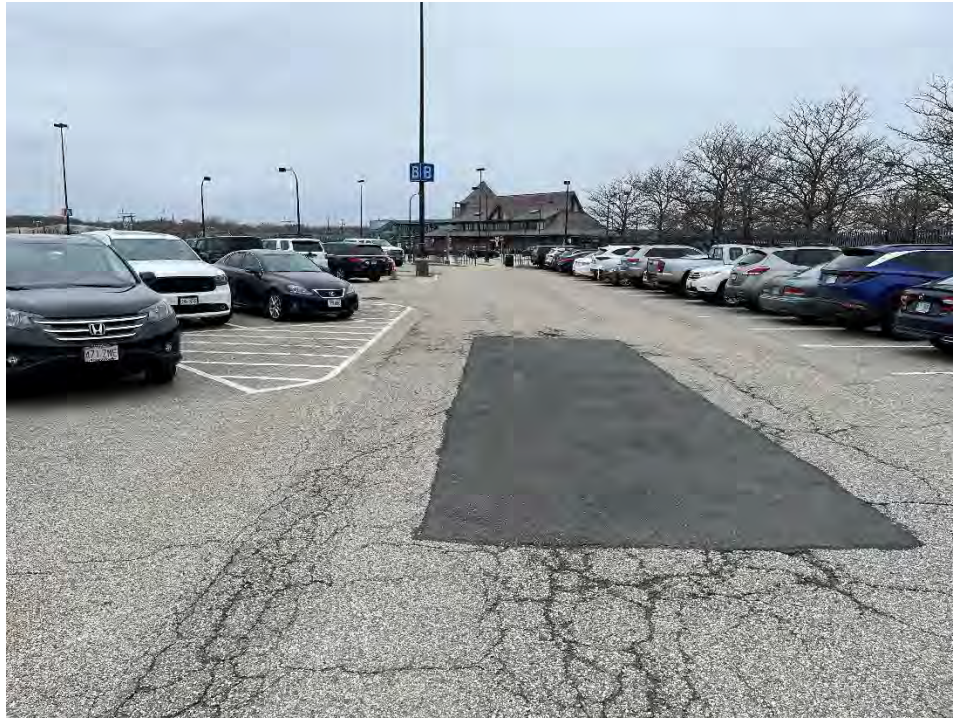
Photo 79: Observed moderate cracking in the pavement in the southern parking area (southeast of CB5A), looking northwest.

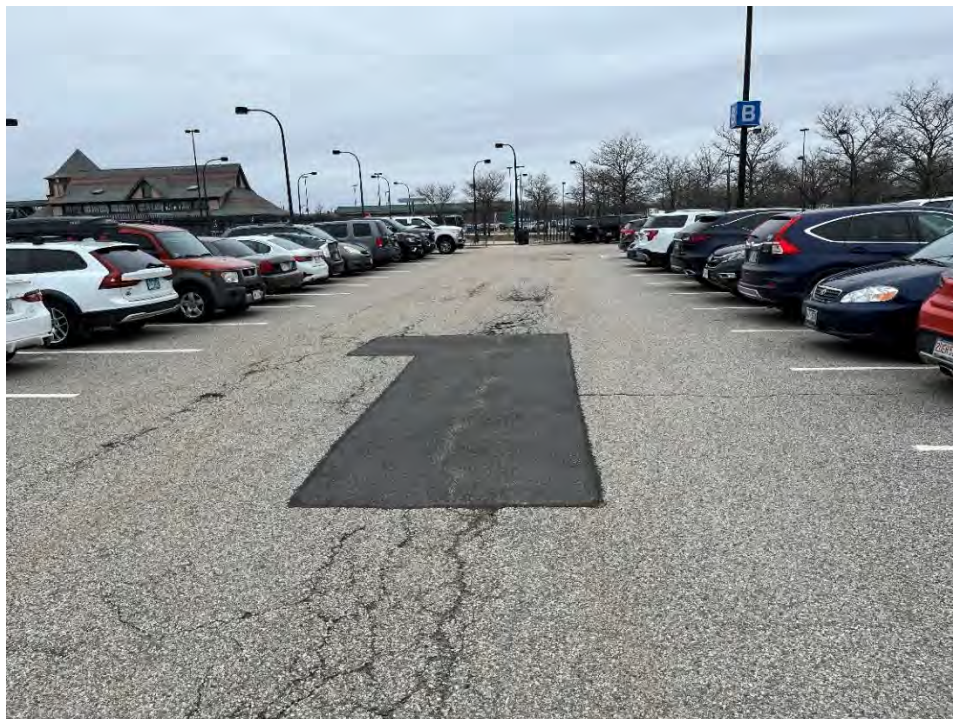
Photo 80: Observed moderate/severe cracking small holes in the southern parking area (southeast of CB3), looking north.

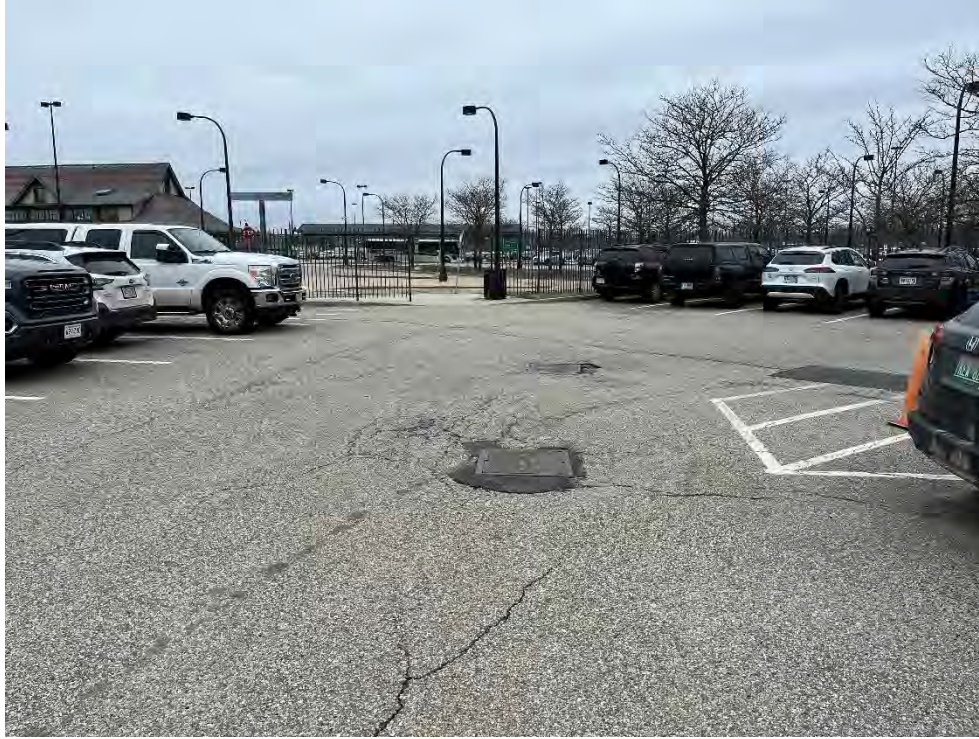
Photo 81: Observed moderate cracking and holes in pavement in southern parking area (northeast of CB3), looking north.

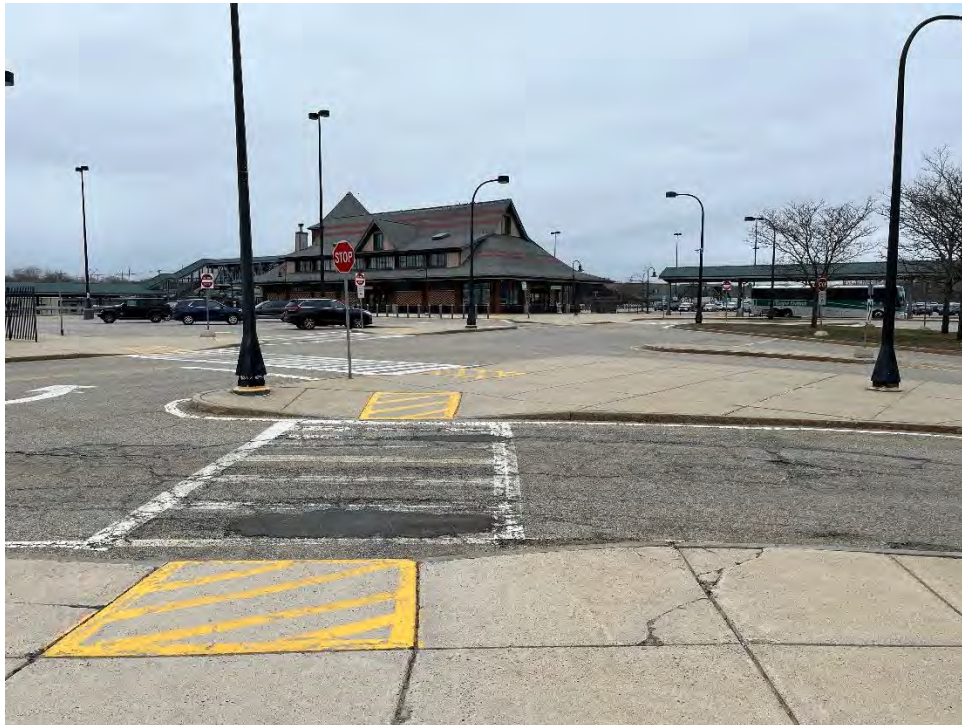
Photo 82: Observed moderate/ severe cracks in crosswalk (near MH-1), looking northeast.

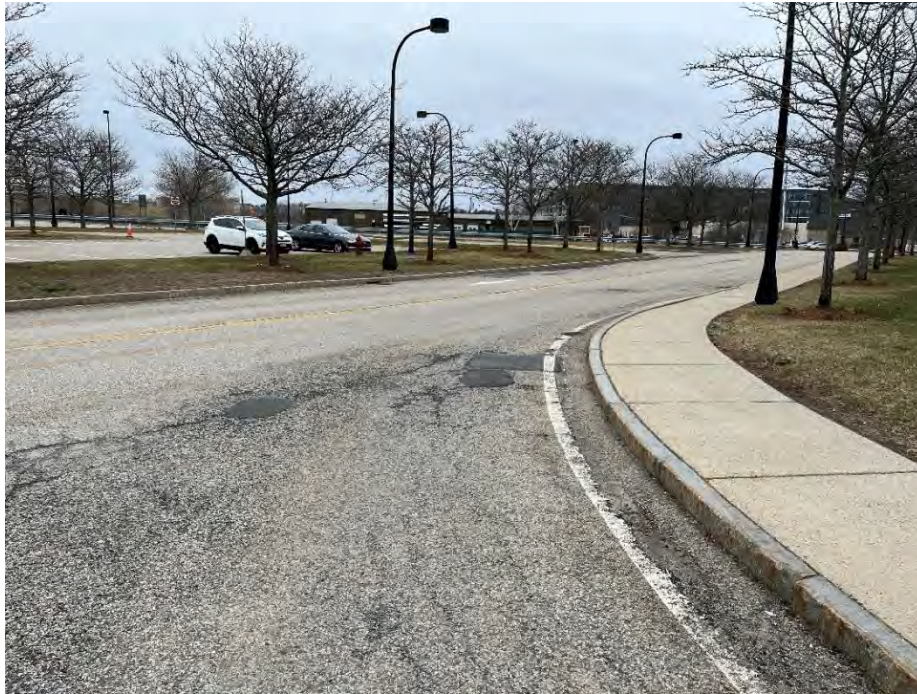
Photo 83: Observed moderate cracking in pavement along entrance (southwest of CB4), looking east.

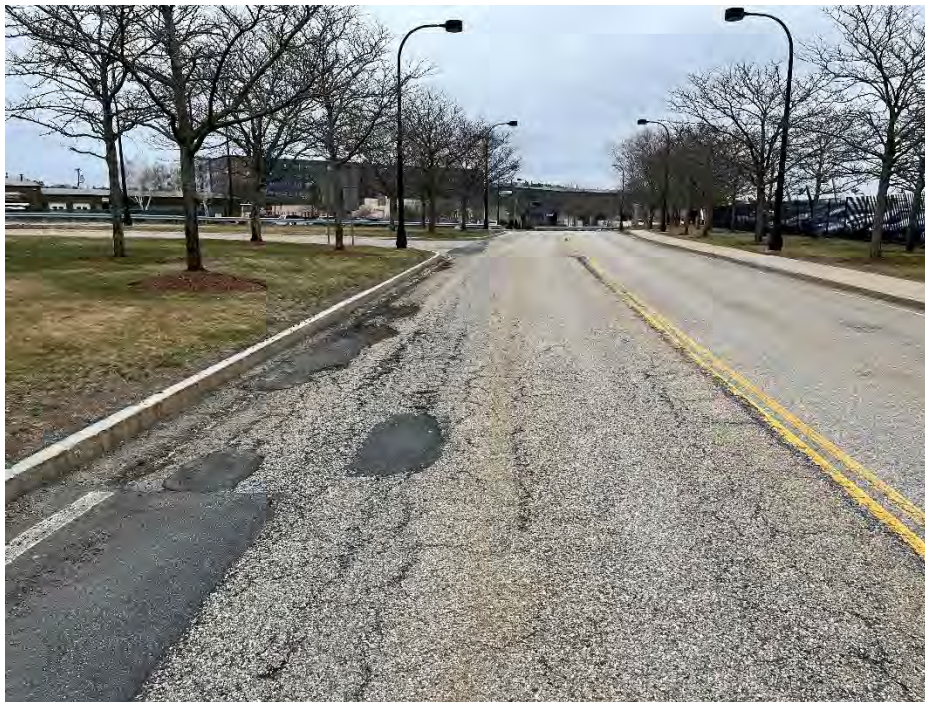
Photo 84: Observed moderate/severe fatigue cracking and holes in the pavement along the entrance (east of CB4), looking east

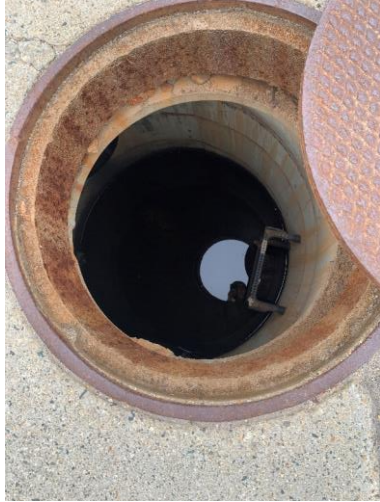
Photo 1: MH-1 appears to be in good condition, unable to observe sediment due to standing water.

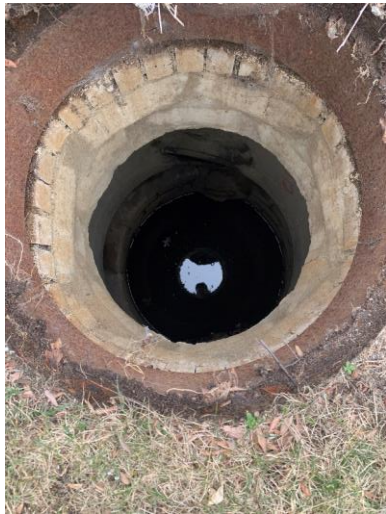
Photo 2: MH-2 appears to be in good condition, unable to observe sediment due to standing water.

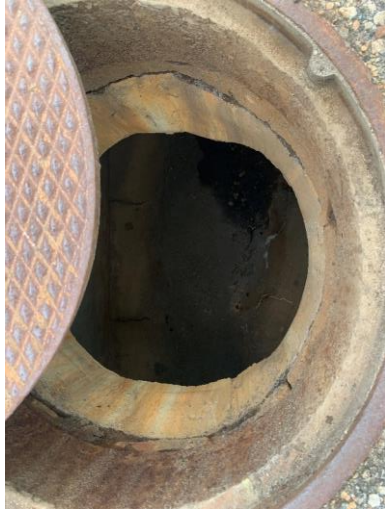
Photo 3: MH3A appears to be in good condition.

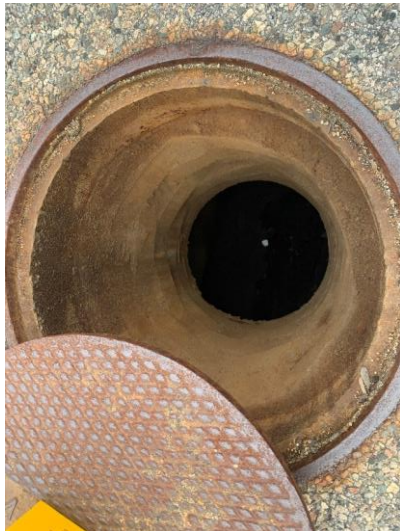
Photo 4: MH10 appears to be in good condition.

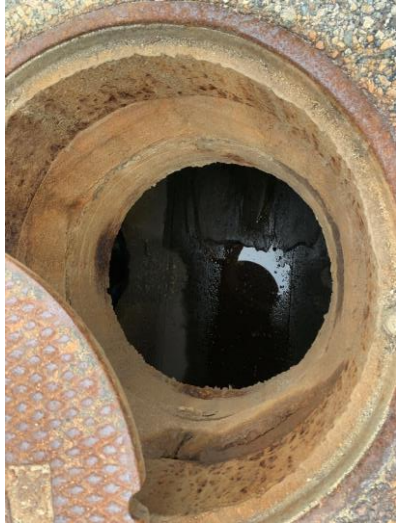
Photo 5: MH15 appears to be in good condition, <1 inch of sediment accumulation.

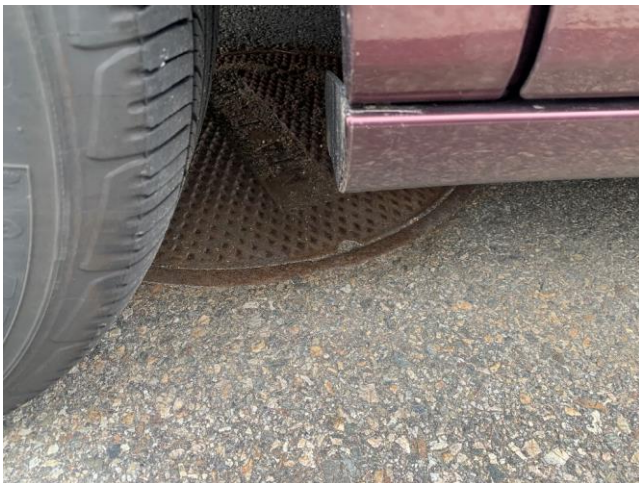
Photo 6: MH28 access restricted; car on the cover.

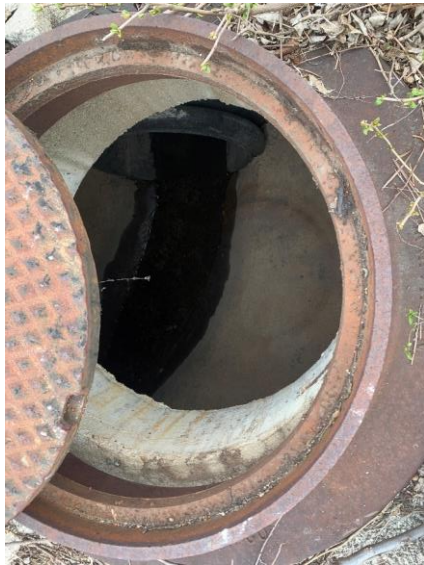
Photo 8: MH34 appears to be in good condition.

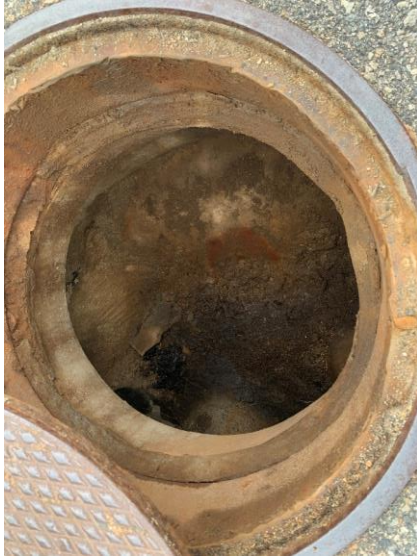
Photo 9: MH102 appears to be in good condition, <1 inch of sediment accumulation.

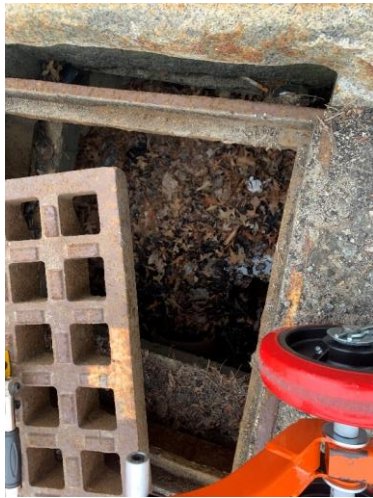
Photo 10: CB1 appears to be in good condition, unable to observe sediment accumulation due to standing water and organic debris.

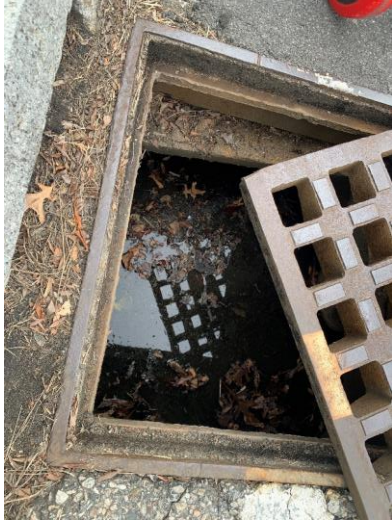
Photo 11: CB2 appears to be in good condition, several inches of sediment and organic debris.

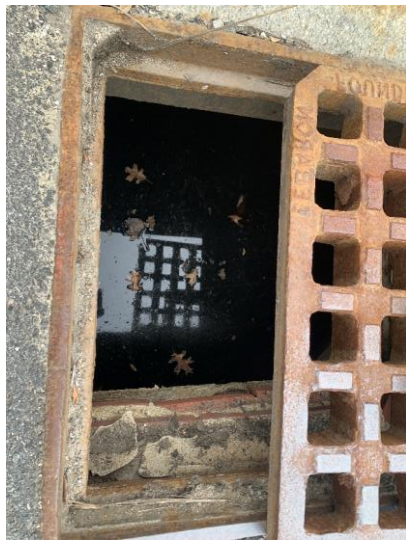
Photo 12: CB3 with moderate deterioration of mortar and missing bricks, unable to observe sediment due to standing water.

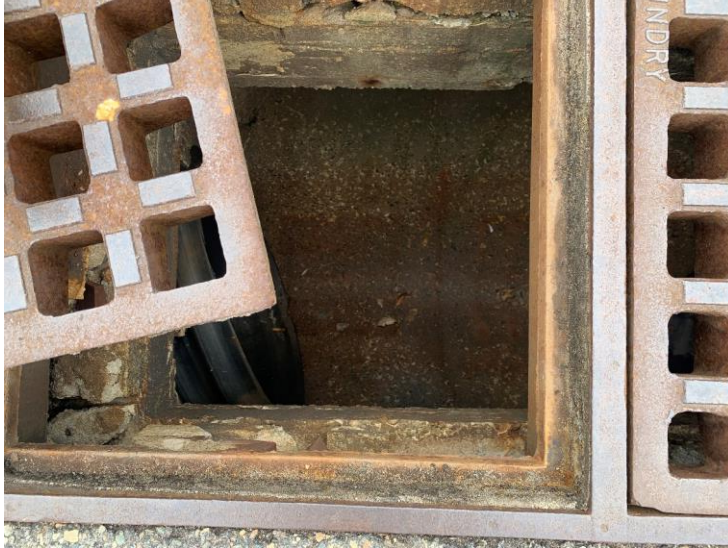
Photo 13: CB3A with moderate deterioration of concrete and loose bricks, no sediment accumulation observed.

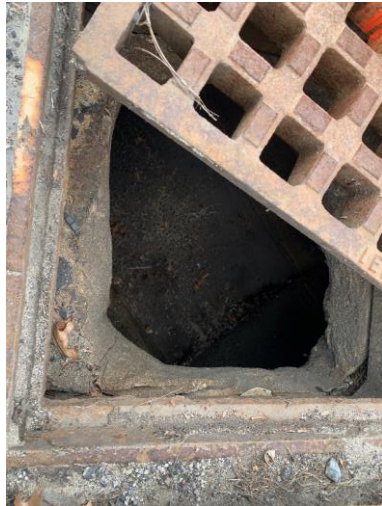
Photo 14: CB4 with moderate concrete deterioration, no sediment accumulation observed.

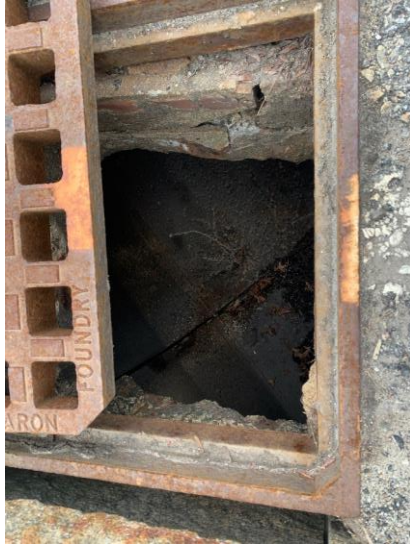
Photo 15: CBS with moderate concrete deterioration, no sediment accumulation observed.

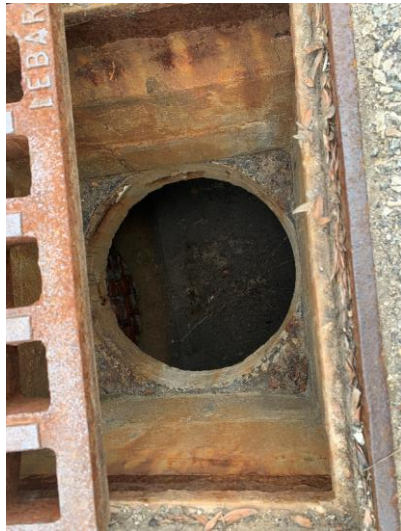
Photo 16: CBSA appears to be in good condition, no sediment accumulation observed.

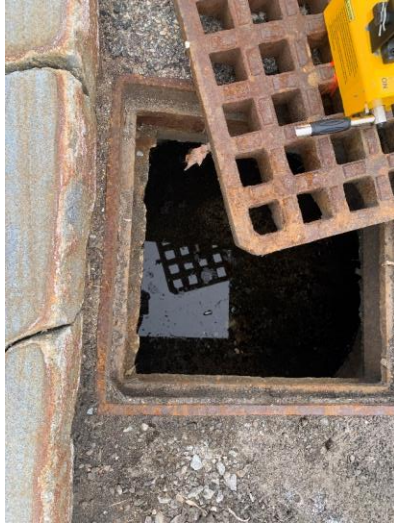
Photo 17: CB6 appears to be in good condition, unable to observe sediment due to standing water.

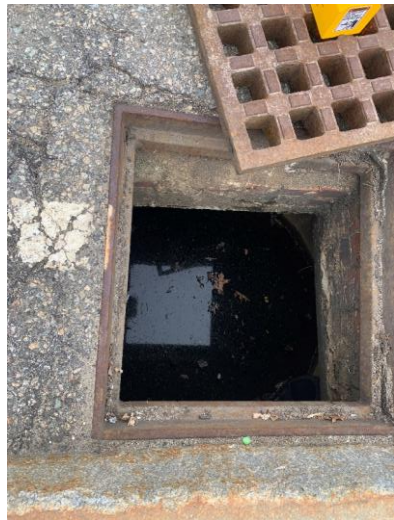
Photo 18: CB7 appears to be in good condition, unable to observe sediment due to standing water.

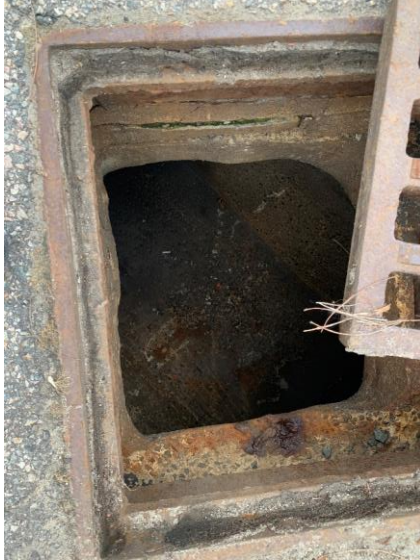
Photo 19: CB8 with moderate deterioration and loose and missing bricks, no sediment accumulation observed.

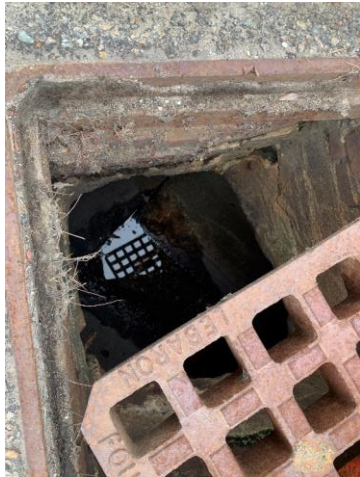
Photo 20: CB9 moderate deterioration and loose and missing bricks, unable to observe sediment due to standing water.

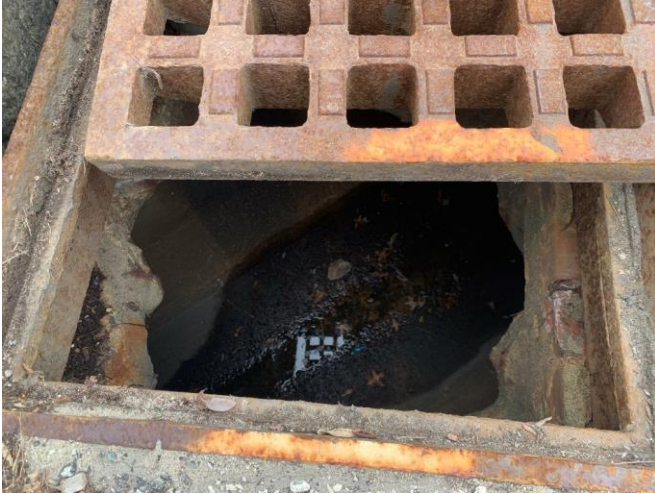
Photo 21: CB10 with minor deterioration. <1 inch of sediment accumulation and organic debris.

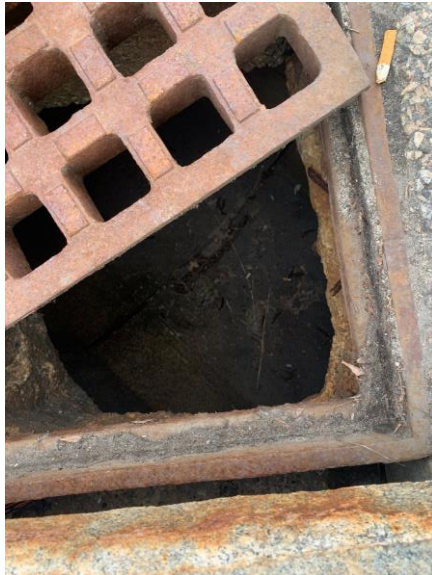
Photo 22: CB11 with moderate deterioration of concrete, no sediment accumulation observed.

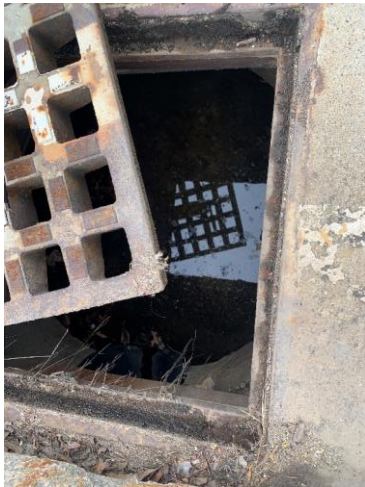
Photo 23: CB12 appears to be in good condition, unable to observe sediment due to standing water.

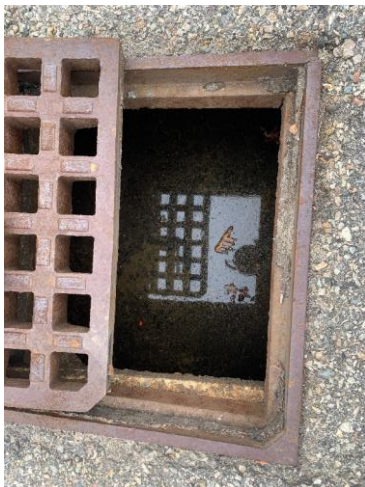
Photo 24: CB13 appears to be in good condition, unable to observe sediment due to standing water.

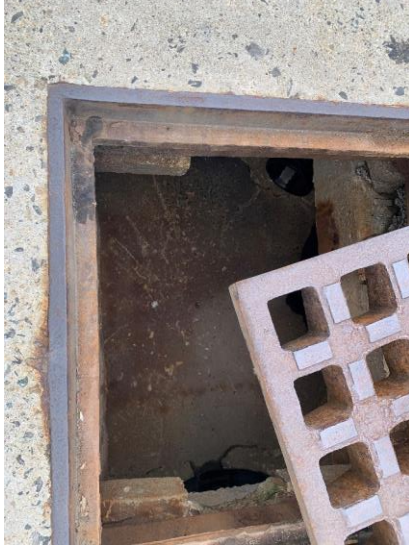
Photo 25: CB14 some loose bricks with moderate concrete and mortar deterioration, no sediment accumulation observed.

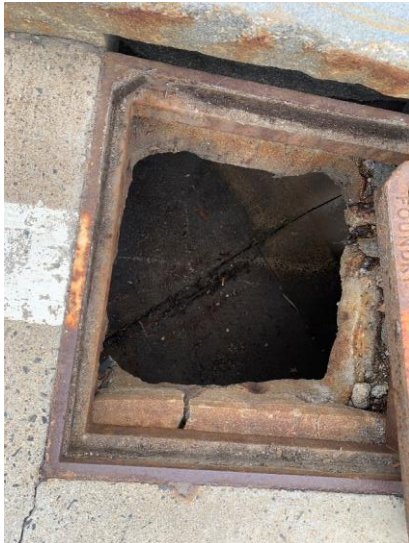
Photo 26: CB15 with moderate concrete deterioration, no sediment accumulation observed.

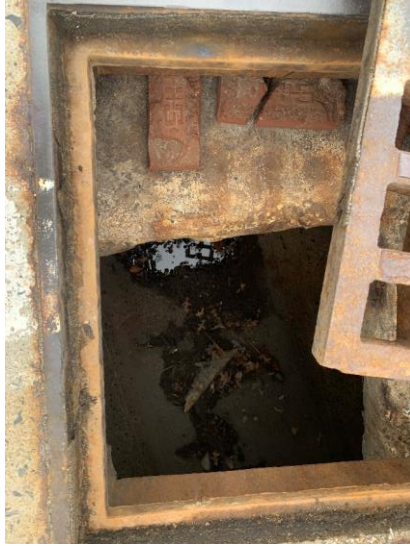
Photo 27: CB16 with moderate mortar deterioration and loose bricks, no sediment accumulation observed.

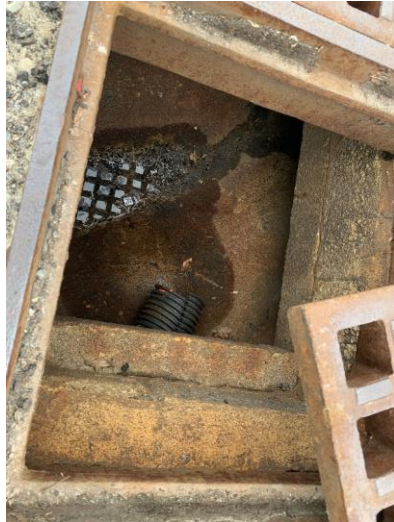
Photo 28: CB17 with moderate concrete deterioration, no sediment accumulation observed.

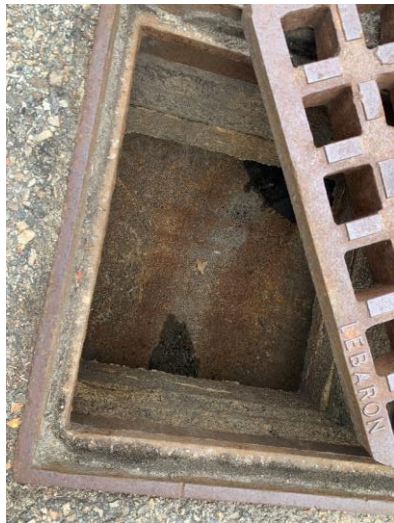
Photo 29: CB18 with minor concrete deterioration.

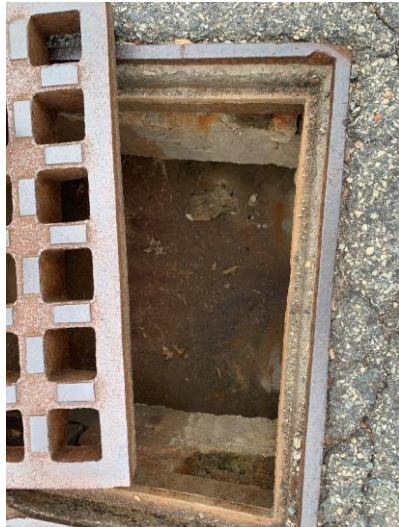
Photo 30: CB19 with moderate mortar deterioration and loose bricks, no sediment accumulation observed.

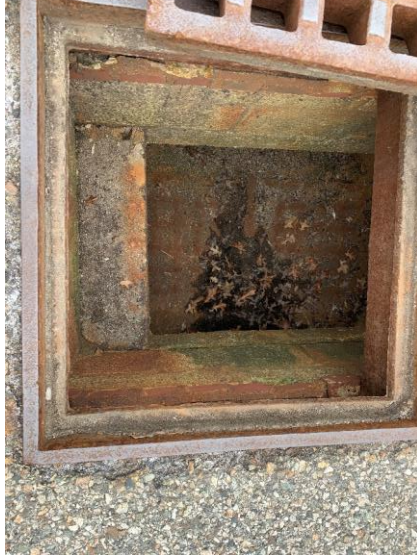
Photo 31: CB20 appears to be in good condition, <1 inch of sediment accumulation and organic debris.

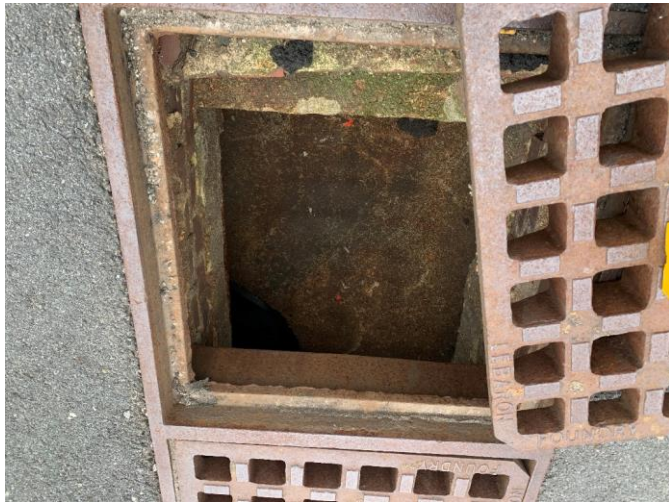
Photo 32: CB 21 appears to be in good condition, no sediment accumulation observed.
