Known for excellence.
Built on trust.

**2023 COVER INSPECTION REPORT
MASSACHUSETTS PORT AUTHORITY
Anderson Regional Transportation Center
100 Atlantic Avenue
Woburn, Massachusetts**

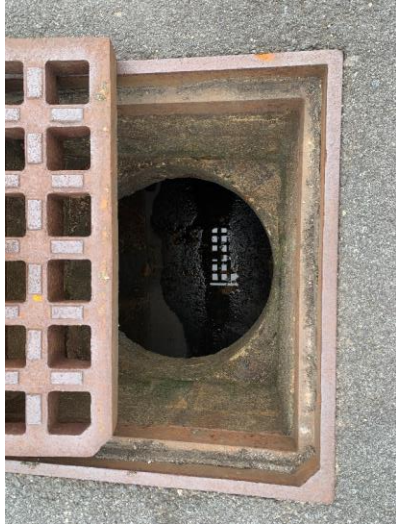
Photo 33: CB21A appears to be in good condition, no sediment accumulation observed due to standing water.

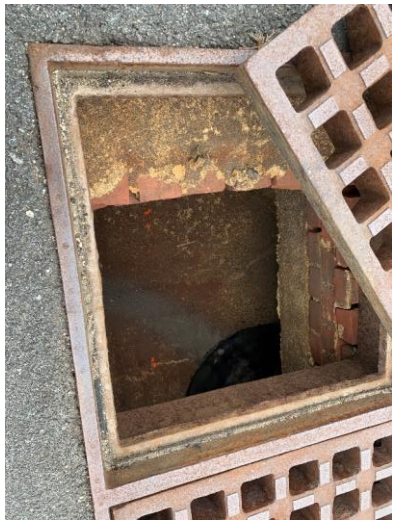
Photo 34: CB22 with minor mortar deterioration and loose bricks, no sediment accumulation observed.

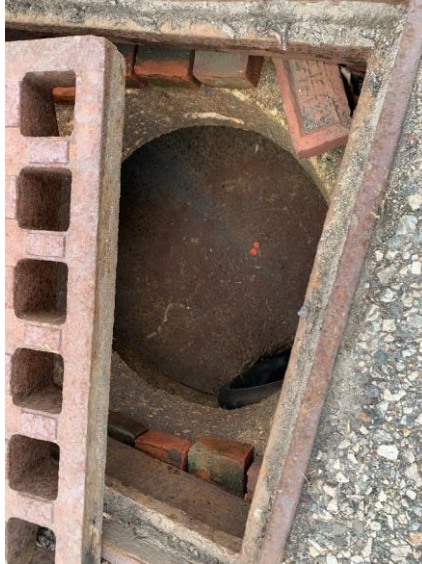
Photo 35: CB23 with minor mortar deterioration and loose bricks, no sediment accumulation observed.

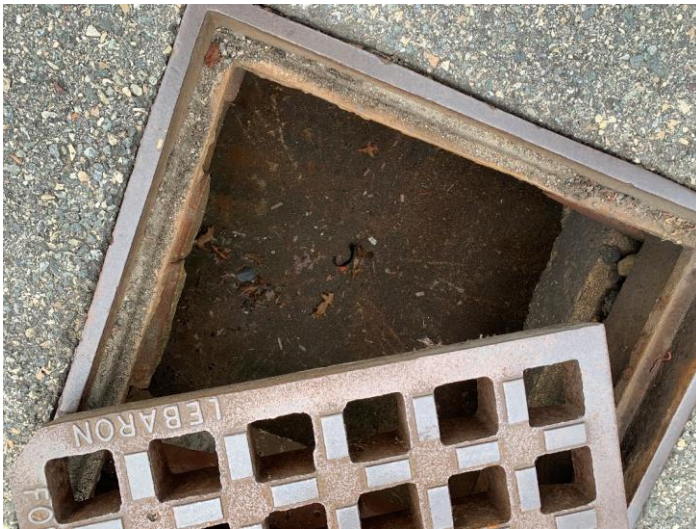
Photo 36: CB24 with minor mortar deterioration and loose bricks, no sediment accumulation observed.

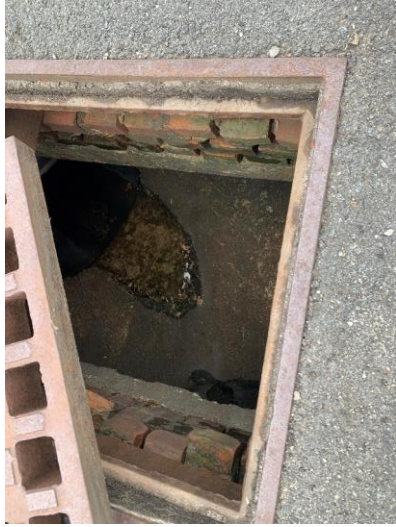
Photo 37: CB25 with moderate mortar deterioration and missing bricks, no sediment accumulation observed, some water.

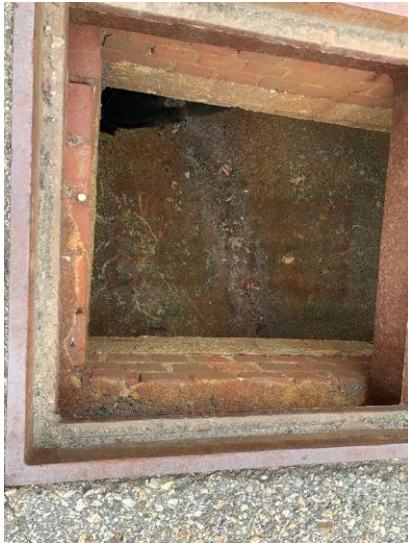
Photo 38: CB26 in good condition, no sediment accumulation observed.

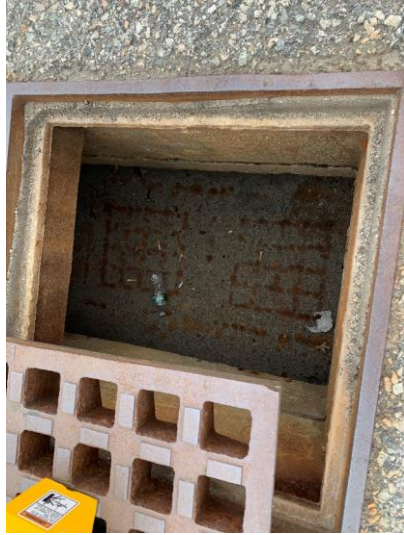
Photo 39: CB27 appears to be in good condition, minor sediment accumulation observed.

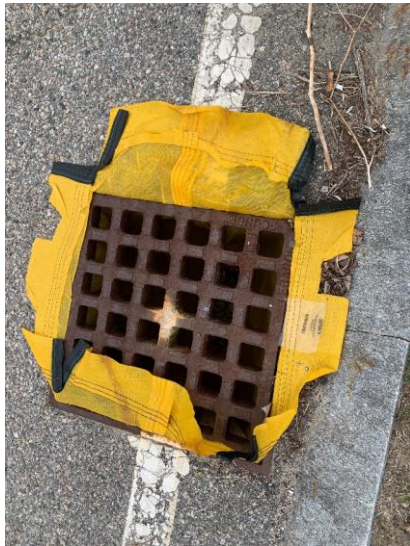
Photo 40: CB28 contained a silt sack with minor accumulation of organic debris.

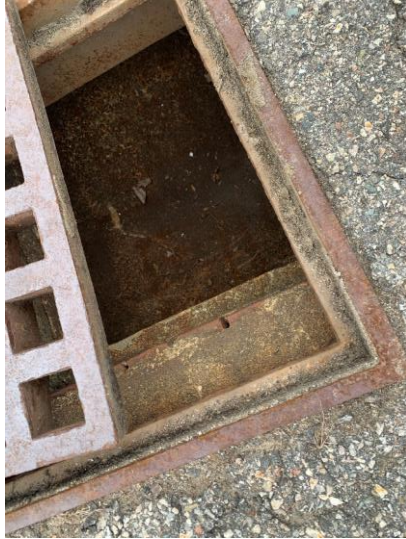
Photo 41: CB29 with moderate concrete deterioration, no sediment accumulation observed.

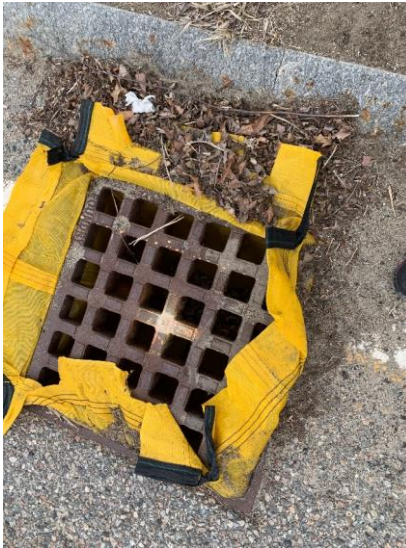
Photo 42: CB30 contained a silt sack with minor accumulation of organic debris.

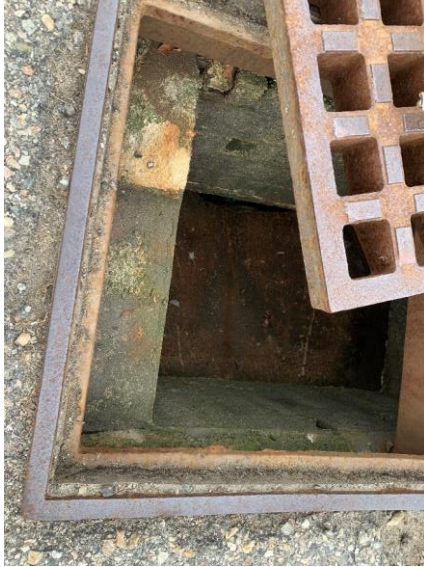
Photo 43: CB32 with moderate mortar deterioration and loose bricks, no sediment accumulation observed.

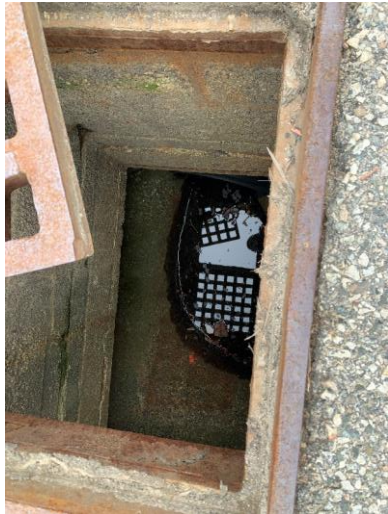
Photo 44: CB33 appears to be in good condition, unable to observe sediment accumulation due to standing water.

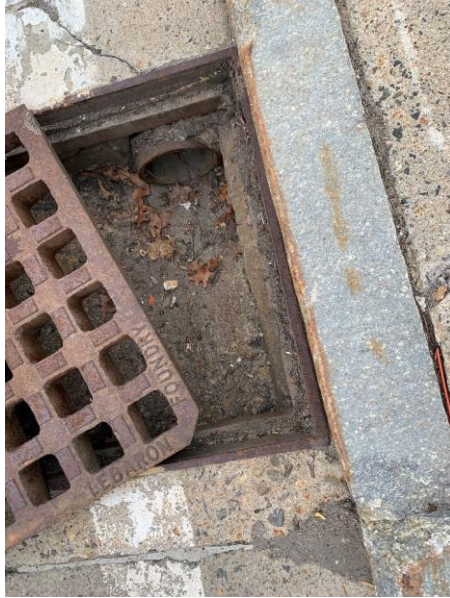
Photo 45: CB-A appears to be in good condition, approximately <1 inch of sediment and organic debris accumulation observed.

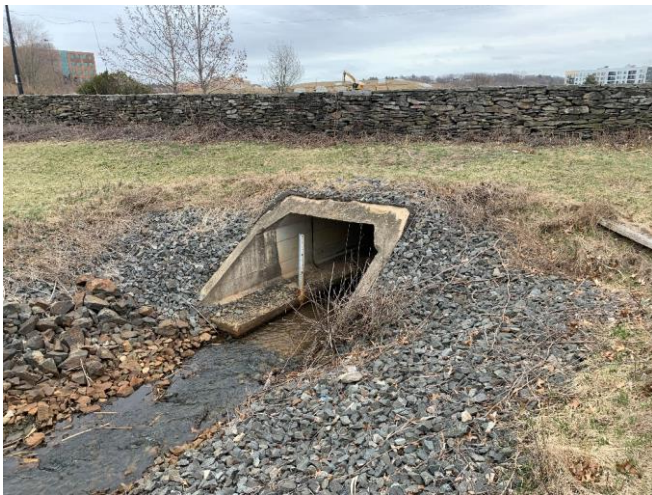
Photo 46: West side of a box culvert that runs under the northeastern corner of the property, looking east.

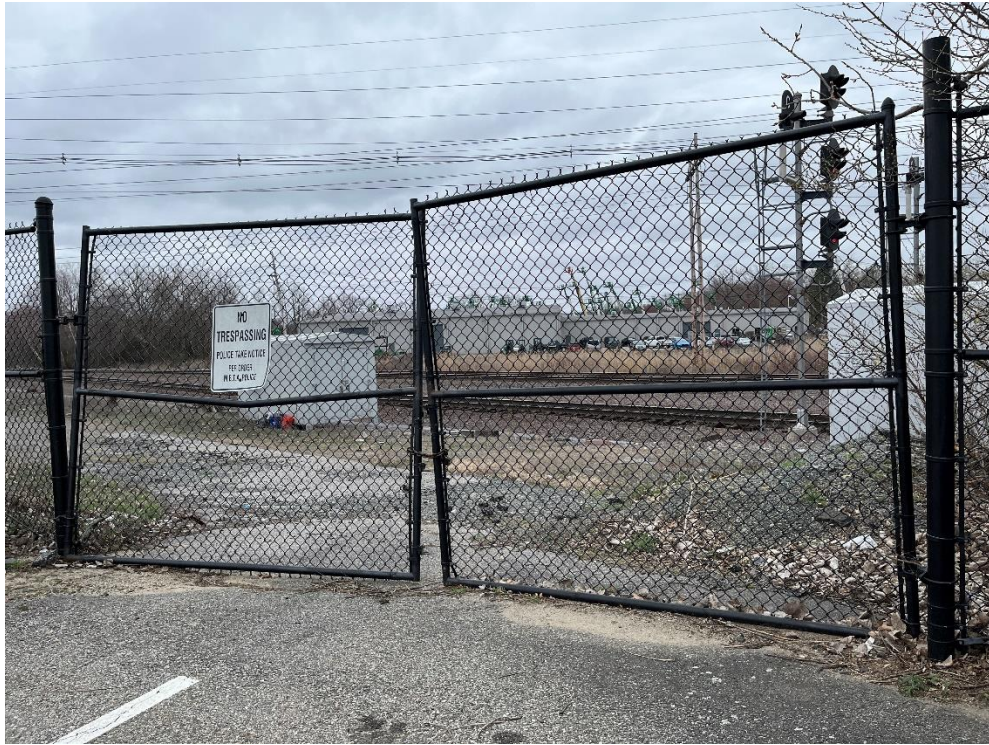
Photo 19: Gate warped, hinge appears damaged, facing south near CB32.

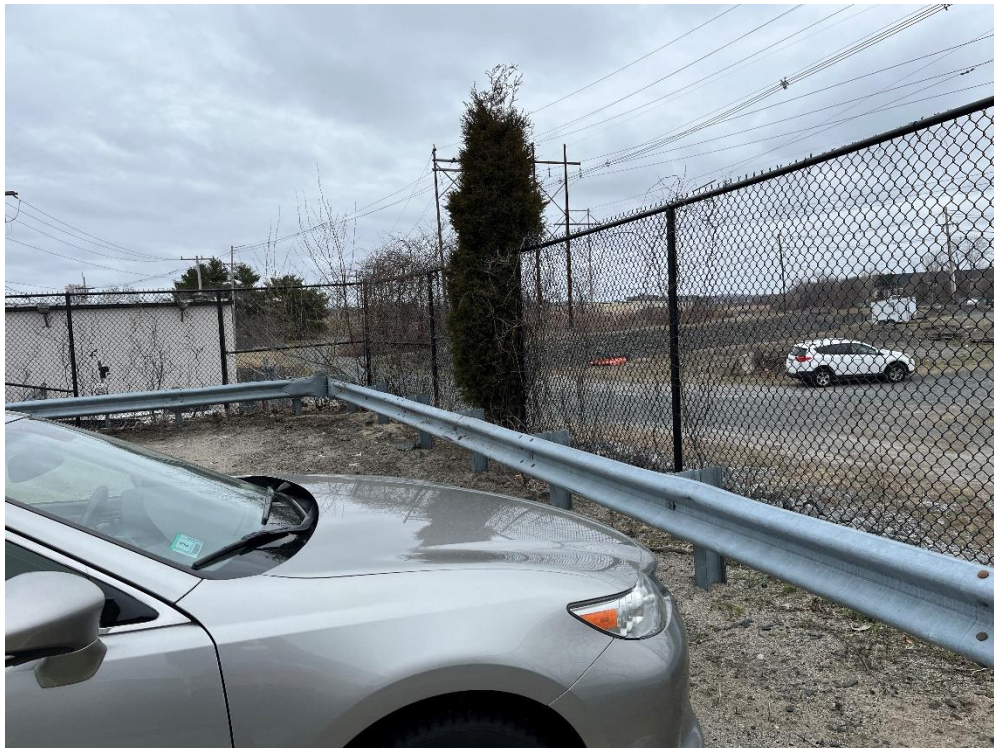
Photo 20: Vegetation growing through fence fabric along the southern edge of the site, looking south.

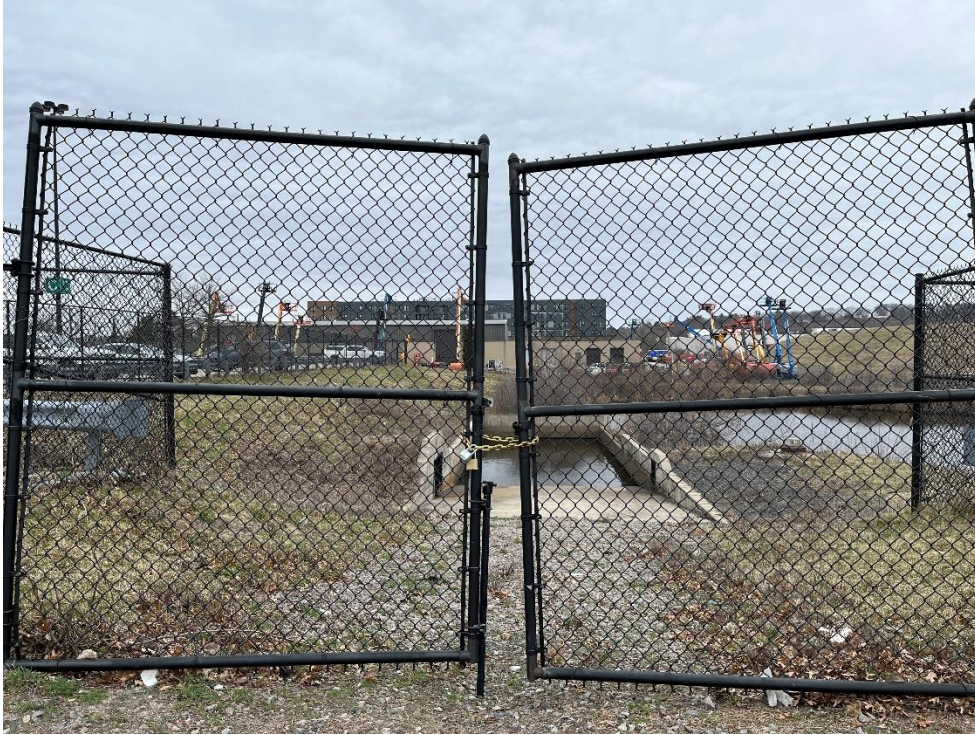
Photo 23: Damage to a gate near the southwest corner of the site, hinge appeared damaged, looking southwest.

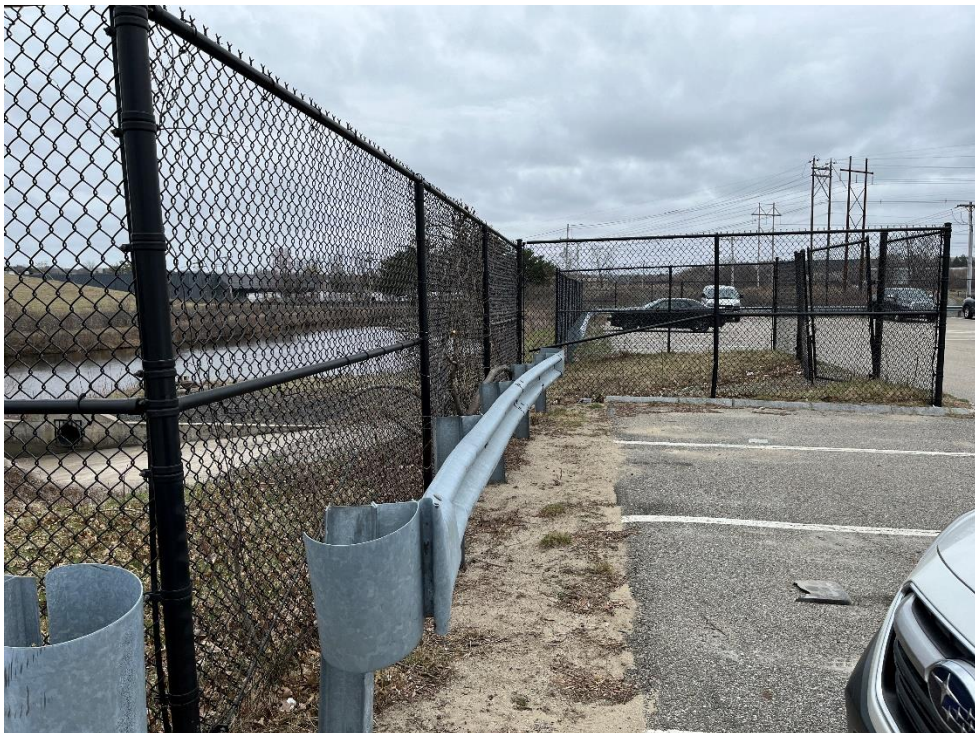
Photo 24: Disconnected fabric near sedimentation station and pole disconnected.

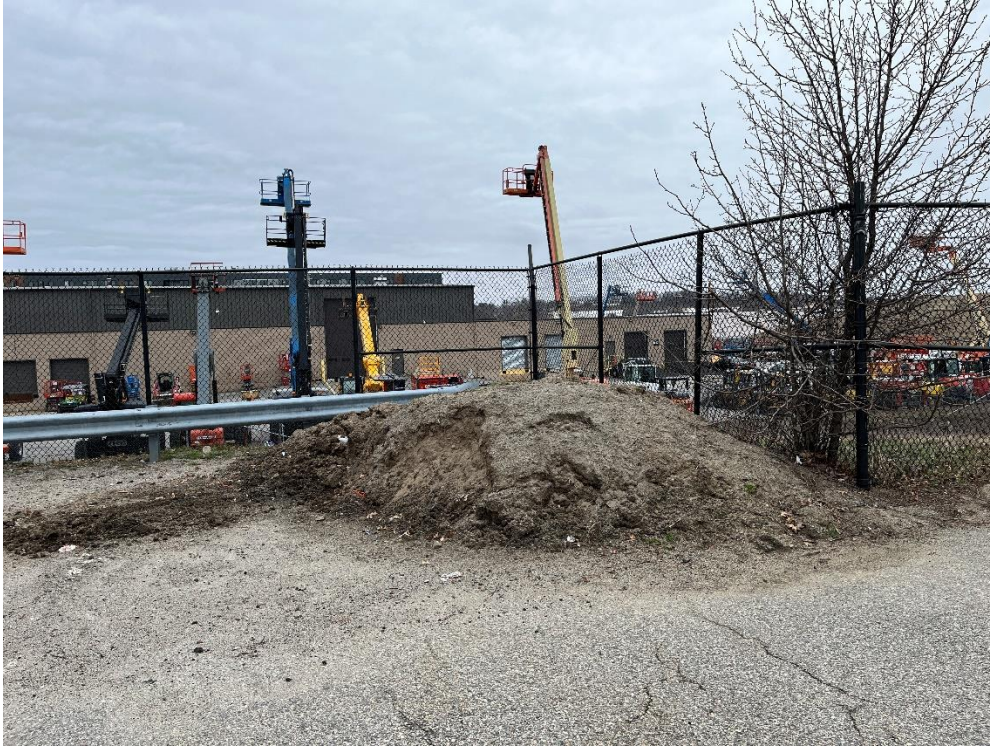
Photo 27: Top of post loose and fabric disconnected, near SF-10 looking east.

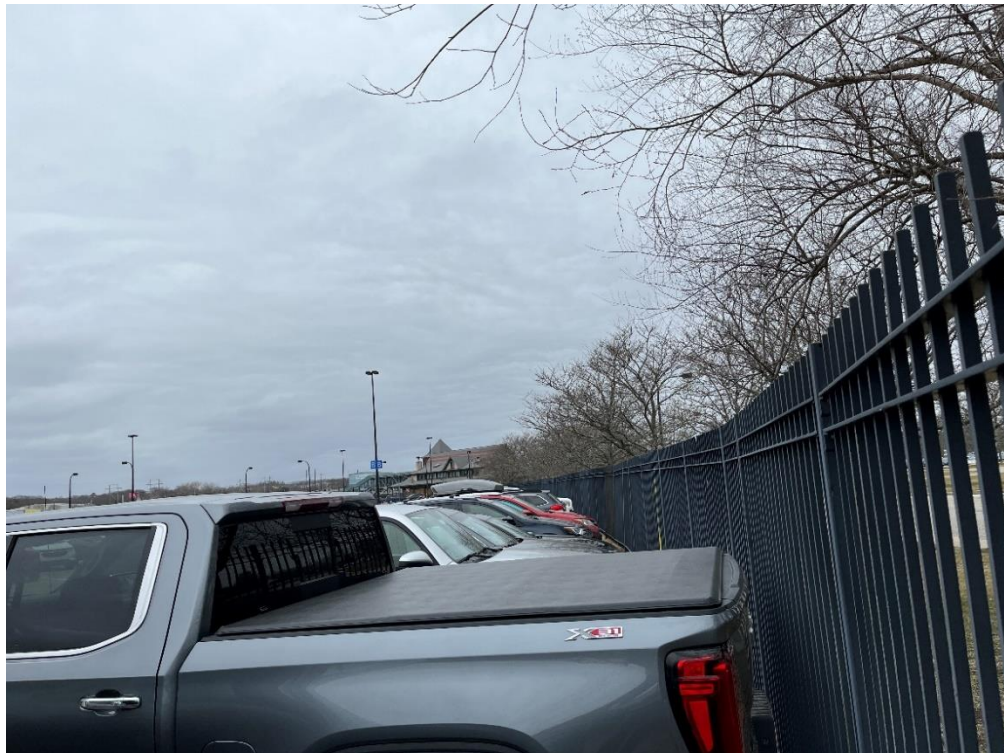
Photo 28: Leaning fence, near Atlantic Ave., looking north.
